Town of Milton Fire Station Space Needs Study

Milton, Massachusetts
November 23, 2015

KAESTLE BOOS
associates, inc

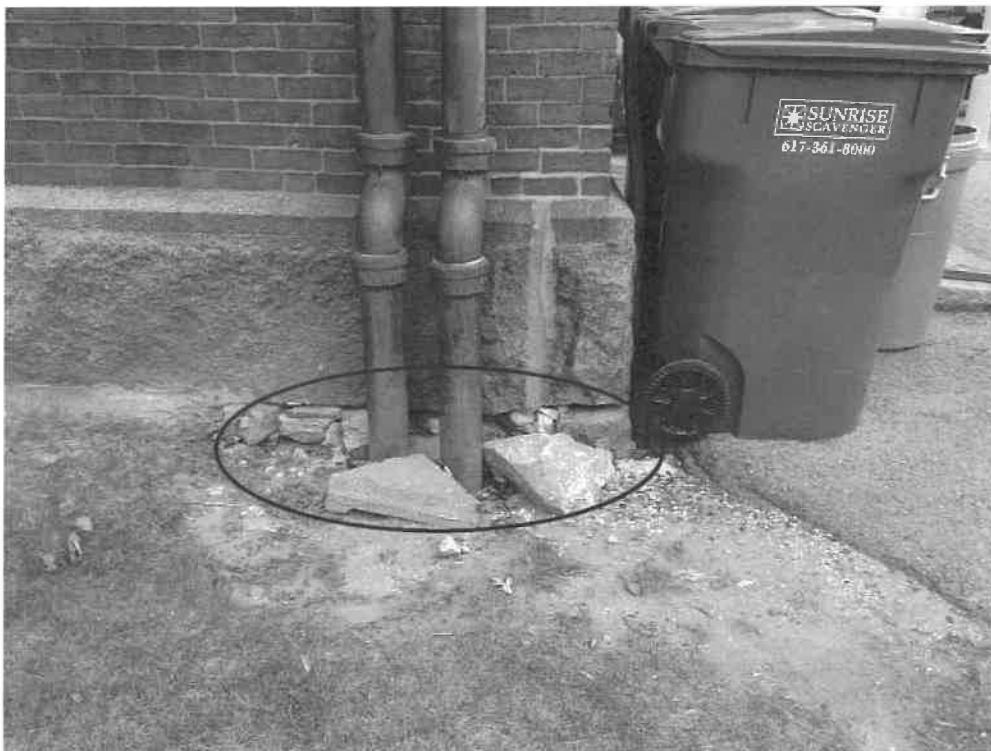
- The stone foundation walls on the northeast side of the original building are exhibiting signs of movement and deteriorated mortar joints which are allowing the infiltration of water into the basement. The cause of the movement is not known by observing the condition.

Deteriorating mortar joint in stone foundation wall.

- The first item involves the movement of the stone foundation wall and spalling of the mortar joints. It appears that some of the damage was caused by water infiltration and possible utility excavations. The foundation wall must be repaired as it supports the masonry bearing above. The repair would consist of forming, installing reinforcing steel and pouring concrete on the exterior and interior of the wall to provide stabilization of the wall.

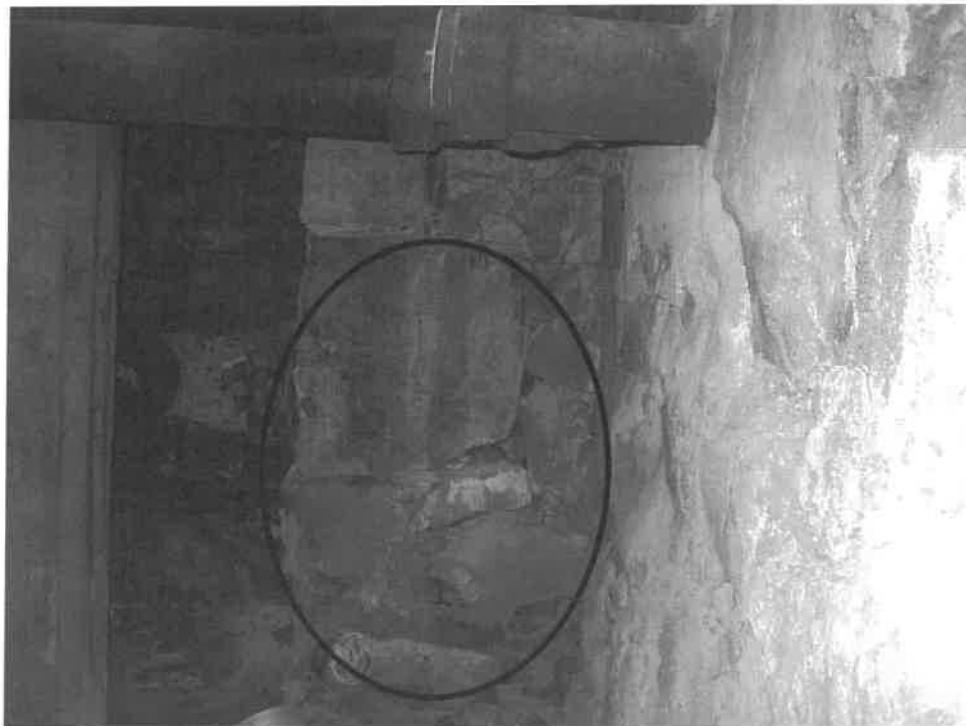
Open mortar joints in the stone foundation wall as viewed from basement.

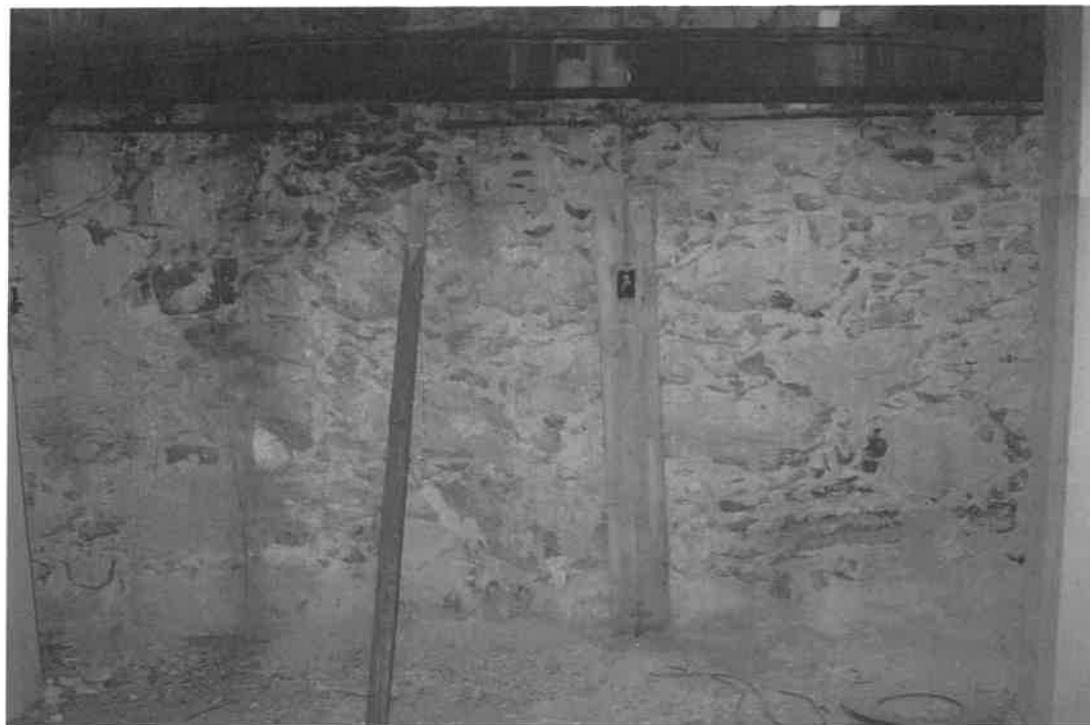
Powdered mortar on the interior basement wall.

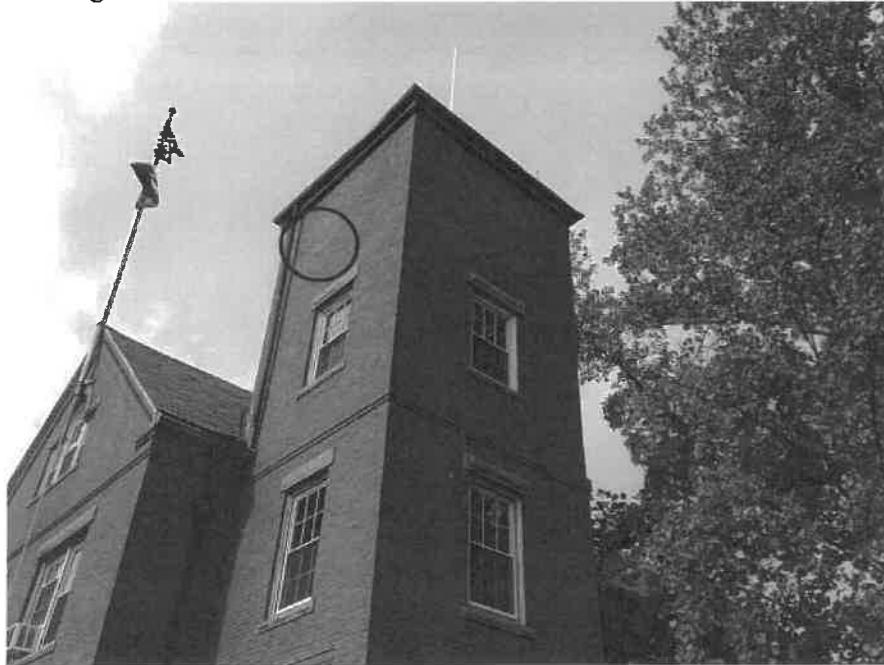
- Cracking, spalling and movement in the brick bearing walls of the stair tower and adjacent northeast wall. The spalling brick is especially noticeable on southeast face of the stair tower at the Upper Level. Cracks are present on the northeast face of the tower and along the east wall of the main building.

Southeast view of stair tower with spalled brick surface

- The movement observed in the stair tower must be further investigated to determine the cause of the movement. Solutions to repair the condition will be developed from the investigation.

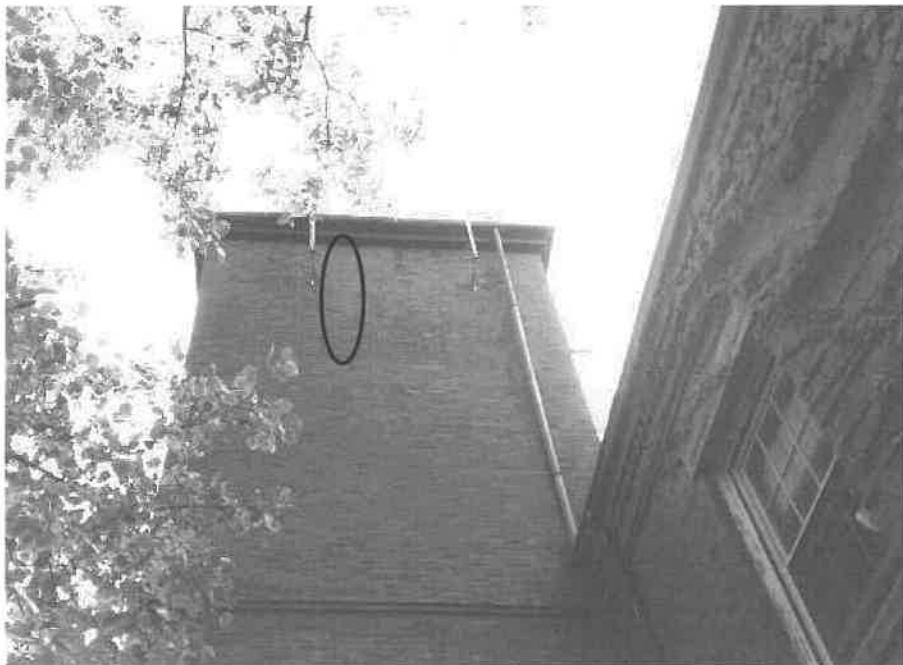
Vertical crack and movement in exterior brick wythe.

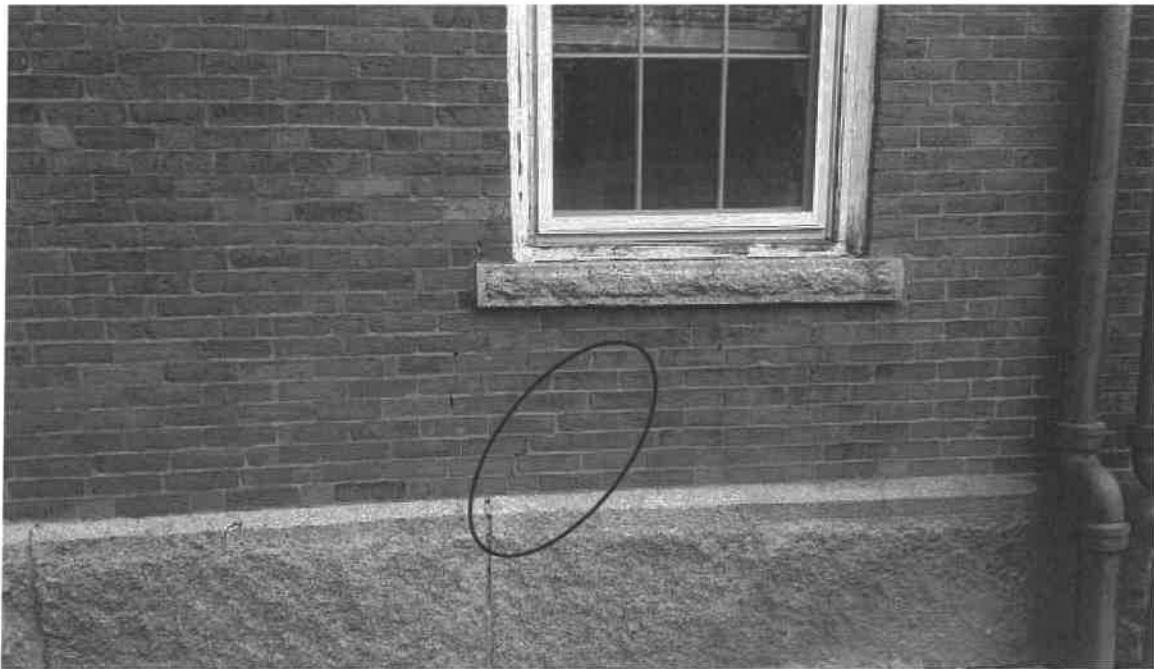
Diagonal cracks in mortar joint.

- Repoint the mortar joints to prevent further water damage to the mortar joints and brick should be scheduled next spring to prevent further damage to the walls.

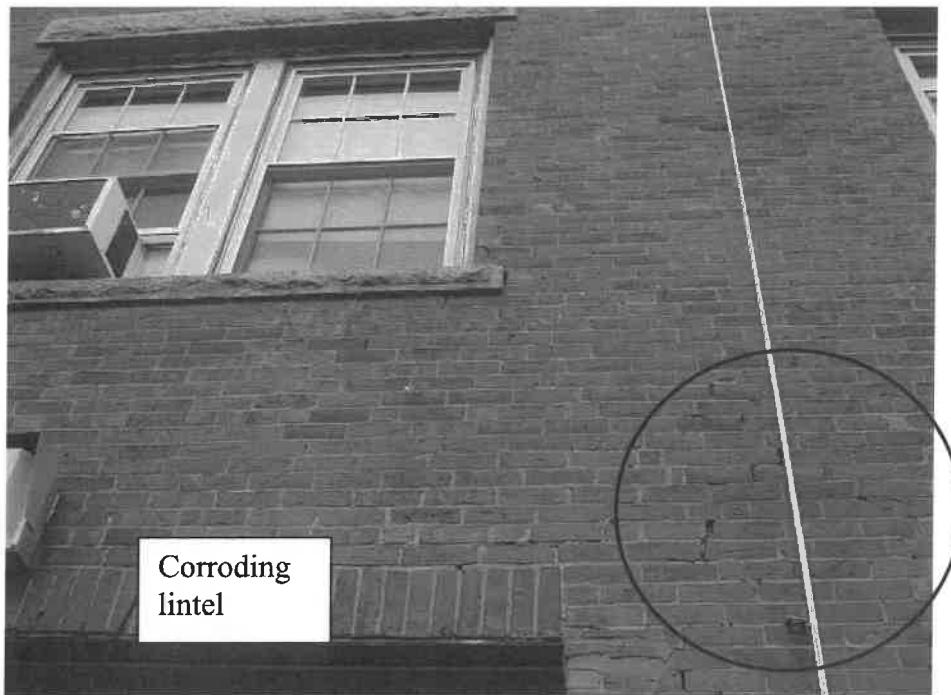
- Corrosion is visible on the steel lintels supporting the masonry above the overhead garage doors. The corrosion is causing spalling and movement in the exterior brick wythe of the building.

Movement and spalling mortar in exterior brick wythe at door opening and beyond.

- The masonry on the front of the building adjacent to the overhead doors on the original building will require further investigation to determine the cause and repair solutions. One cause is the infiltration of rain water into the wall and corrosion of the existing steel lintel which will displace the brick and mortar. An investigation of the damage will identify the condition of the steel lintels and damage to the masonry due to movement and water.

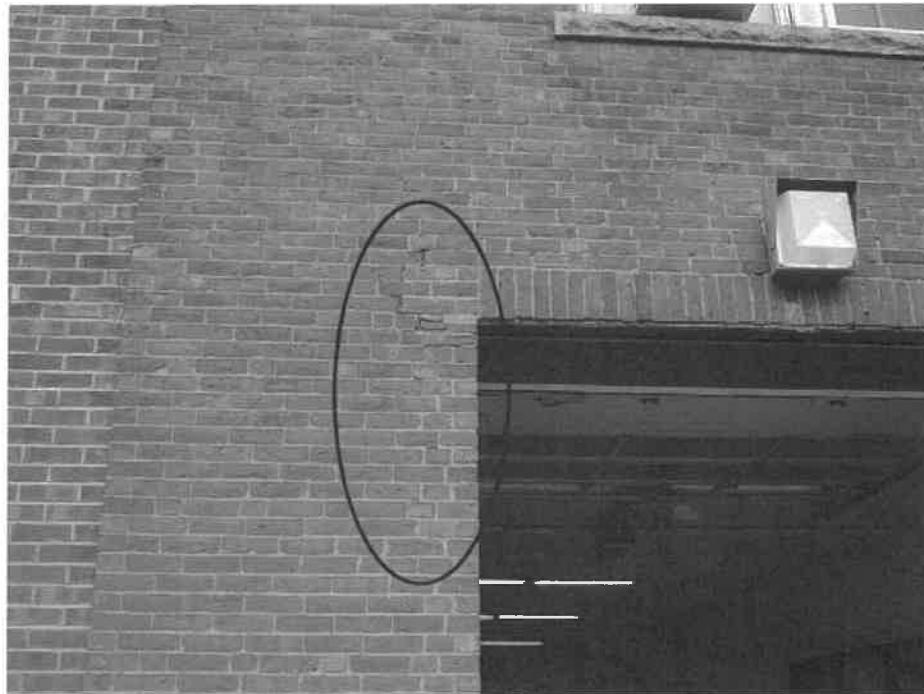
Movement in brick wall due to corrosion in steel angle lintel.

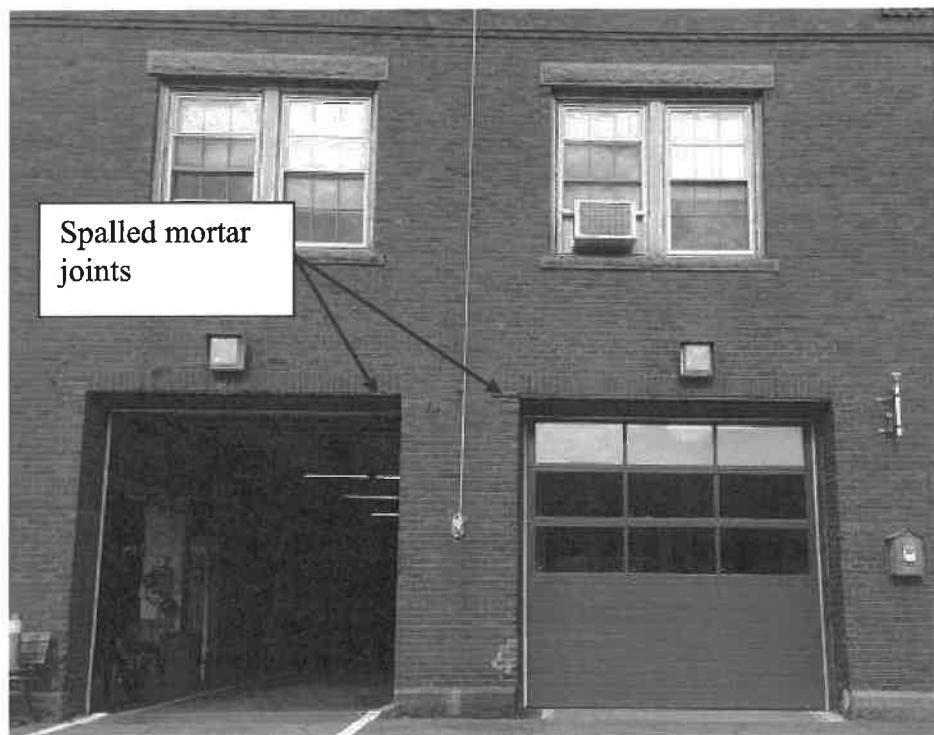
Spalled mortar joint at steel lintel bearing points

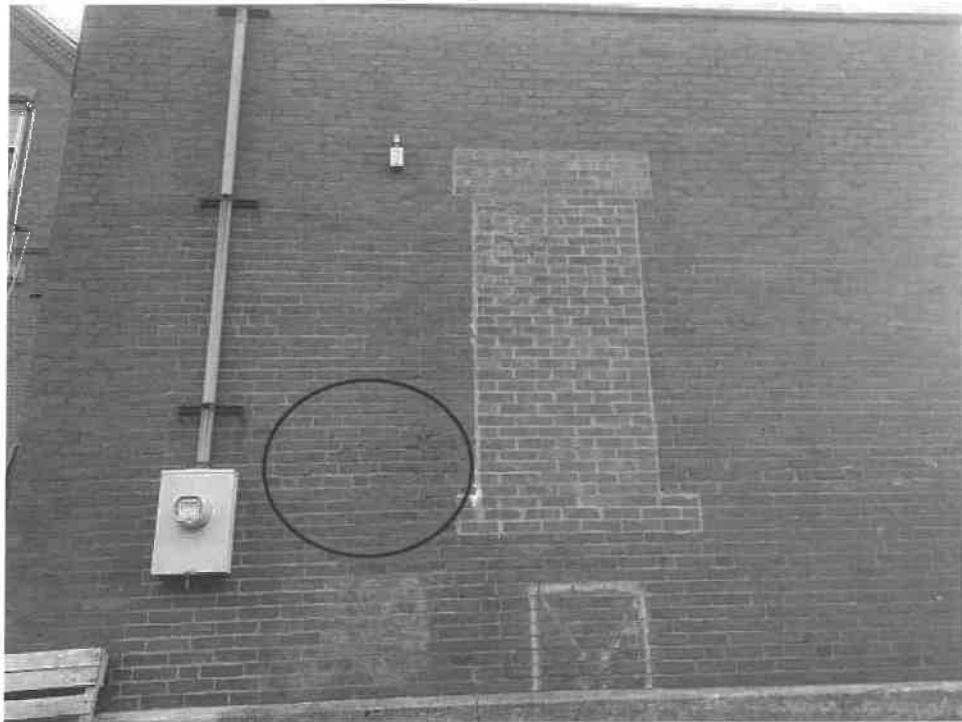
- Spalled mortar joints and cracked bricks were observed on the northwest face of the single story addition. Mortar joints are partially or completely open due to the spalled mortar and water is able to enter into the joints between the bricks and be absorbed by the inner masonry wythes which causes more damage over time.

Spalled mortar joint on northwest face of single story addition.

- Repointing of the entire building after the other repairs are completed. This will seal the mortar joints, remove all deteriorating mortar and replace any damaged bricks in the process.

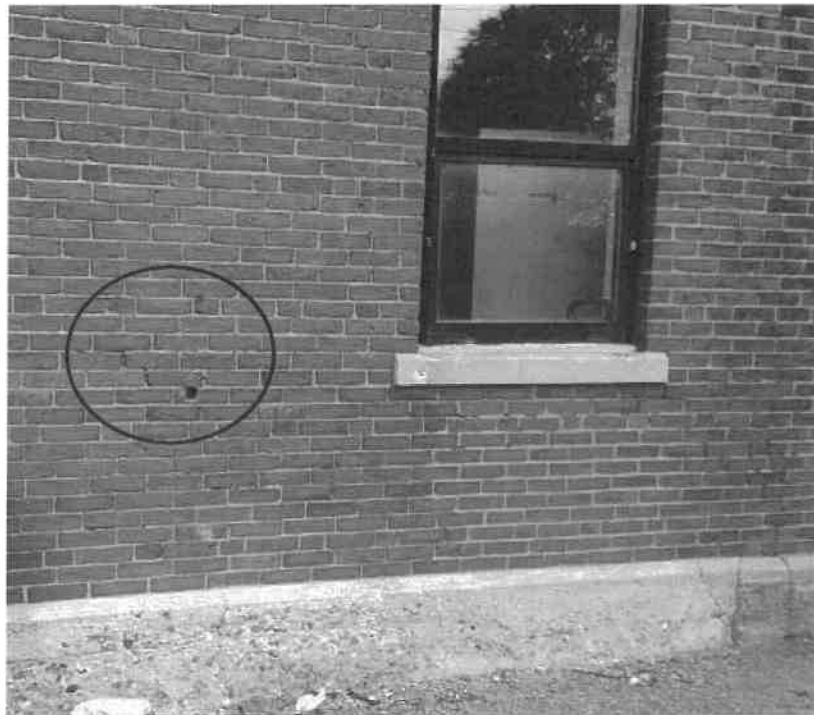
Spalling mortar joints on northwest wall.

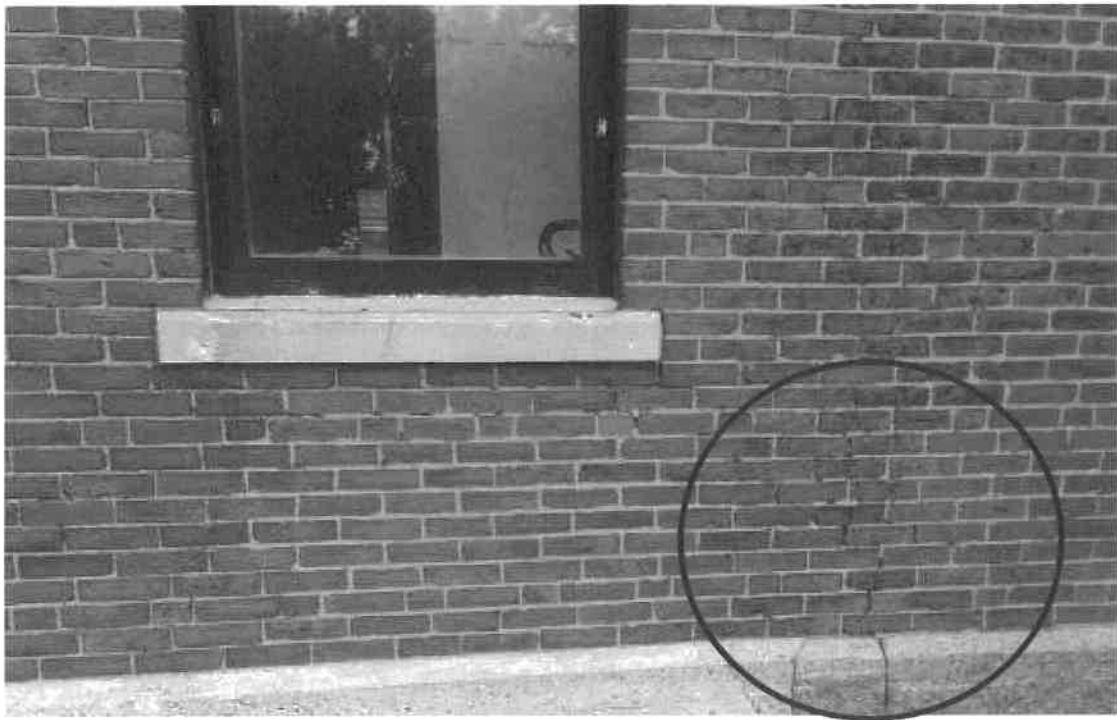
Cracks in exterior brick wythe below and between window openings

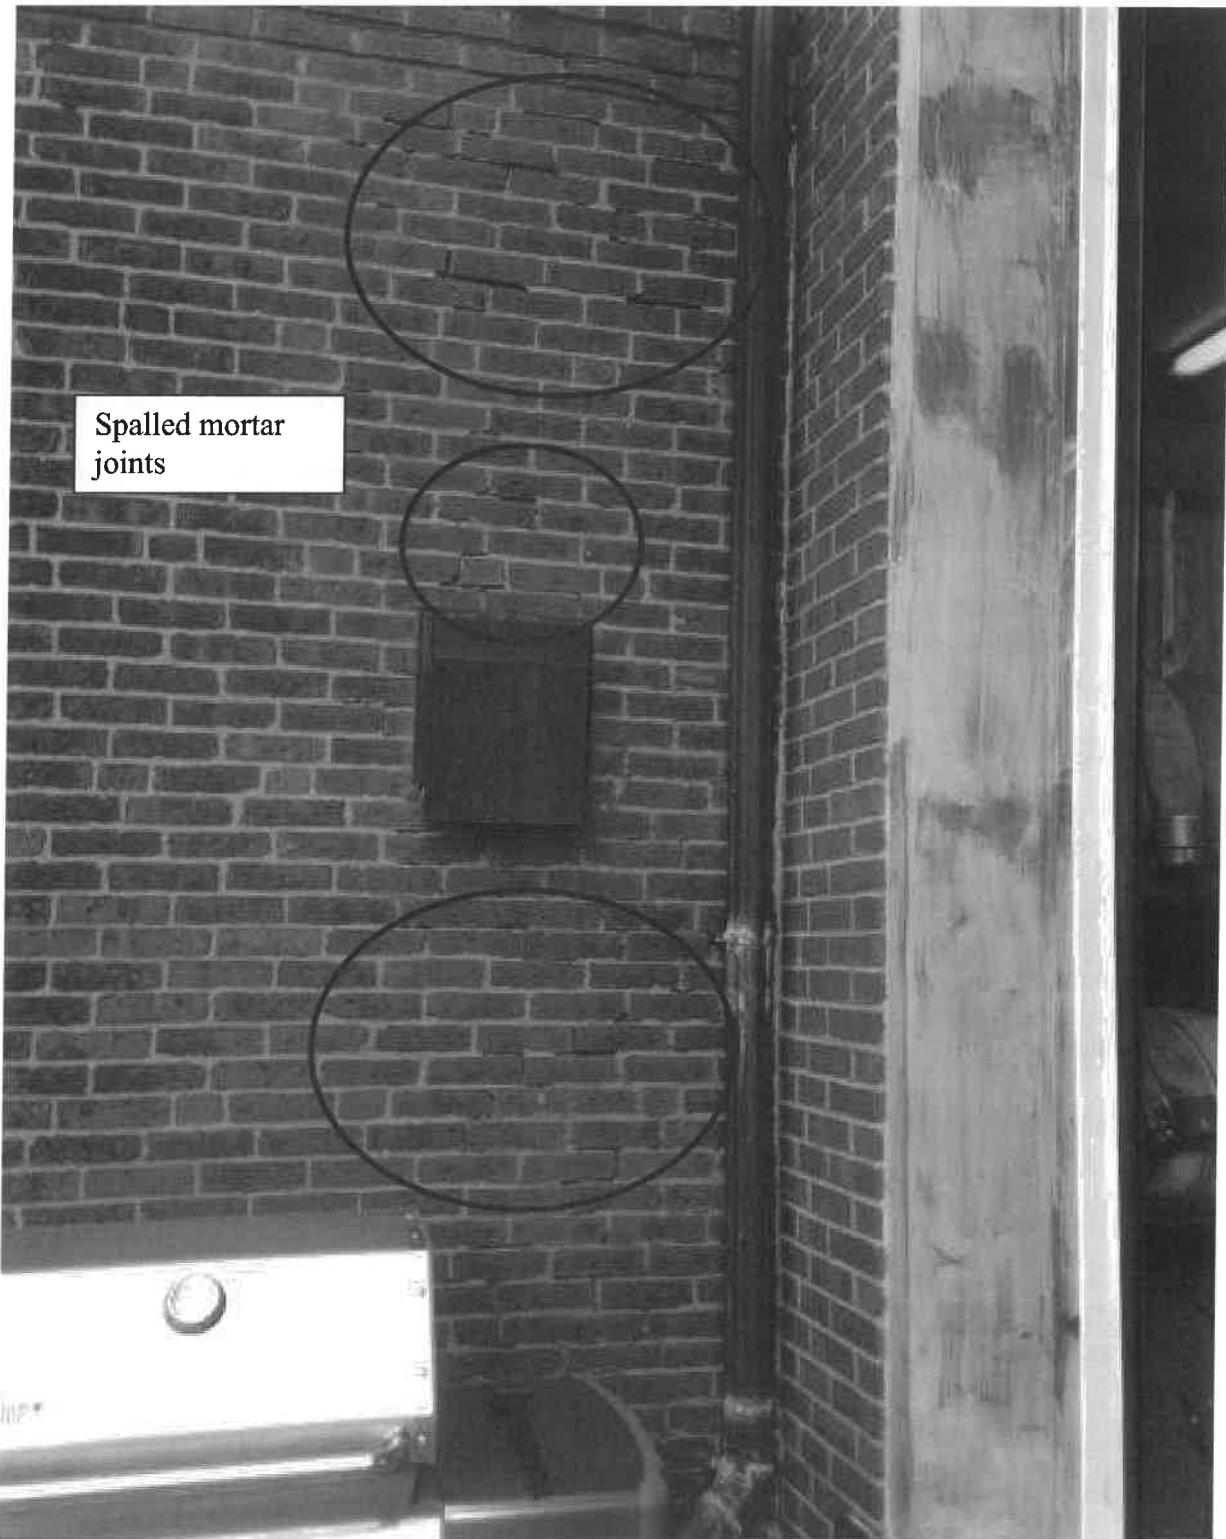
Spalled mortar joints.

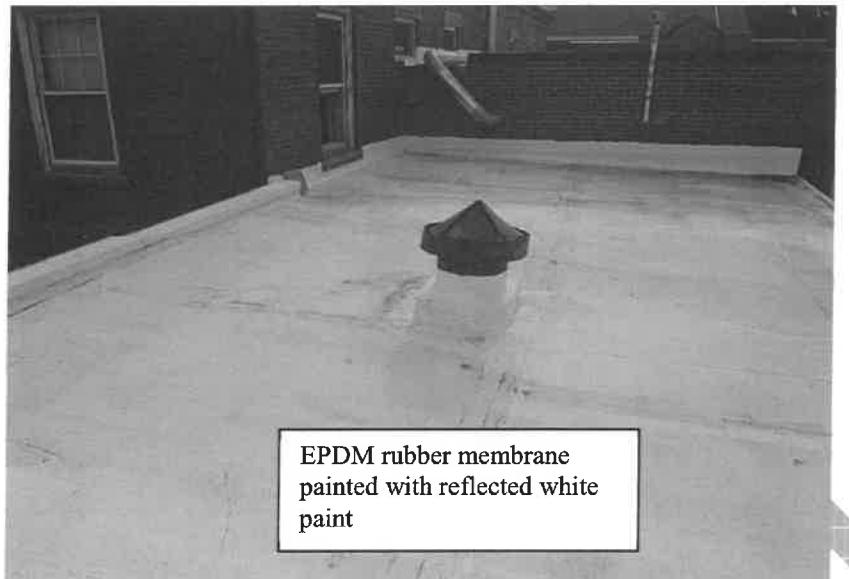
The reflective paint was applied a number of years ago and the paint is wearing and peeling off.

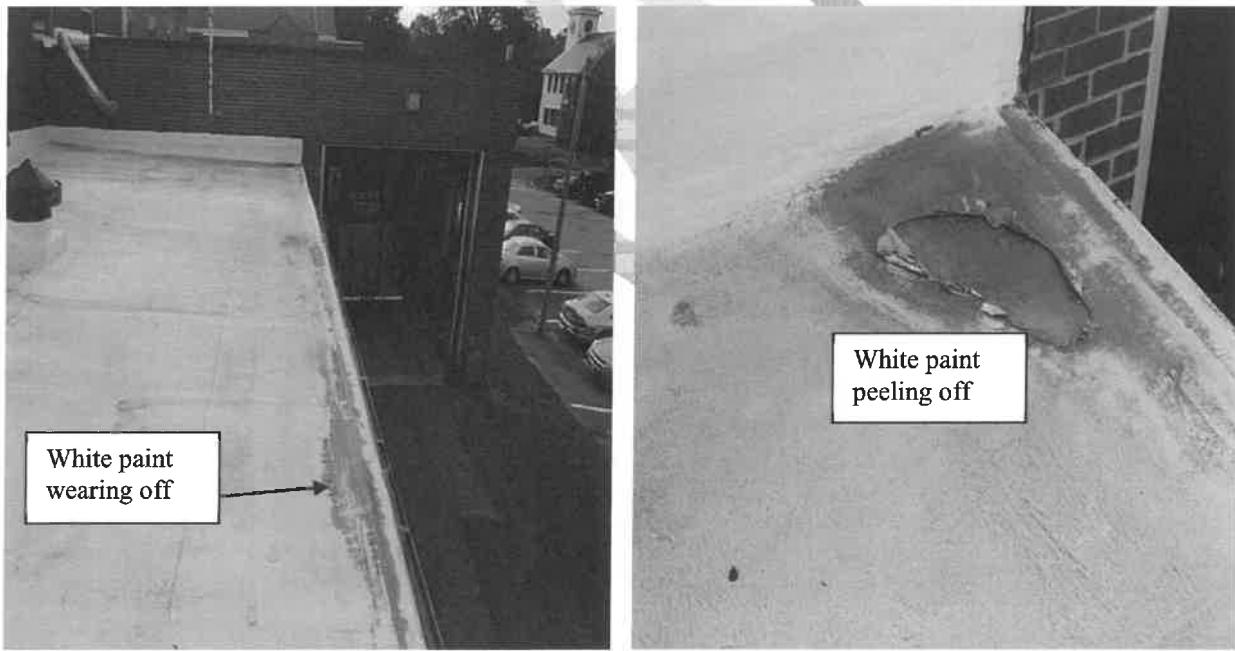
Patches were observed under the painted surface and the roof was soft and spongy indicating water saturated insulation trapped beneath the membrane. The moisture is a problem which could lead to the growth of mold and mildew. The roof on the addition should be removed down to deck and replaced with a new single ply membrane roof with a 20 or 30 year warranty on new insulation that meets current energy code requirements.

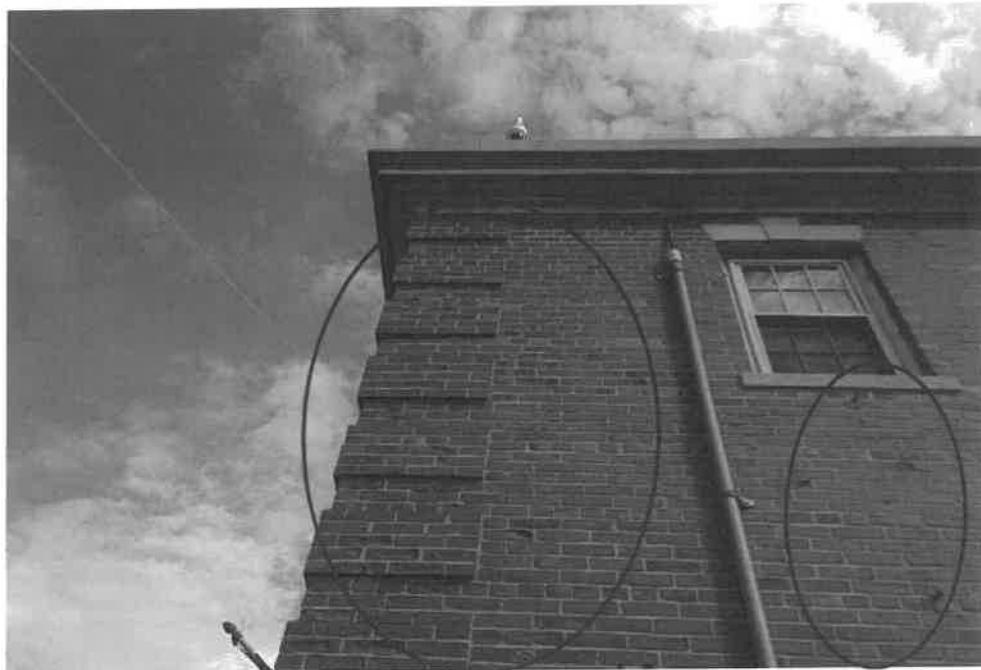
- Considerable spalling and cracking of the exterior brick around the entire building but especially on the south face.

Spalling brick on the southeast corner of the building.

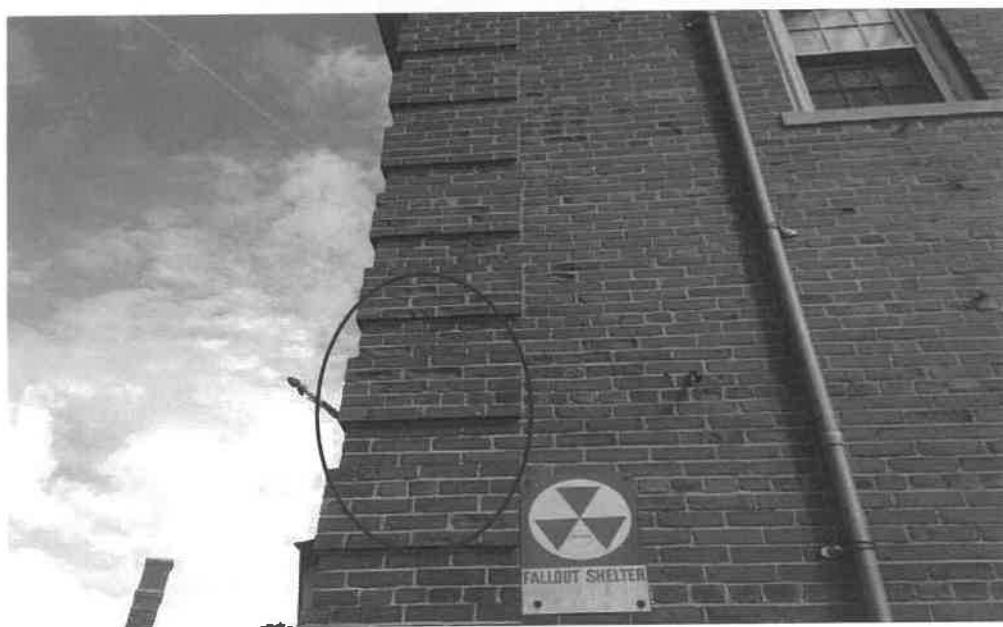
Close up of spalling of bricks on south face.

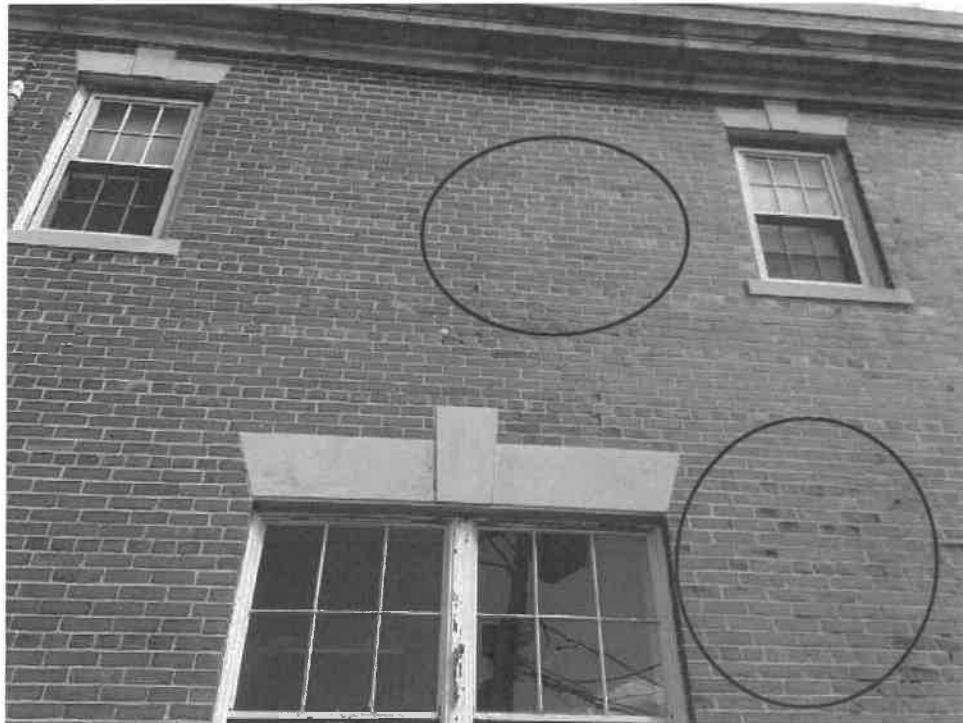
Areas of spalling on south face

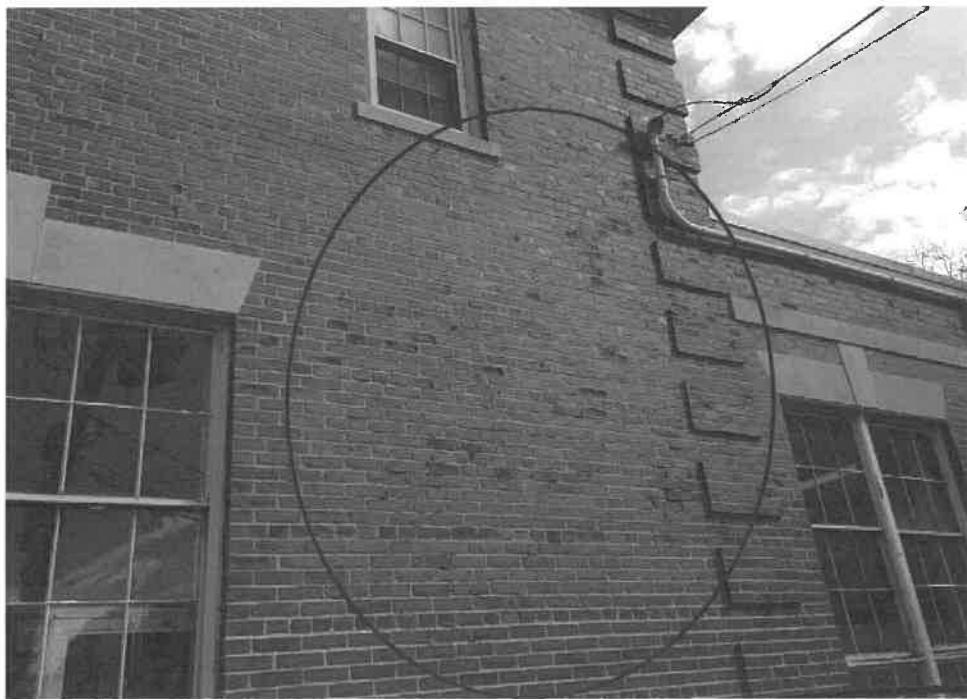
Large spalling brick surface

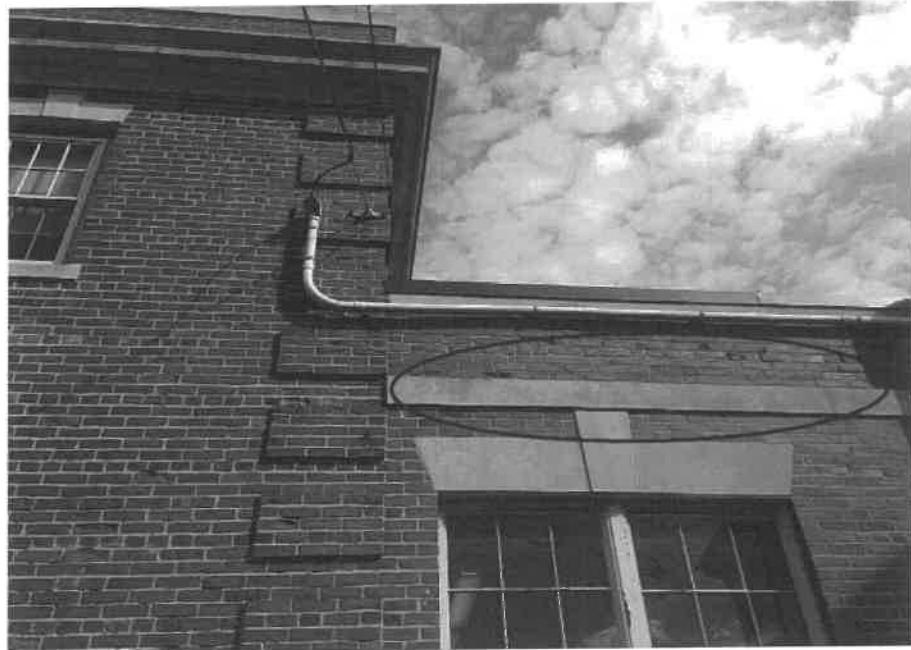
Spalling brick

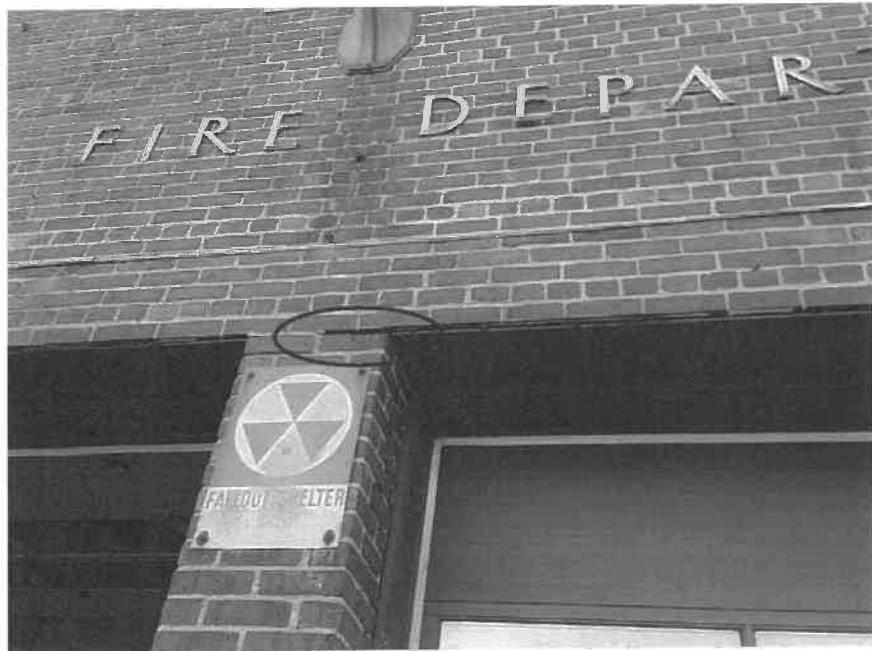
- Corrosion of the steel lintels is visible along with cracking and movement of the exterior brick and spalling of mortar joints above the overhead doors on the front (west) side of the building. A similar condition is present above the windows on the north face of the fire station.

Spalled mortar and lack of weep holes to provide drainage of the masonry.

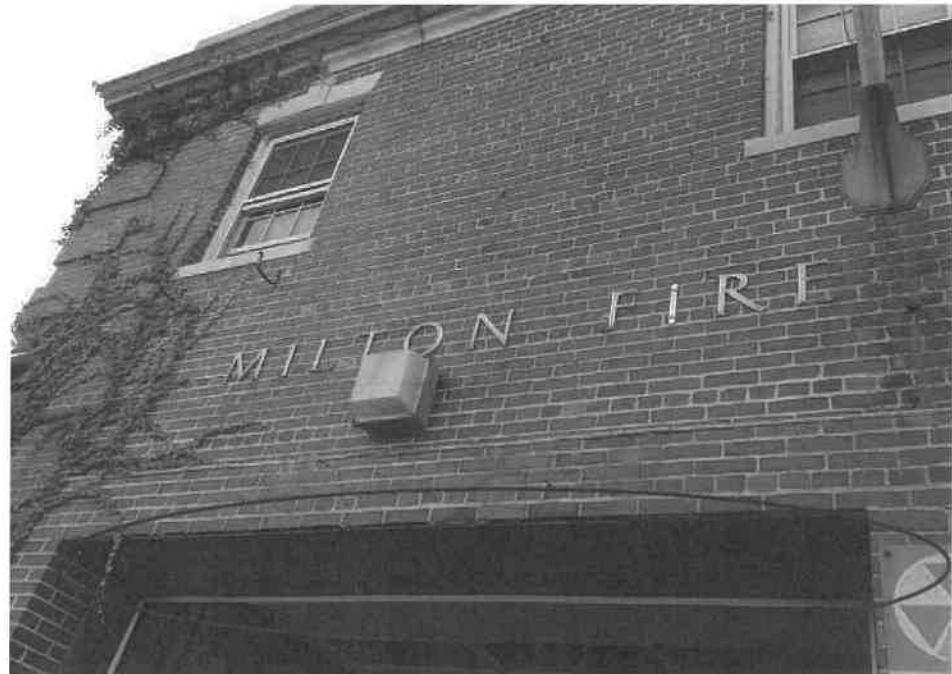
Downward rotating steel lintel indicating corrosion damage.

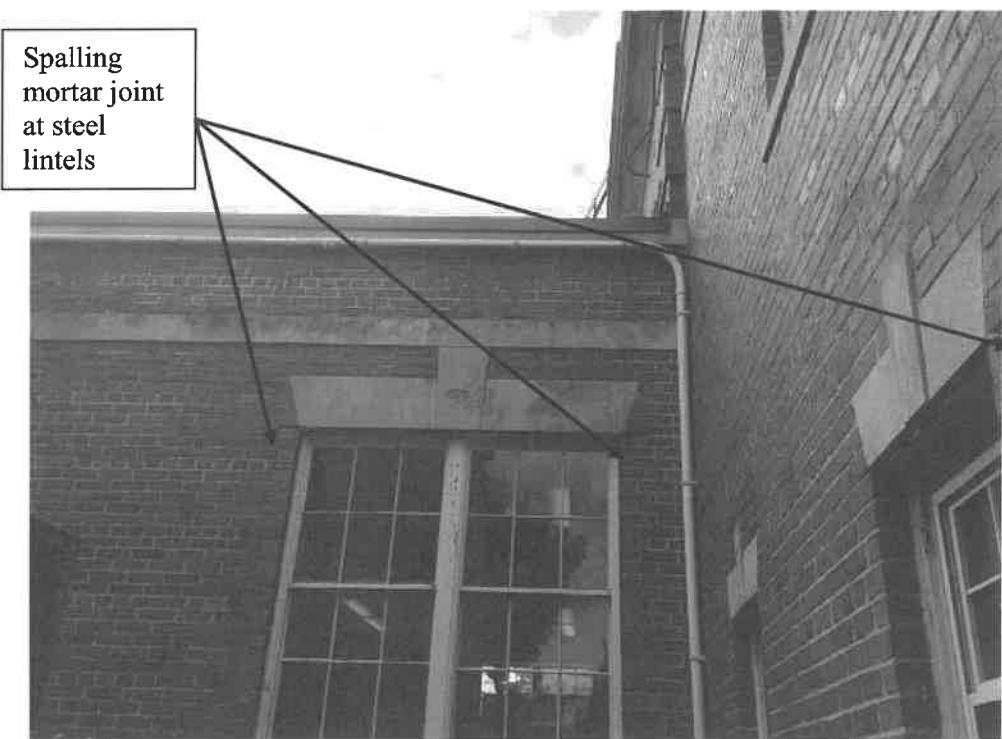
Corroding steel lintels supporting masonry above window openings.

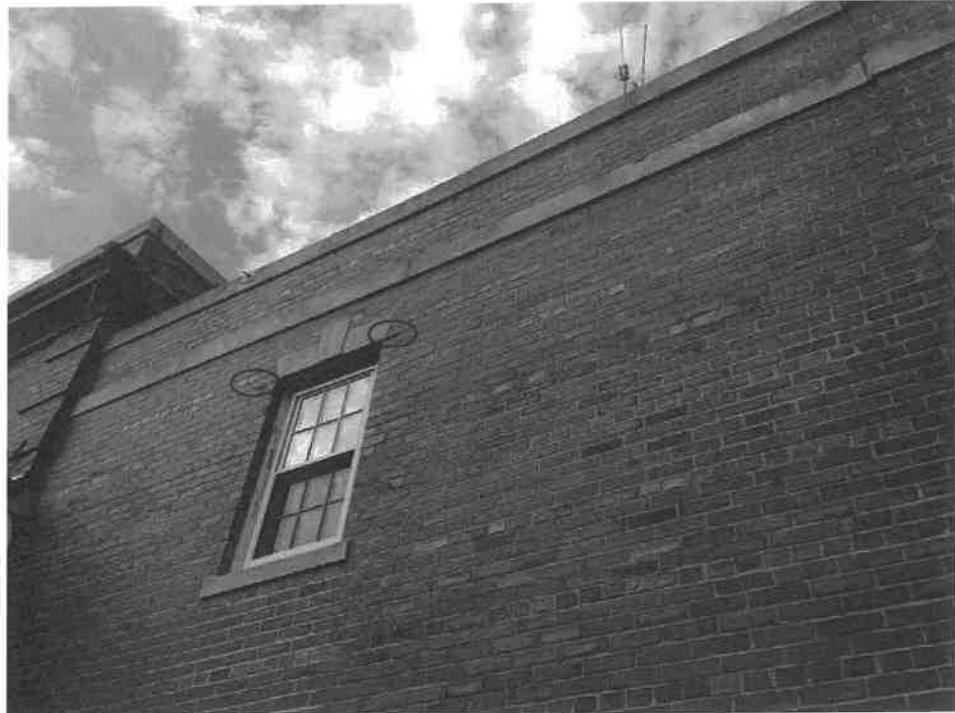
Spalled mortar joint above window opening.

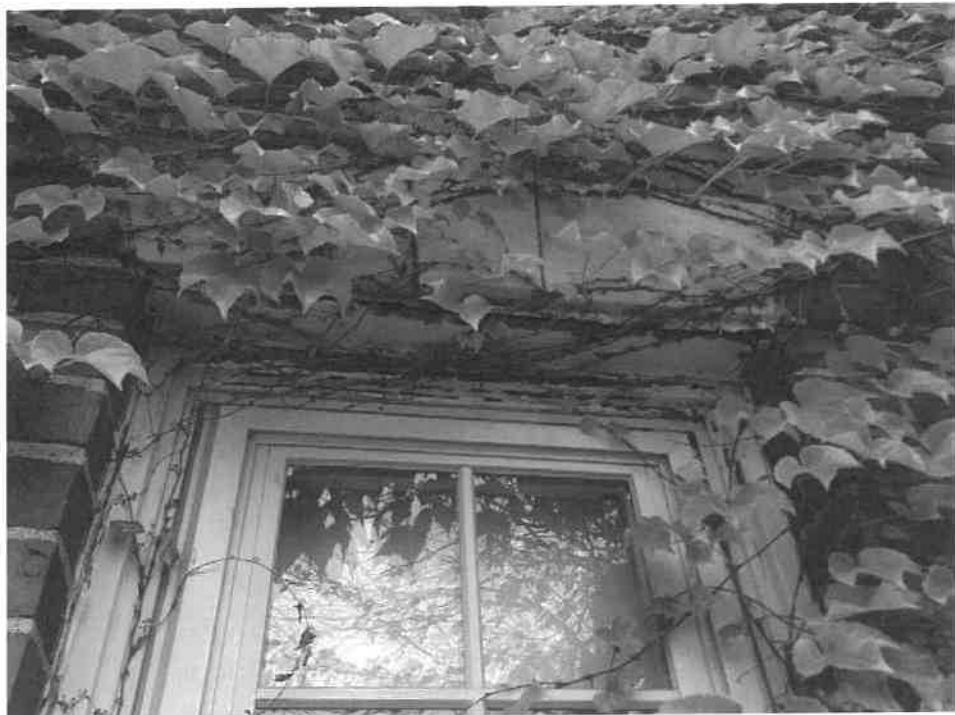
Ivy attached to mortar joints and brick damages the materials.

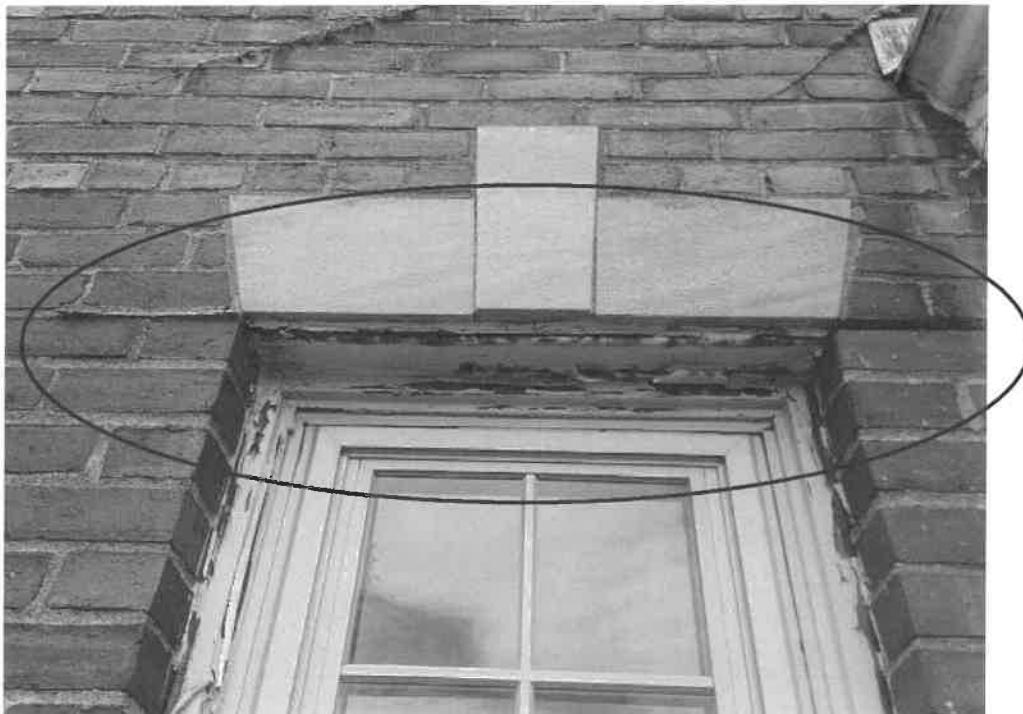
Close up of outward and upward movement due to corroded steel angle

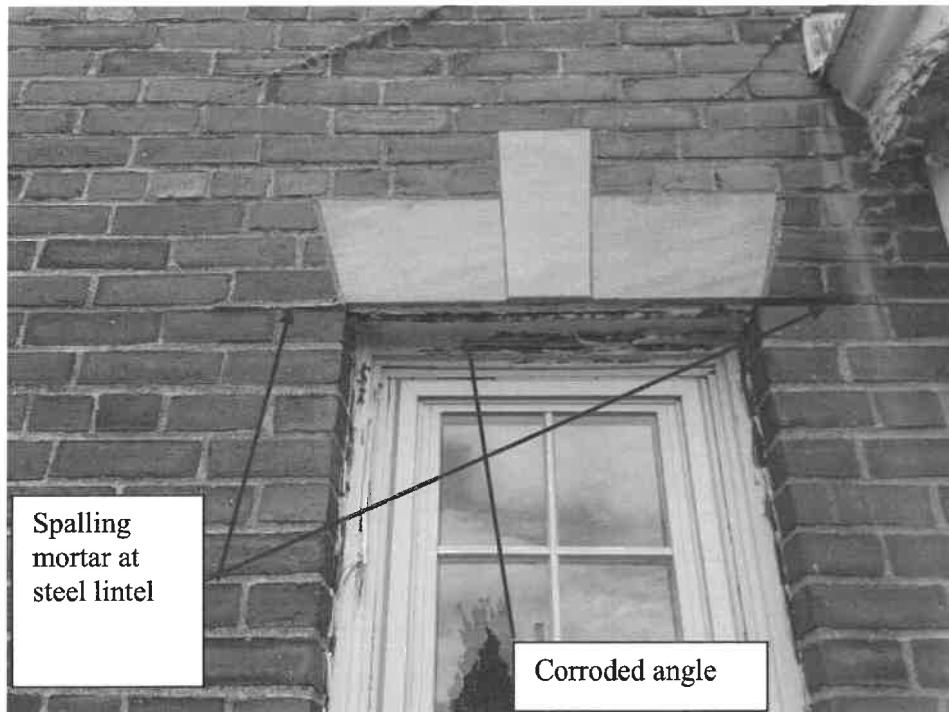
Corroded steel lintel lifting brick and limestone header off lintel.

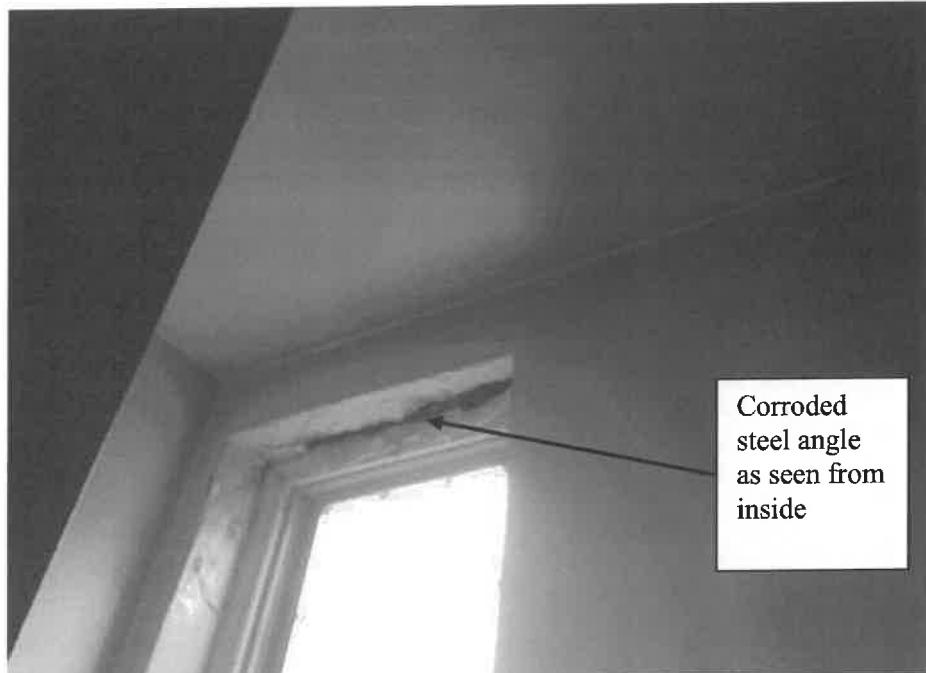
Interior view of rusting steel angle and water infiltration damage to sheetrock walls.

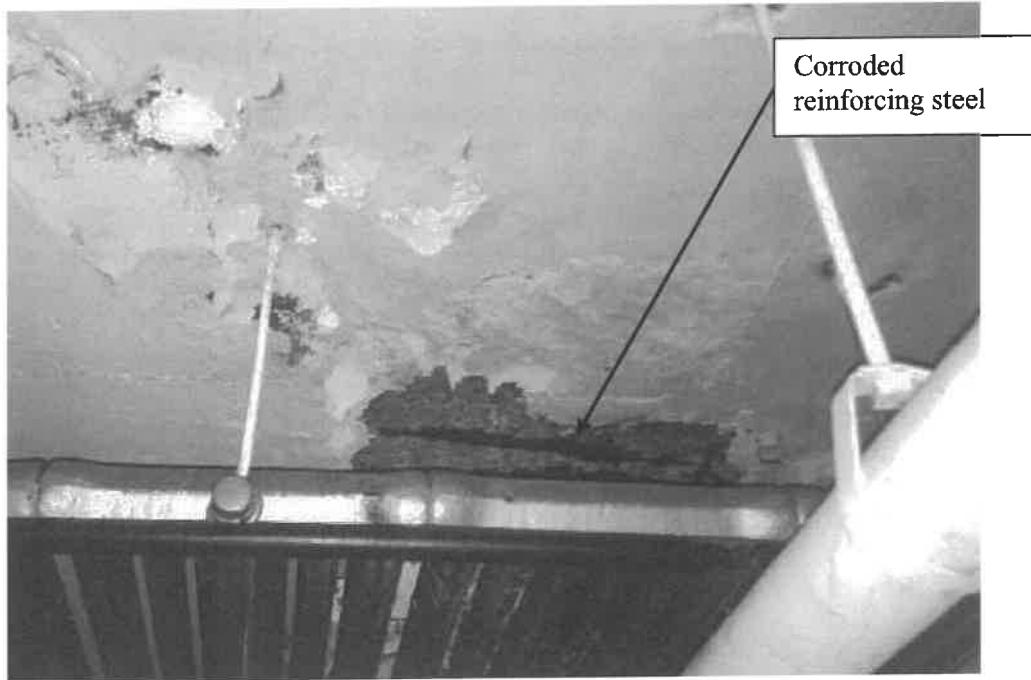
- Spalled concrete is visible on the underside of the Apparatus Bay concrete slab. The majority of the spalls are $\frac{1}{4}$ " deep but in some instances they are deeper exposing reinforcing steel.

Exposed rebar in the slab and extensive cracking of the slab beyond the spalled concrete.

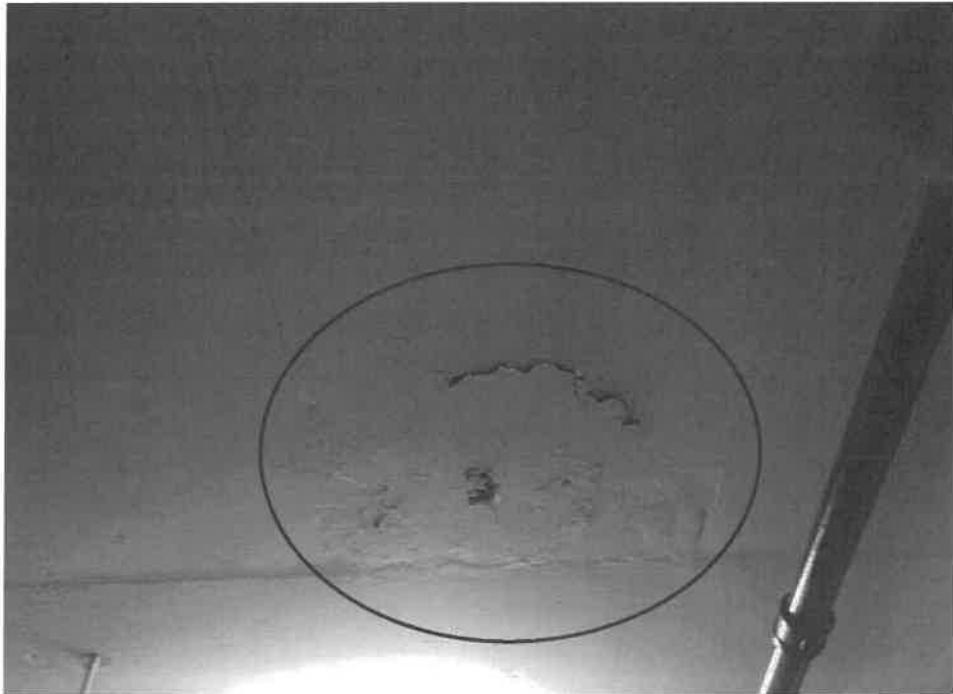
Underside surface of the spalled concrete slab.
