Town of Milton Fire Station Space Needs Study

Milton, Massachusetts
November 23, 2015

KAESTLE BOOS
associates, inc

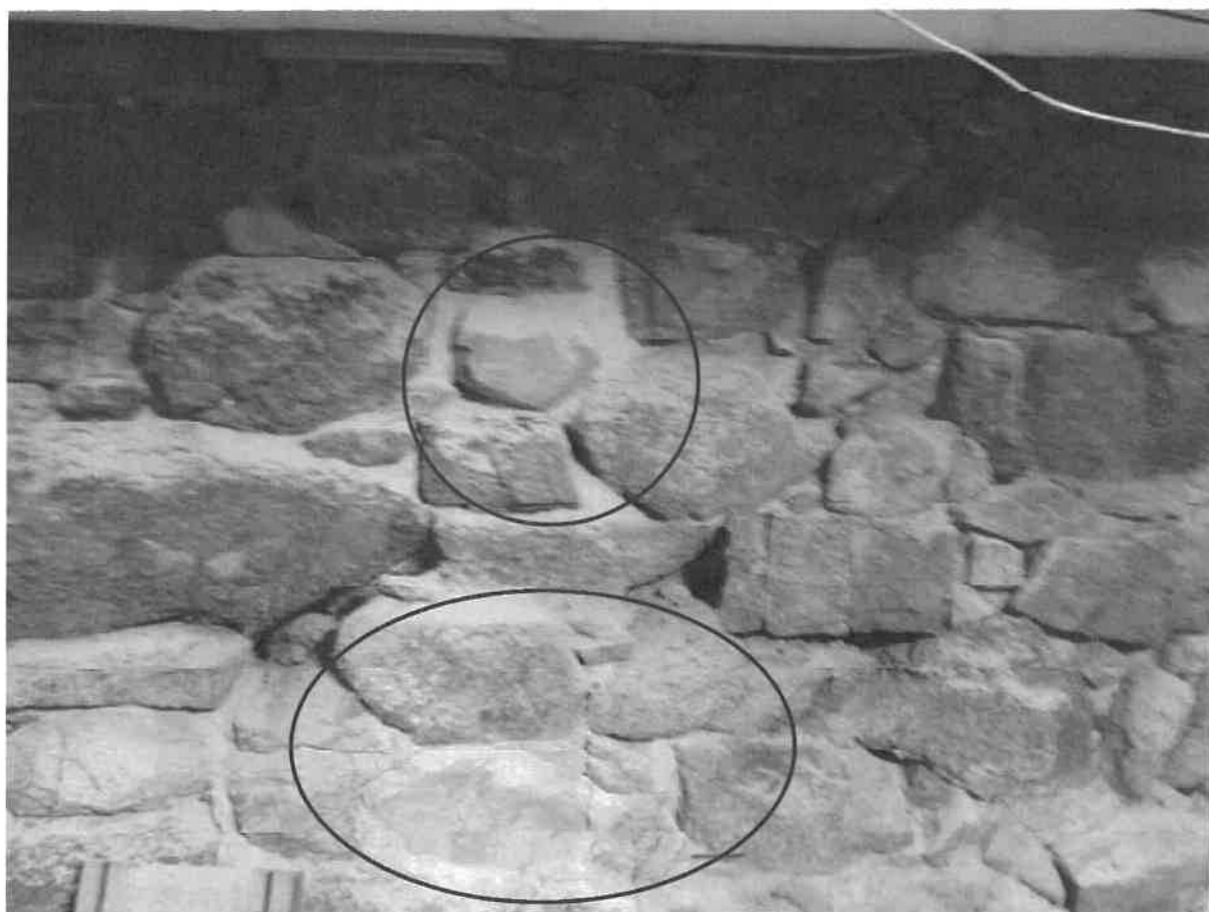
- There are several areas where the mortar is becoming powdery and is disengaging from the surface of the stone wall. Loose mortar is visible in many locations both inside and outside. Cracks were also observed in some of the stones. Both conditions will allow water to enter into the walls and subject them to freeze/thaw damage.

Powdered mortar collected on top of the stones which form the foundation wall as viewed from the basement.

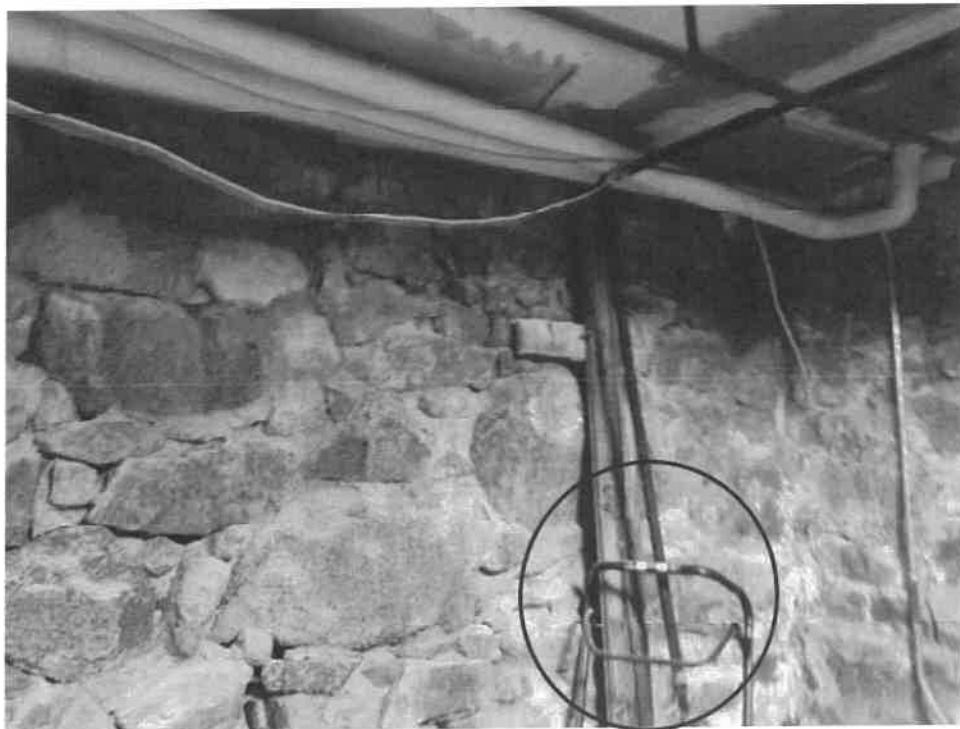
Powdered mortar collected on foundation wall surface viewed from the interior.

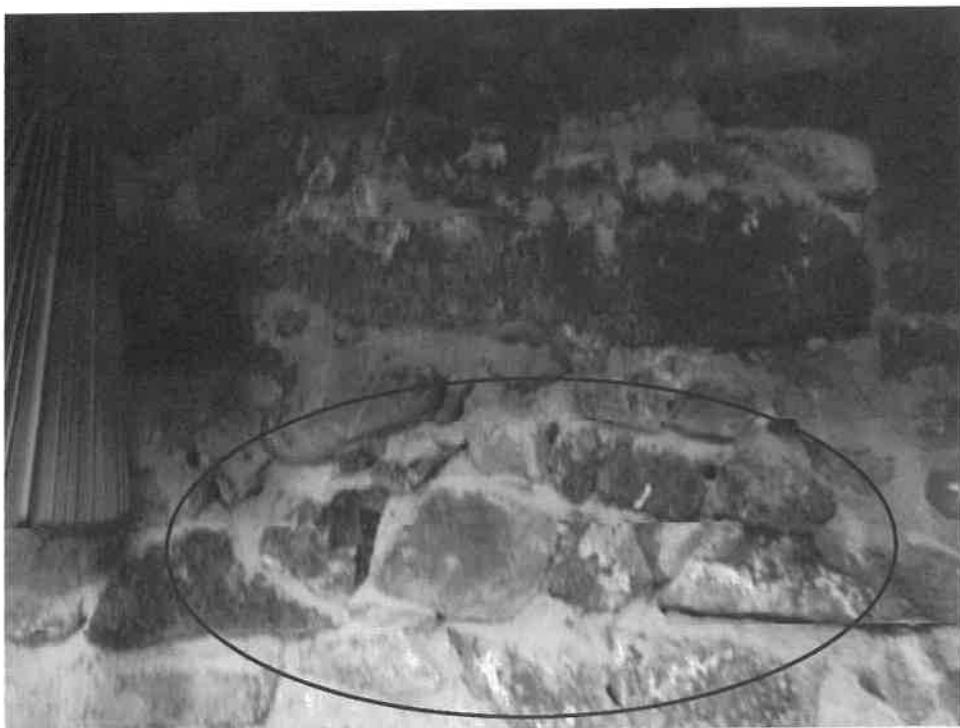
Powdering mortar as viewed from the basement

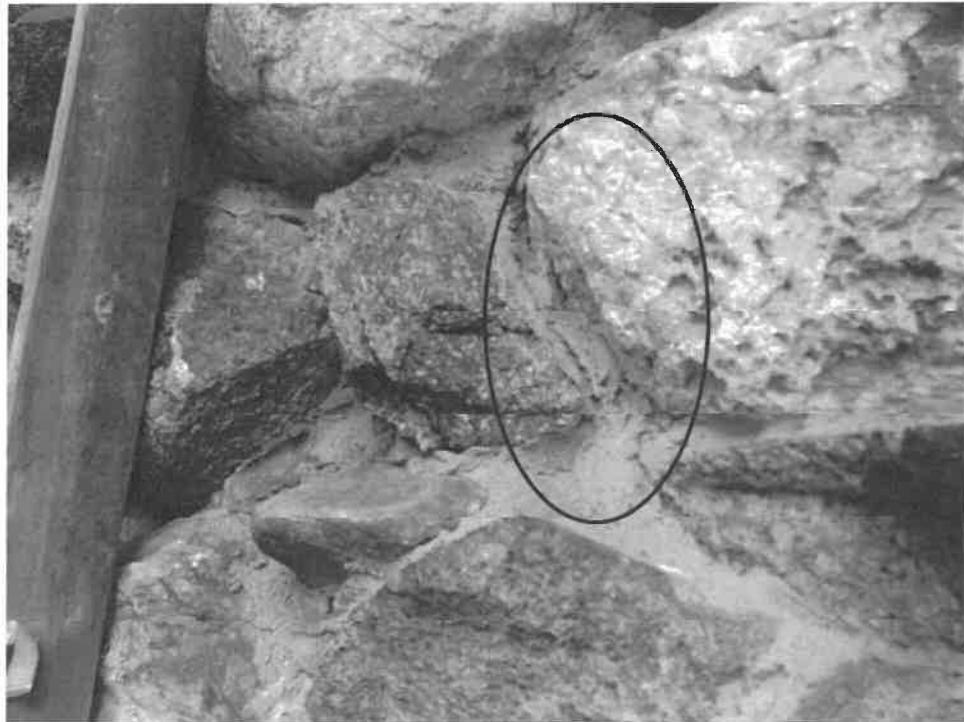
Cracked mortar joint between stones.

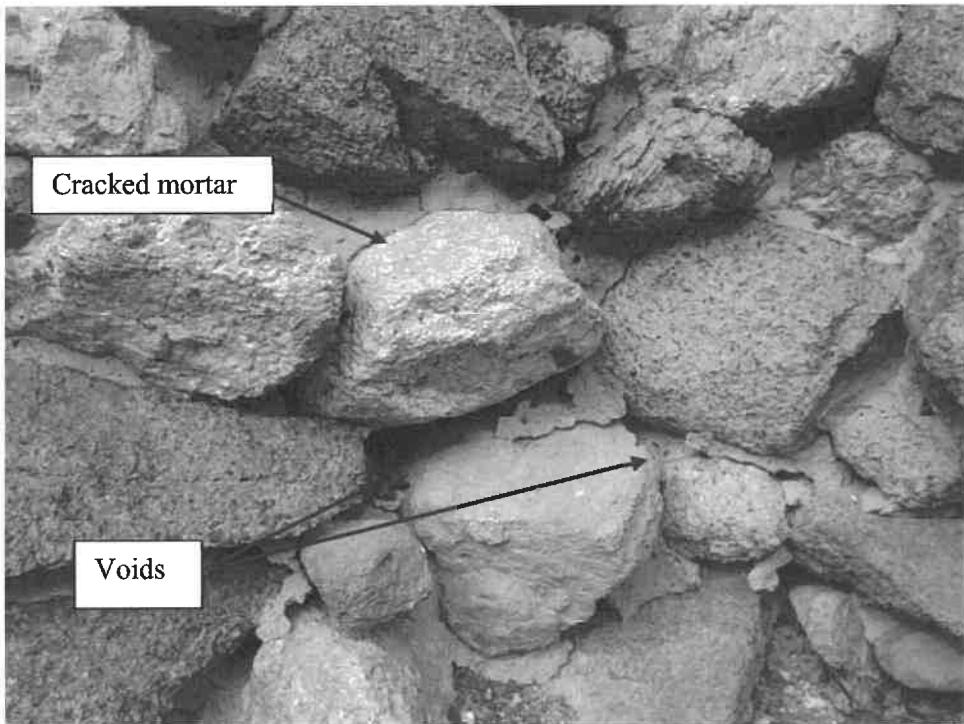
Open voids between stones and fractured stones

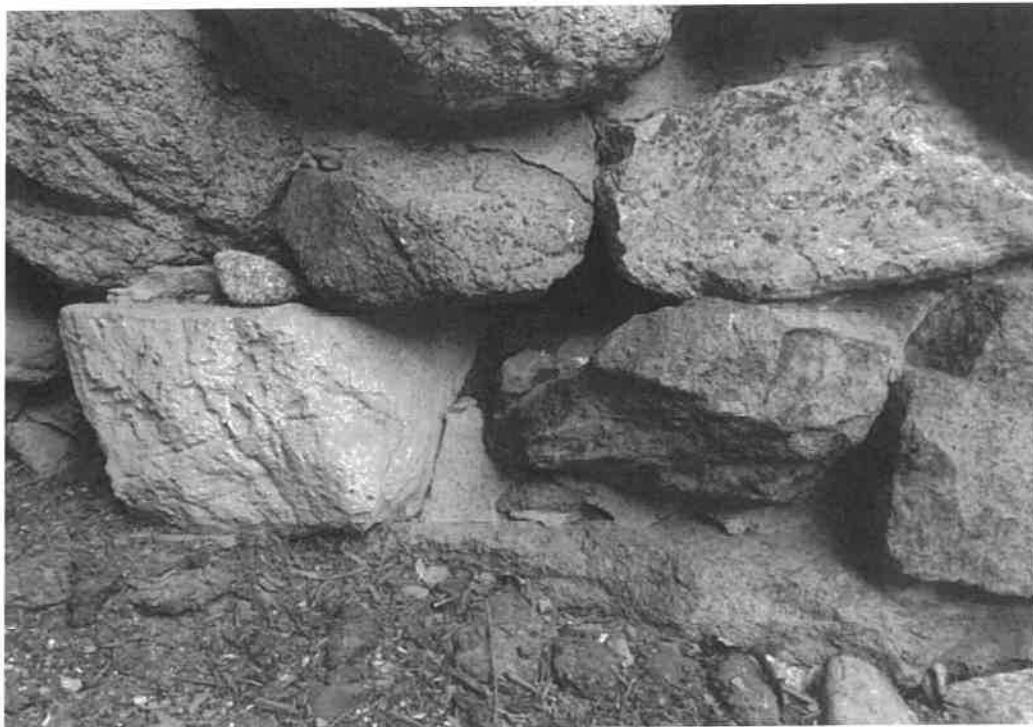
Close up of voids, cracked stones and mortar.

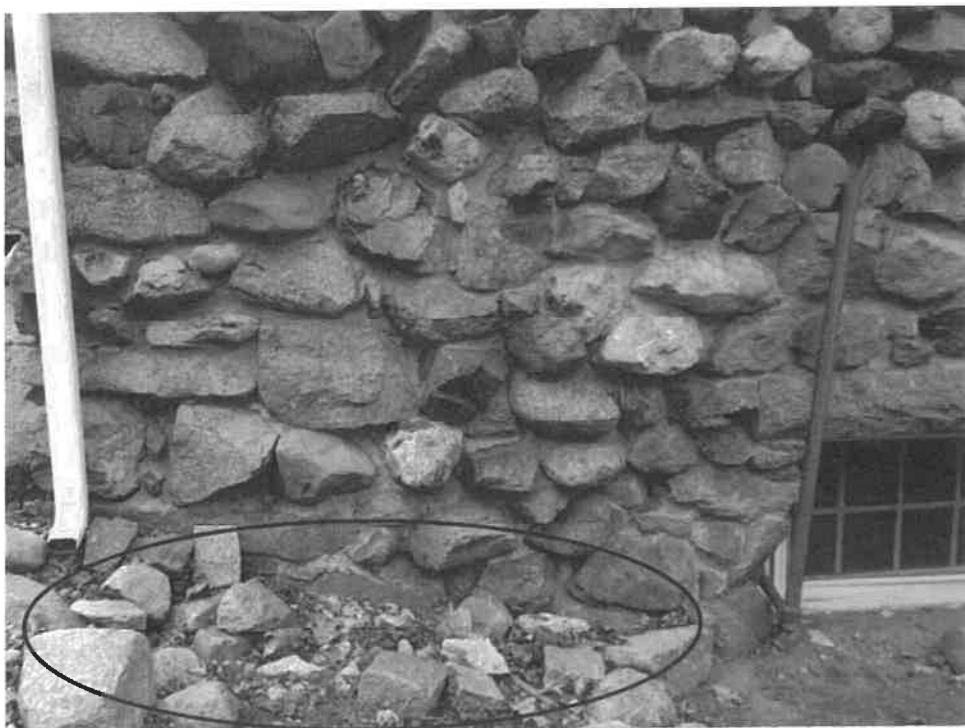
Dislodged stones from exterior face of wall.
