## Great Blue Hill Observation Tower

## Access to Pavilion and Tower

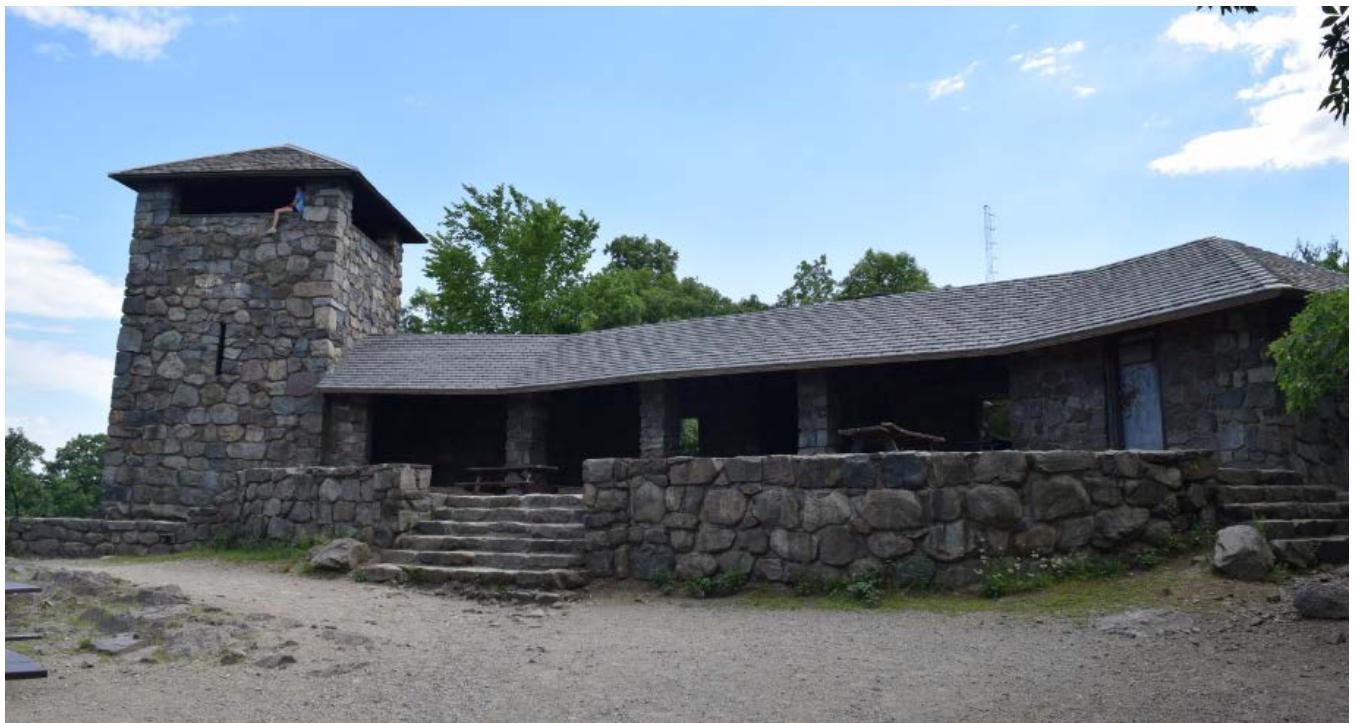
1. Great Blue Hill Observation Tower, north facade

The 35-foot tall Great Blue Hill Observation Tower, also known as Eliot Tower, stands to the northeast of the summit of Great Blue Hill in the Blue Hills Reservation (see photo 1). The tower and connected pavilion were built between 1937 and 1938 by the Civilian Conservation Corps (CCC) as part of a summit landscape dedicated in honor of landscape architect Charles Eliot. Its rubble stone walls combined with heavy timber construction and overhanging slate roofs is very characteristic of CCC and Works Progress Administration rustic “parkitecture” of the era, and the tower design is very similar to that of other contemporaneous local summit towers including Chickatawbut Observation Tower in Quincy and Wright’s Tower in Medford. The tower, pavilion, and pavilion terrace blend seamlessly into the exposed, undulating stony ledge of the summit through the use of native stone in the structure’s walls, retaining walls, and rough-cut steps.

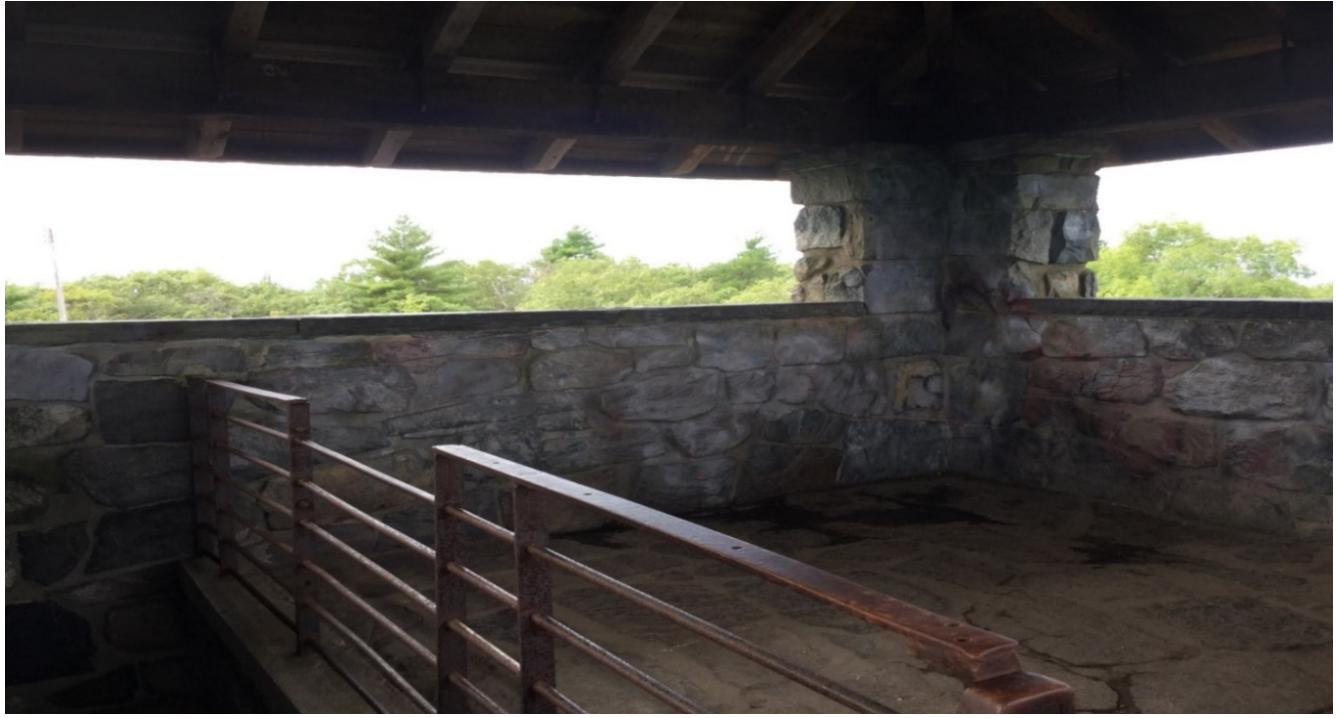
2. View of observation level from the top of the staircase, showing two of the viewing windows. Left is the West view, right is the North view. The existing railing shown will be replaced with a compliant safety railing.

In addition, the damaged historic railings at the east tower stair (Stair D) will be replaced with compliant railings that are in keeping with the style of the original railings. At the Observation Level, the interior railing above the stairwell opening will be replaced with a new railing that meets modern codes.

In addition, the existing openings at the Observation Level are located 45" off of the floor (see photo 2). The height of these openings restricts the view of chair users. To open up the view for chair users in accordance with the Forest Service Outdoor Recreation Accessibility Guidelines (FSORAG), the tower would need to be altered to provide an unrestricted viewing opportunity that accommodates eye levels at a minimum of 32" above the ground or floor. (FSORAG 3.4.3). Enlarging the openings to lower their sill heights to 32" would create a significant change to the tower's original design that would have an adverse effect on its architectural integrity. An opening at 32" would require a railing at a height of at least 36", further altering the historic design.

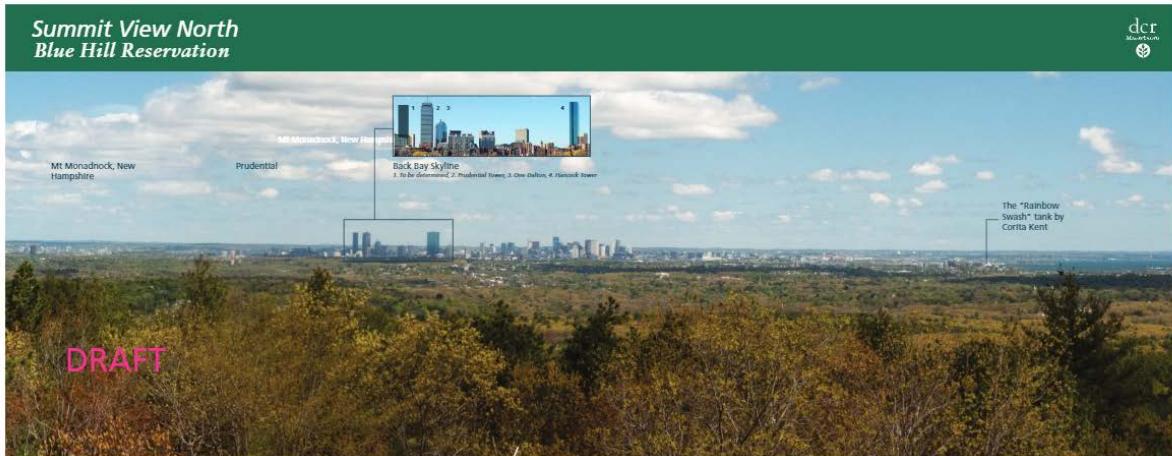
3. Sample view panel to be installed on pavilion terrace (still in draft form).

Programmatic access to the views provided from the Observation Level will be provided in the form of two interpretive panels that will be installed on the north terrace. The panels will show the views to the East and to the North on a clear day. A view study has identified landmarks that will be indicated on the panels. The panel showing the north view will be installed on the north side of the north terrace, and the panel showing the East view will be installed on the east side.

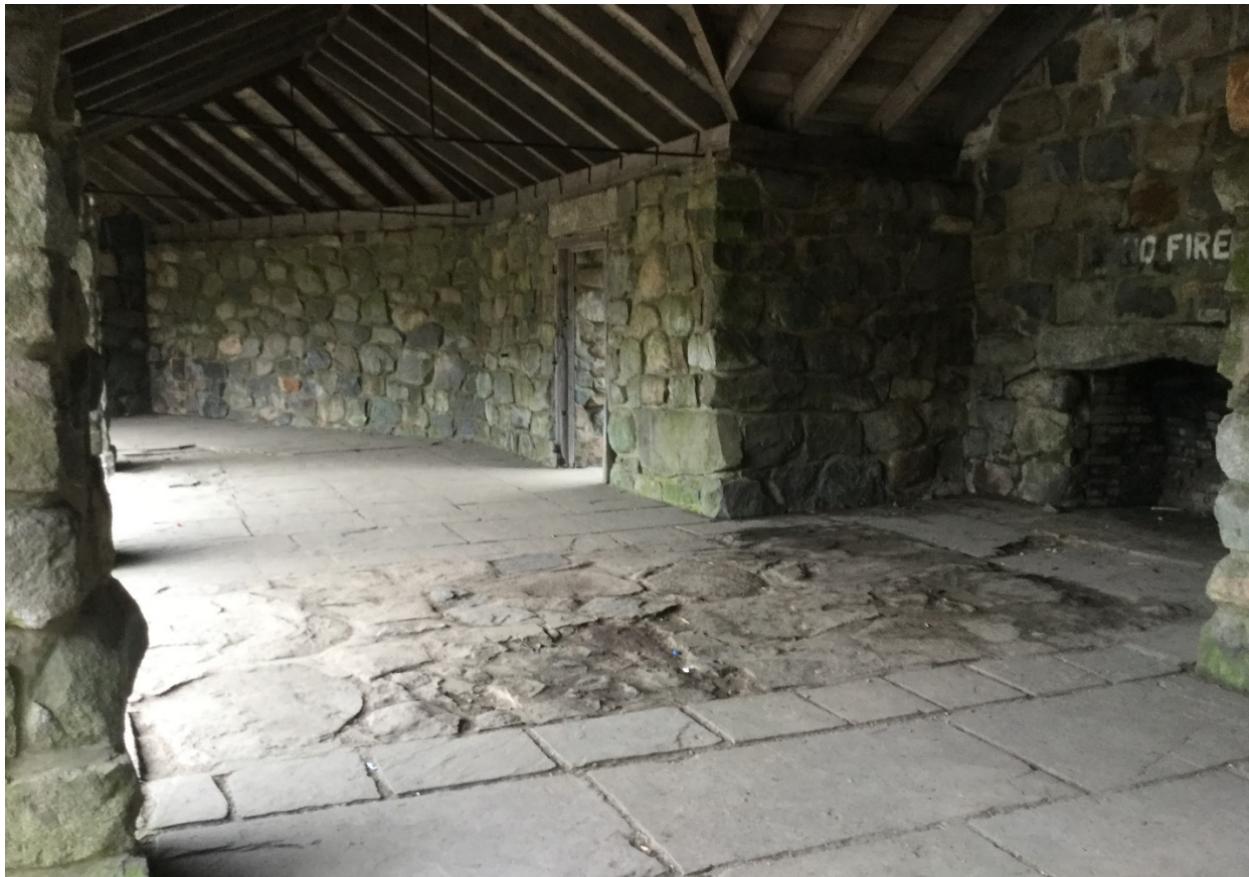
4. Interior view of pavilion showing uneven stones at fireplace hearth and surrounding flagstone flooring.

The floor of the pavilion consists mostly of smooth flagstone, but there is a section of floor in front of the fireplace that is constructed of rough rubble stone, held together with mortar (see photo 4). Changes in level in this section of flooring are typically  $\frac{3}{4}$ ", but can reach up to 2" in depth in limited locations.

Bringing the hearth area up to standards for an accessible route through this area would require replacement of the rough stones with an alternative material due to the uneven nature of the existing stones. This would require the removal of this original, distinctive feature of the pavilion that visually emphasizes the interior architectural focal point of the fireplace.

To make this section of flooring less of a barrier to access, DCR proposes to repoint the existing stones to minimize their vertical reveal. Where the stones create changes in level beyond  $\frac{3}{4}$ ", those stones will be replaced with flatter stones that match the type, color, and finish of the original stones.

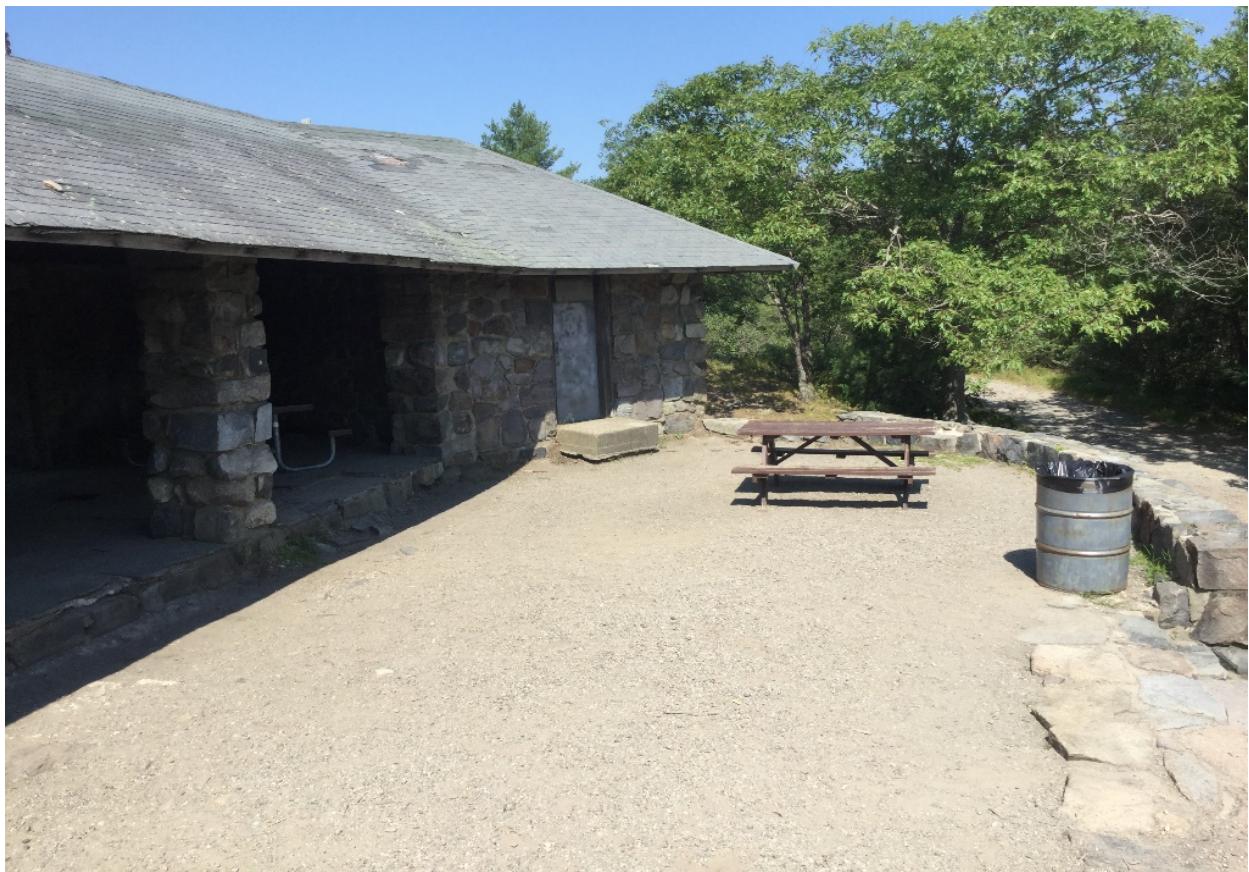
5. Existing conditions at pavilion terrace.

DCR will also resurface the pavilion terrace with new bluestone pavers to improve access to this area for persons with disabilities.
