Final Report

Facility Needs Assessment and Feasibility Study

Department of Public Works, Parks Department, and Consolidated Facilities
Milton, MA

August 21, 2015

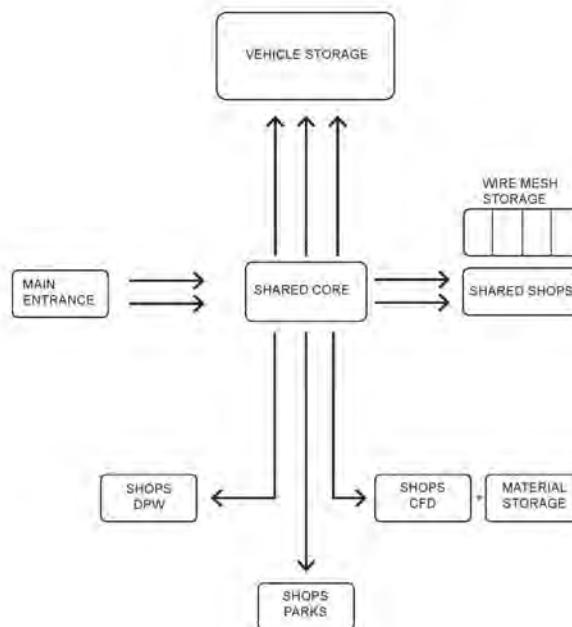
Figure 1: Diagram of shared functional relationships between CFD, Parks, and DPW operations

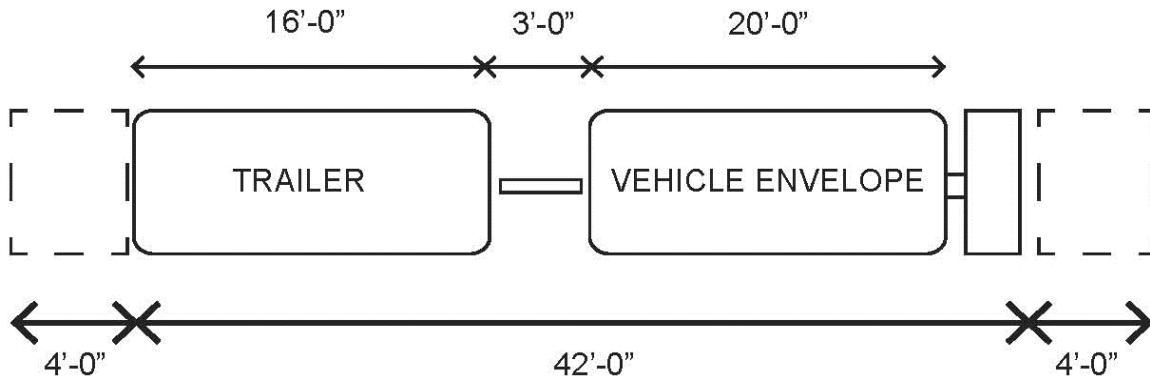
Figure 2: Diagram of Parks & Recreation vehicle with trailer attached

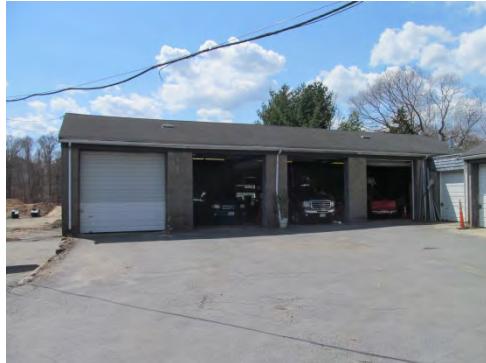
The Equipment Garages were built in the 1930's and currently house the Town's Highway and Parks Departments. The Equipment Garages are single-story structures, 9,702SF approximately 15 feet in height. The Parks Department building is a two story, 1,766SF structure approximately 25 feet in height.

Figures 1: Equipment garages, built in 1930's, currently unable to store all Vehicles & Equipment

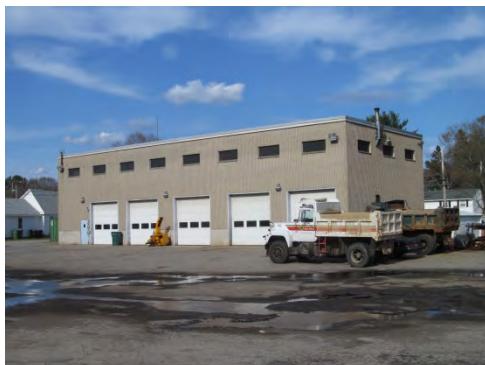
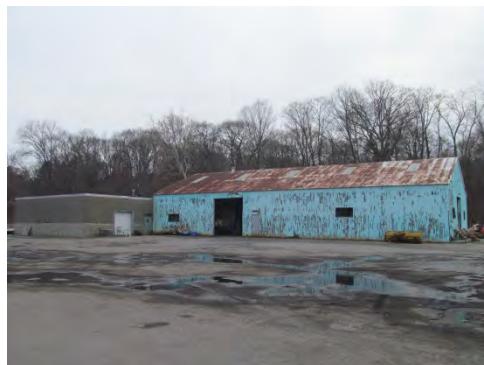
The Central Vehicle Maintenance department is located in a separate building built in the 1970's. The building houses five vehicle maintenance and storage bays accessed by overhead garage doors, the mechanics offices and a parts storage room make up the lower level of a 6th bay. The typical maintenance bay is 18' wide x 38' deep. There are two mezzanine storage areas located within the garage area, one over the mechanics office area that is used for parts storage. The second mezzanine storage area is used for tire storage.

Figure 5&6: Vehicle Maintenance / Water & Sewer Department, Crew Lockers, Shower, Toilet

The Water/Sewer Department is located in a separate metal building in a highly rusted condition. Crew lockers, showers and toilets are located in a single-story building adjacent to the Water/Sewer Department. Additional equipment storage is located in separate trailers parked on the side of the building.

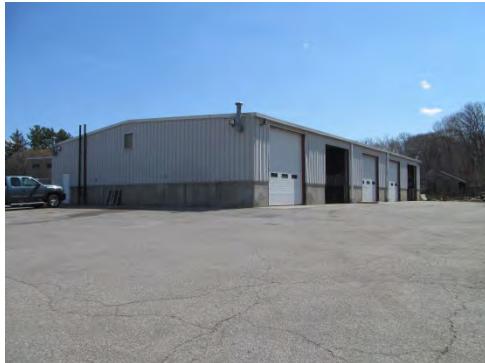
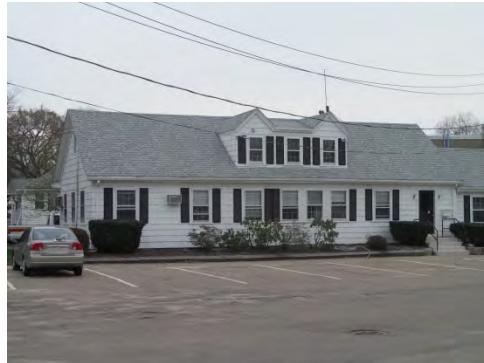
Figure 7&8: Engineered Metal Building / DPW Headquarters

The Engineered Metal Building located at the center of the site is used to store vehicles and equipment. The building houses five vehicle storage bays accessed by overhead garage doors. The building is in good condition but inadequate for the storage of DPW vehicles and equipment and its central location constricts site circulation.

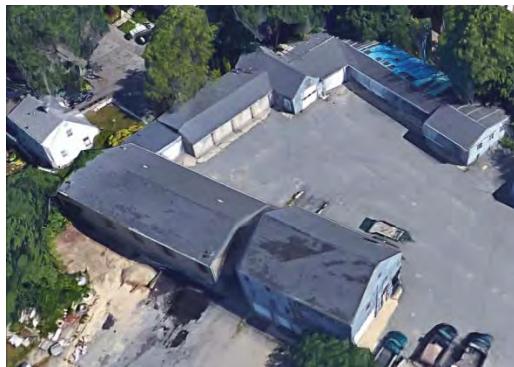
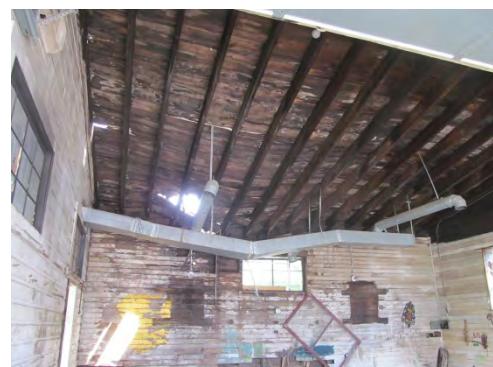
Access to the roof was not provided, but it appears from online aerial images and what could be observed from the ground that the current roof is asphalt shingles which are pitched to perimeter drainage gutters connected to downspouts. There is evidence of rotted roofs, interior water damage due to roof leaks, and failure of roof systems in (3) buildings. The roof is not insulated. It is not clear how old the current roof is, but a typical asphalt shingle roof should be expected to last 15-20 years.

Figure 10&11: Equipment Garages & Parks Department: Completely failure of roof systems on (3) buildings

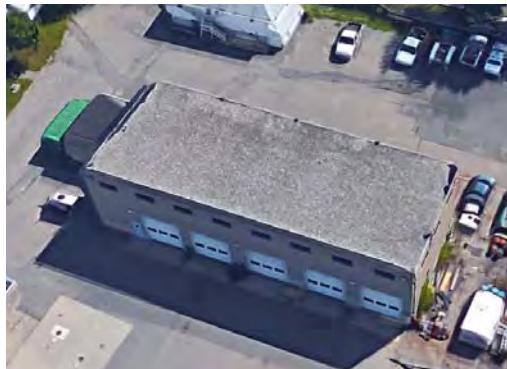
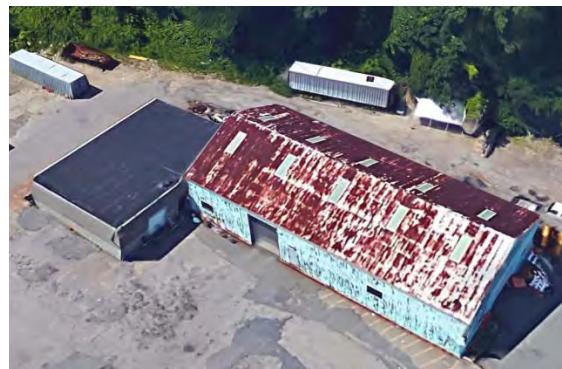
The current roof is a ballasted roof with a single-ply membrane which is pitched to perimeter drainage scuppers connected to downspouts. There is some evidence from the online aerial photographs of ponding at either end of the roof which could be the result of a blocked drainage path. It is not clear how old the current roof membrane is, but a typical single-ply membrane roof should be expected to last between 20-25 years.

Figure 12&13: Vehicle Maintenance Ponding at Corners / Water & Sewer Department highly rusted roof

It appears from online aerial images that the current roof is corrugated metal in a highly rusted condition. The roof over the Crew Lockers, Showers, and Toilet Building is a single-ply membrane pitched to the rear with a gutter and downspout system.

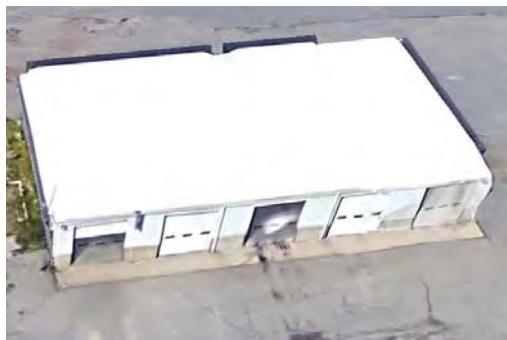
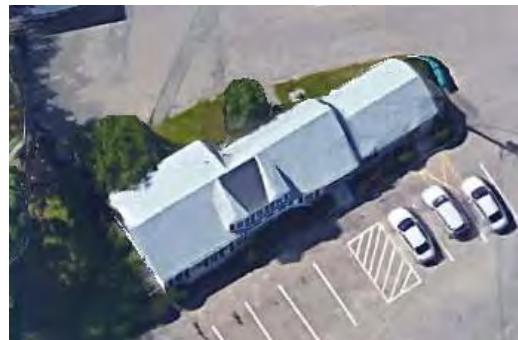
The Engineered metal building roof is a standing seam metal, sloped to the long edge of the building. Roof drainage is a gutter and downspout system. The DPW Headquarters roof is asphalt shingles with a gutters and drainage to the DPW yard, it was replaced in 2013.

Figure 14&15: Engineered Metal Building / DPW Headquarters

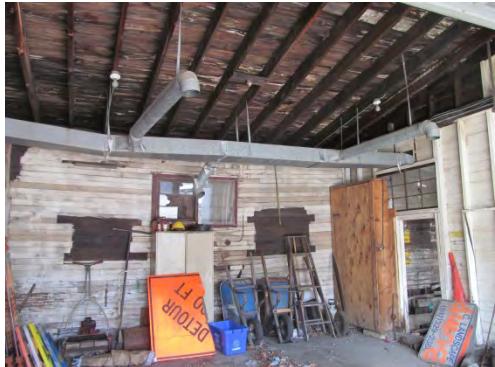
The exterior walls are constructed of wood framed walls in some areas and single-wythe load bearing concrete masonry units in some areas. The wood framed walls do not contain insulation and the un-grouted block cores, would provide only minimal heat-loss benefit by current energy code standards. There is some evidence of building settlement with resultant mortar cracking and voids in the concrete block coursing especially near wall openings.

Figure 16: Sag in the failed rear wall system

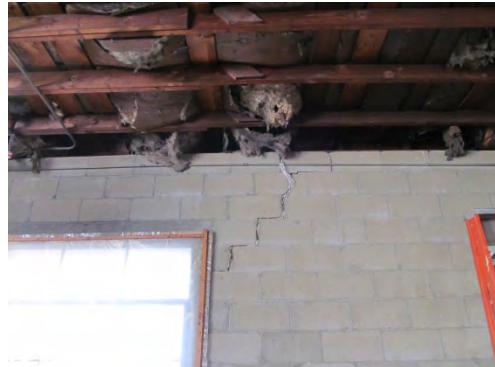
Figure 17: Failure of masonry wall at window opening

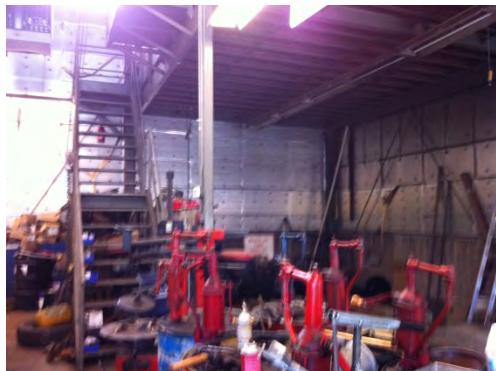
The tire storage mezzanines are accessed by steel stairs with open risers and without proper hand rails or guards resulting in a potential fall hazard for employees. The mezzanines are not considered legally occupiable spaces by current building code standards as they lack the minimum required egress requirements. The edge of the mezzanine is not protected by compliant guards or toe kicks to prevent either occupants or tools from potentially falling to the maintenance shop floor below.

Figure 20: Non-compliant, unsafe, stairs to mezzanine

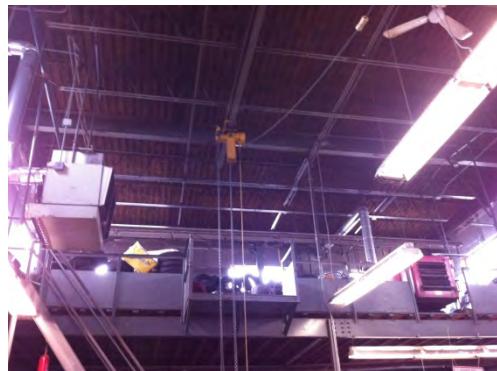
Figure 21: Mezzanine with non-compliant guardrails

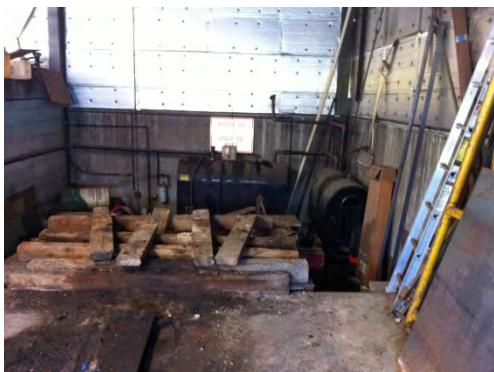
The vehicle maintenance bay area lacks sufficient length for the Fire Department ladder trucks. There is no function to the service pit at the end of one of the maintenance bays. The pit has an open side without guardrails representing a fall hazard.

Figure 22: Service pit with open side

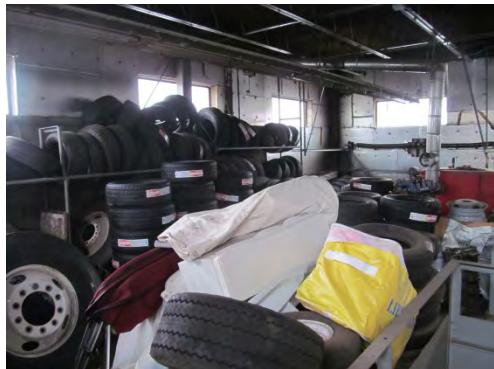
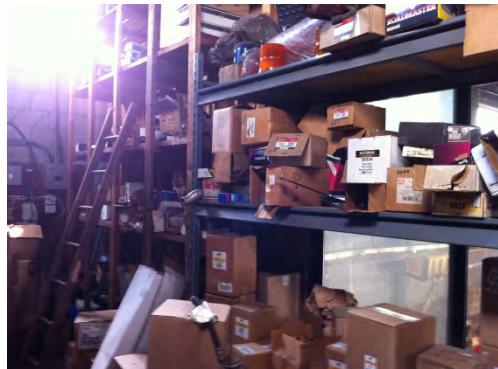
Figures 24 & 25: Insufficient storage space for tires, and parts

There is inadequate storage space for tires and parts within the building causing the “stacking” of tires and parts in an inefficient manner.

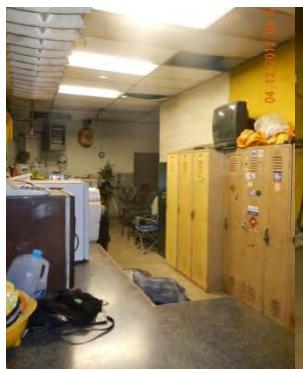
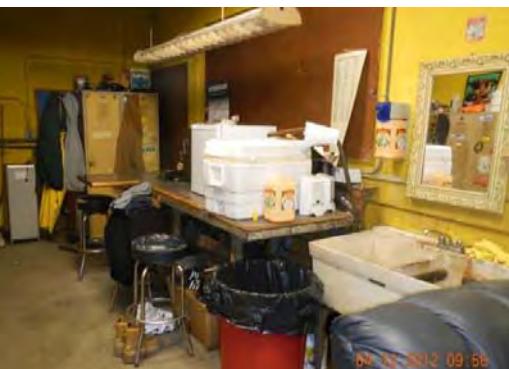
Figures 28, 29, & 30: Crew lockers were salvaged from a building being demolished; no eating facilities, no windows or ventilation, there is one toilet, one urinal, and a shower stall.

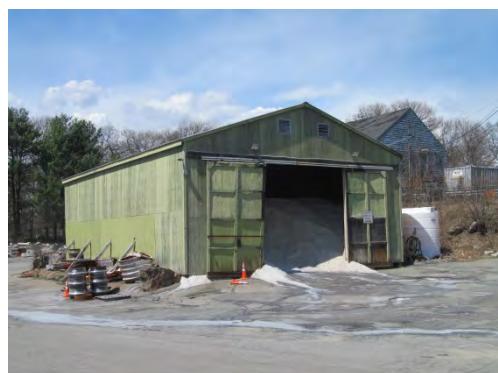
The sand and salt shed is in poor condition with its exterior walls supported by wood bracing. These structures, along with other outbuildings on the site, do not adequately protect the stored materials or equipment from the elements increasing maintenance costs and reducing their effectiveness in an emergency event.

Figure 33: Failing salt and sand storage shed

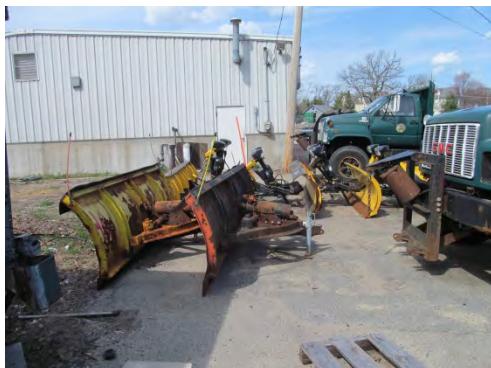
Figure 34: Unprotected town equipment
