ROAD SAFETY AUDIT

Route 28 at Chickatawbut Road

Town of Milton

November 14, 2016

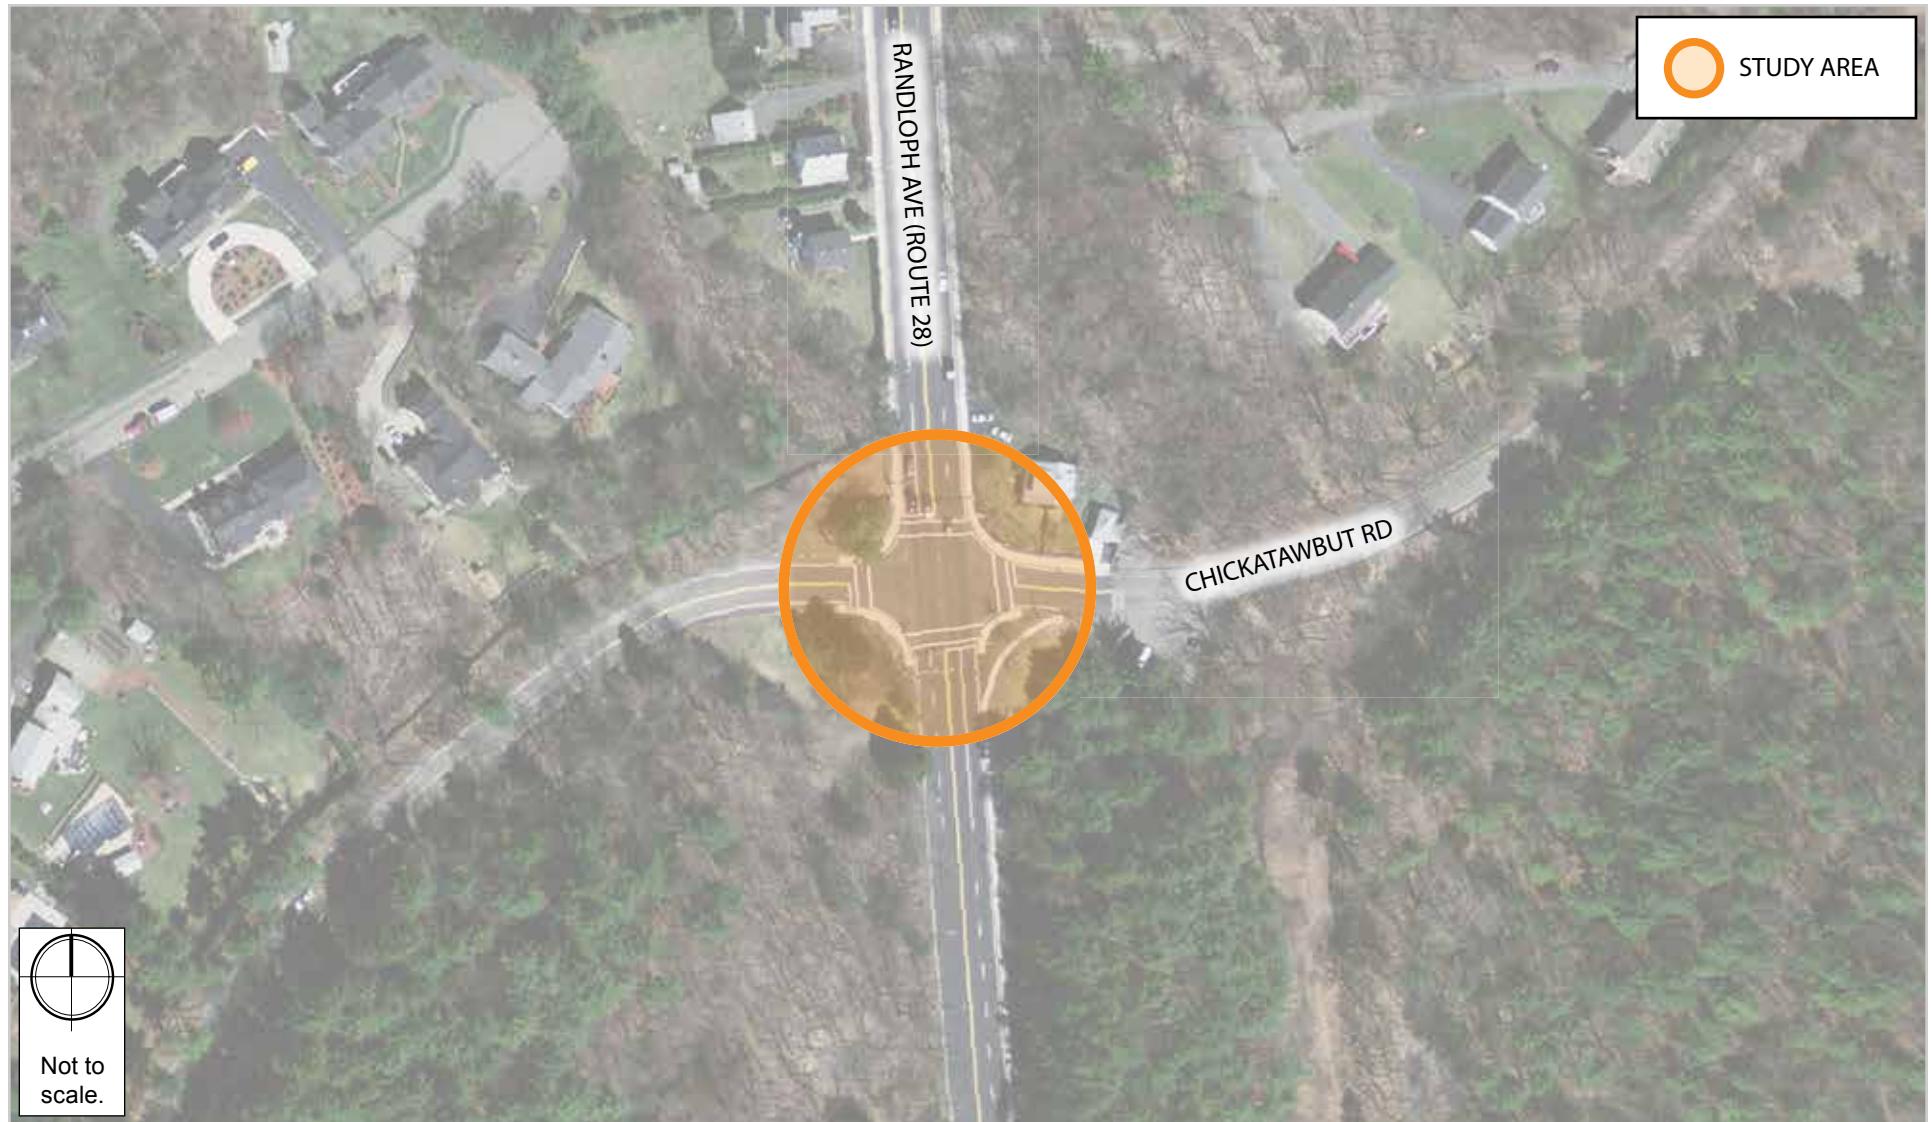
Figure 1. *Study Area Intersection*

The intersection of **Route 28/Chickatawbut Road** is a four-legged intersection with four approaches. The Chickatawbut Road eastbound and westbound approaches each consists of a single travel lane. The Route 28 northbound and southbound approaches each consists of two travel lanes, which function as a shared left-turn/through lane and a shared through/right-turn lane. The Route 28 northbound approach receives a leading protected left-turn phase during the morning peak period, while the southbound approach receives a leading protected left-turn phase in the evening peak period. Crosswalks and pedestrian indications are provided across all legs of the intersection. Pedestrian ramps are provided at each corner of the intersection, although sidewalks are only provided along Route 28 north of the intersection.

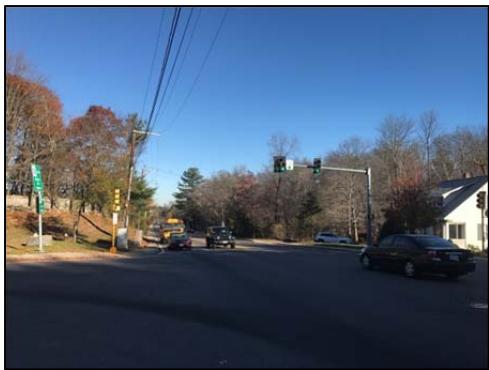
Of the 60 crashes reported at the intersection from 2012-2015, 41 of the crashes, or 68%, involved left-turning vehicles from Route 28 northbound or southbound and through vehicles from the opposite direction. Thirty crashes involved northbound through vehicles and southbound left turning vehicles,

while 11 crashes involved northbound left-turn vehicles and southbound through vehicles. Of the 41 crashes, 25 resulted in personal injury. Additionally, one single-vehicle crash occurred on Route 28 southbound as a southbound through vehicle swerved to avoid a northbound left-turning vehicle. The phasing at the intersection includes a leading left-turn phase for the peak direction, and no left-turn phase for the off-peak direction. Route 28 northbound receives a leading left-turn phase during the morning peak period, while the southbound direction receives a leading left-turn phase during the evening peak period. All left turns in the off-peak direction are permissive. Motorists that are unfamiliar with the intersection may expect a protected left turn phase to appear both northbound and southbound, causing confusion, red light running, and dangerous permissive movements when the protected phase does not appear.

Permissive left turns at the intersection are made against two lanes of oncoming traffic. Southbound permissive left turns must wait for a gap in northbound traffic that is traveling on a downgrade after traveling through a 50 mph zone with few intersections and often is traveling faster than the posted 40 mph speed limit. The vertical curve south of the intersection also makes it difficult for southbound motorists to judge the speed of oncoming traffic. It is difficult to see oncoming traffic from Route 28 northbound while waiting to turn left from Route 28 southbound, which may cause some crashes as well as congestion as motorists wait until the signal turns red to complete their left turn.

1. Consider designating the left lanes on both Route 28 northbound and southbound as left-turn-only lanes and limiting left turns at the intersection to protected left turns only to reduce the number of crashes involving northbound or southbound left-turning vehicles and associated rear-end crashes. Consider the impact to operations at the intersection, taking into account that the left lane may already operate as a de facto left-turn lane. Consider that this enhancement may lead to more cut-through traffic on Chickatawbut Road. Also consider that both approaches should be merged into a single travel lane upstream of the intersection so that motorists do not find themselves unexpectedly trapped in left-turn lanes.

2. Consider converting one Route 28 southbound receiving lane into a Route 28 northbound left-turn pocket, while designating the left travel lane on Route 28 southbound as a left-turn lane. This enhancement would make Route 28 northbound permissive left turns easier, as these motorists would only need to determine an acceptable gap in one lane of oncoming traffic, while maintaining two northbound through lanes. Southbound left turning vehicles would also have a better view of oncoming northbound through vehicles. Consider impacts to northbound operations.

3. Consider the safety benefits of widening the Route 28 northbound and southbound approaches to the intersection to include exclusive left-turn lanes while maintaining two through lanes. The left-turn lanes should be aligned to allow for simultaneous protected left-turn signal phases from each direction. Consider the potential negative impacts of widening, which may include increased travel speeds during off-peak periods, longer pedestrian crossing distance, and impacts to the Blue Hills Reservation.

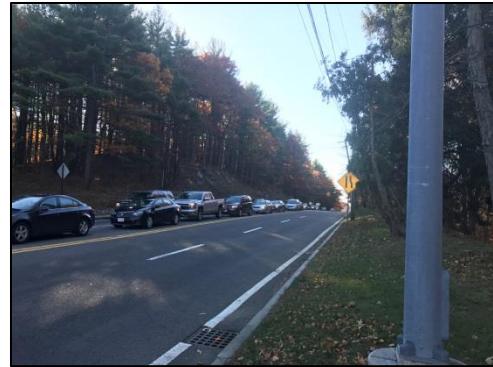
According to RSA team members and observations during the RSA, there is a significant amount of red light running at the intersection, particularly on Route 28 northbound and southbound. This is likely due to the amount of congestion that is common at the intersection and the surrounding area during peak periods. RSA attendees stated that vehicles avoiding I-93 often use Route 28 as a cut-through, and that traffic volumes and queues have grown considerably over the past 10 years. Motorists may use Route 28 to bypass I-93 entirely, or use Chickatawbut Road and Route 28 to avoid the split between I-93 and Route 3 in Braintree, which is often a source of considerable congestion. Chickatawbut Road also connects to I-93 at Route 138, just east of the I-93/I-95 interchange. The use of Chickatawbut Road as a cut-through creates a demand for left turns from Route 28

Congestion along Route 28 northbound and southbound has grown considerably in the past 10 years, according to RSA attendees.

1. Consider restricting left turns onto Chickatawbut Road, either entirely or during peak hours only, to reduce cut-through traffic and the number of crashes involving left turns onto Chickatawbut Road. Consider the operational benefits of having two fully operational through lanes at the intersection without delays caused by left-turning vehicles. Also consider the potential impact on the regional transportation network.
2. Check yellow and all-red clearance intervals at the intersection to ensure that motorists have sufficient time to clear the intersection. Note that vehicles may be traveling slower than the 40 mph posted speed limit due to congestion at the intersection, which may require longer clearance intervals.
3. Consider placing speed feedback signs on Route 28 northbound and southbound to reduce speeding along the roadway.

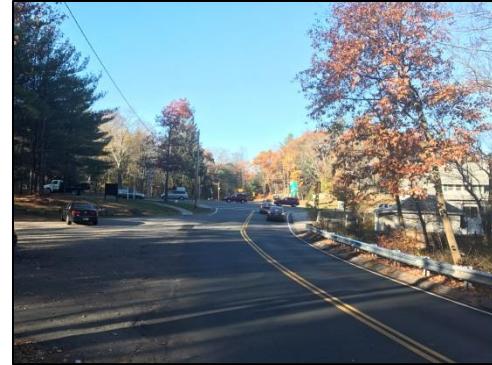
The area south and east of the intersection consists of trails that are used actively as part of the Blue Hills Reservation. This includes a trail entrance and parking lot located in the southeast corner of the intersection. While pedestrian accommodations, including crosswalks, pedestrian signals, and curb ramps are provided at the intersection, the only continuous sidewalks are located north of the intersection. Sidewalks do not connect to the parking lot in the southeast corner of the intersection, forcing trail users to walk on the roadway if they wish to cross Route 28 to access another trail entrance. RSA attendees also noted that the existing Skyline Trail crossing, located about a mile south of the intersection across Route 28, which does not have a marked crosswalk or pedestrian signal to cross the roadway, may be relocated to the intersection of Route 28/Chickatawbut Road so that trail users would have a safe place to cross.

A parking area and trail entrance is located just southeast of the intersection, which generates pedestrian traffic across Route 28.

1. Consider providing a sidewalk connecting the southwest corner of the intersection to the existing parking area and trail entrance to provide a safe connection between the trail entrance and destinations on the west side of the intersection.

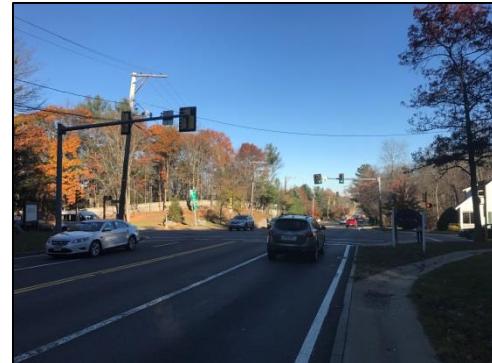
There are no lane use signs or pavement markings on Route 28 approaching the intersection to inform motorists that the left travel lane is a shared left/through lane. While this is typical for approaches with no dedicated turn lanes, rear-end and sideswipe crashes along the Route 28 northbound and southbound approaches indicate that motorists may not expect vehicles to be stopped in the left lane as they wait to make a left turn. Seven rear-end crashes and one sideswipe crash occurred along the Route 28 northbound approach, and four rear-end crashes occurred along the Route 28 southbound approach to the intersection.

Lane use signage and pavement markings are not provided along the Route 28 northbound and southbound approaches.

1. Consider placing lane use signage in advance of the intersection on Route 28 northbound and southbound and on the mast arms at the intersection to alert motorists that both travel lanes may be used for turns and for through movements. Consider supplementing with pavement markings approaching the intersection.
2. Consider placing street name signage for Randolph Avenue and Chickatawbut Road on the mast arms so that they may be more easily seen by motorists.

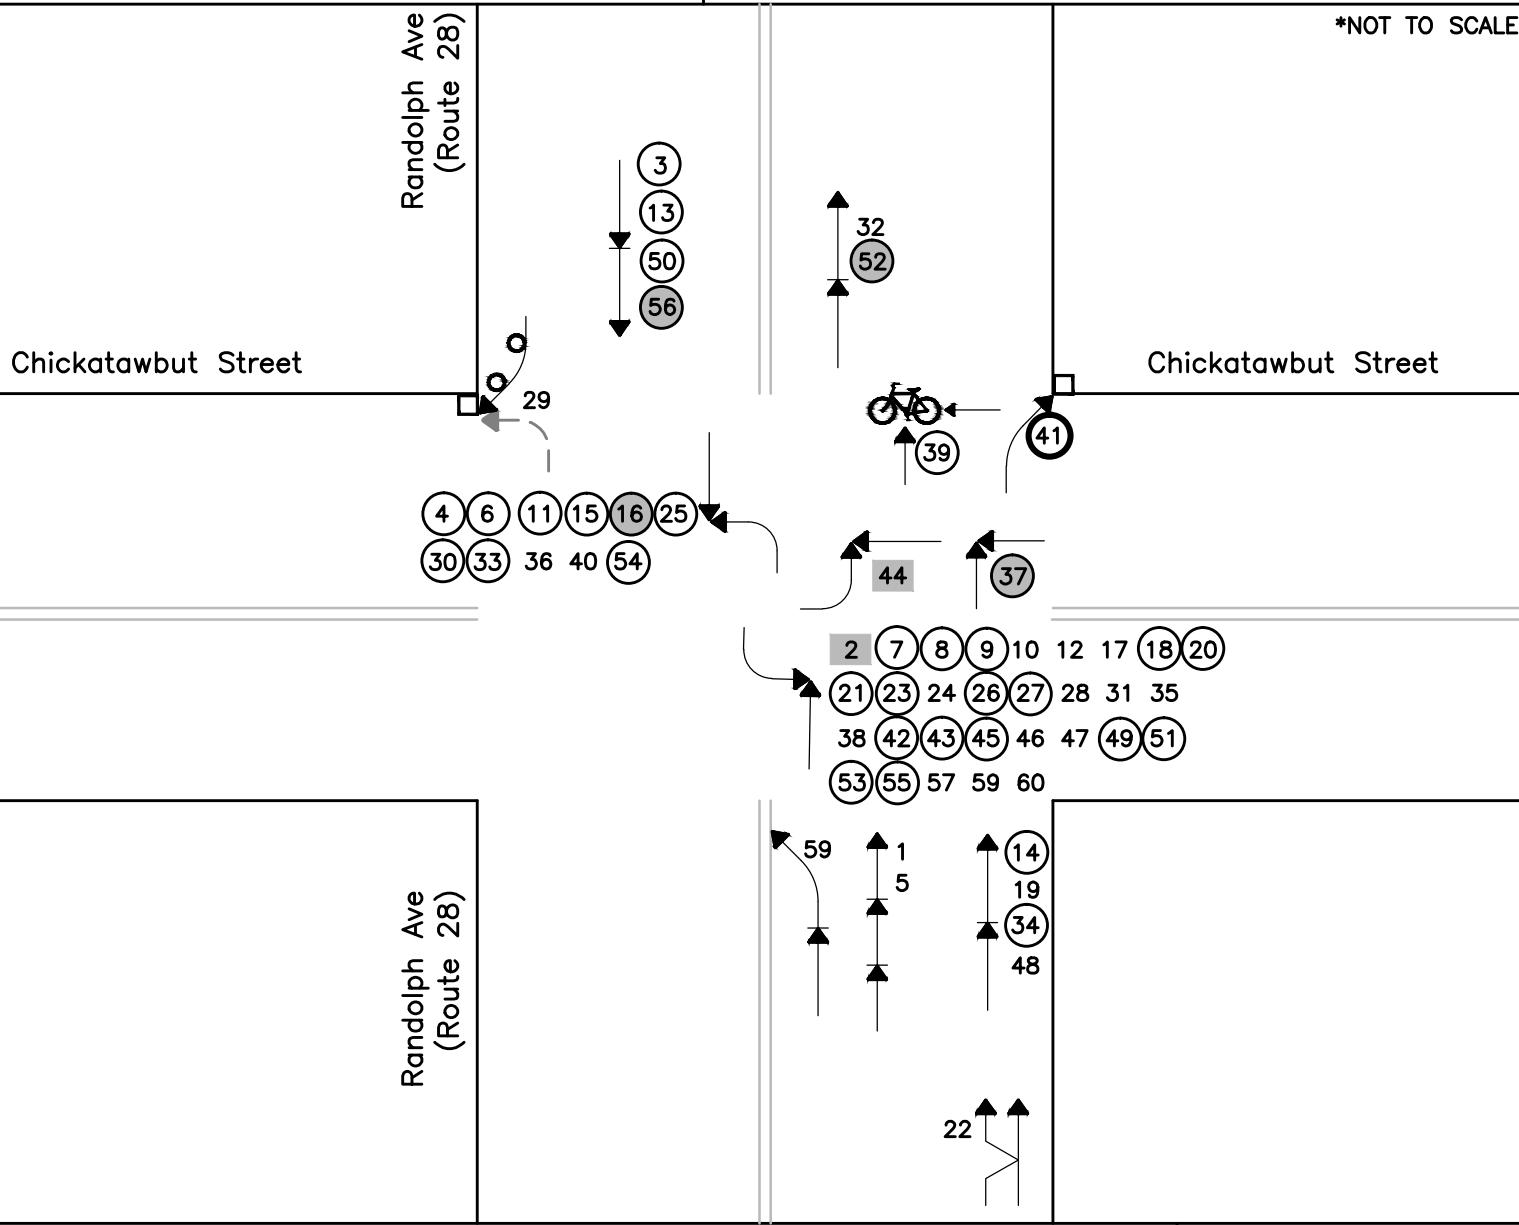
COLLISION DIAGRAM

TIME PERIOD ANALYZED: 2012–2015

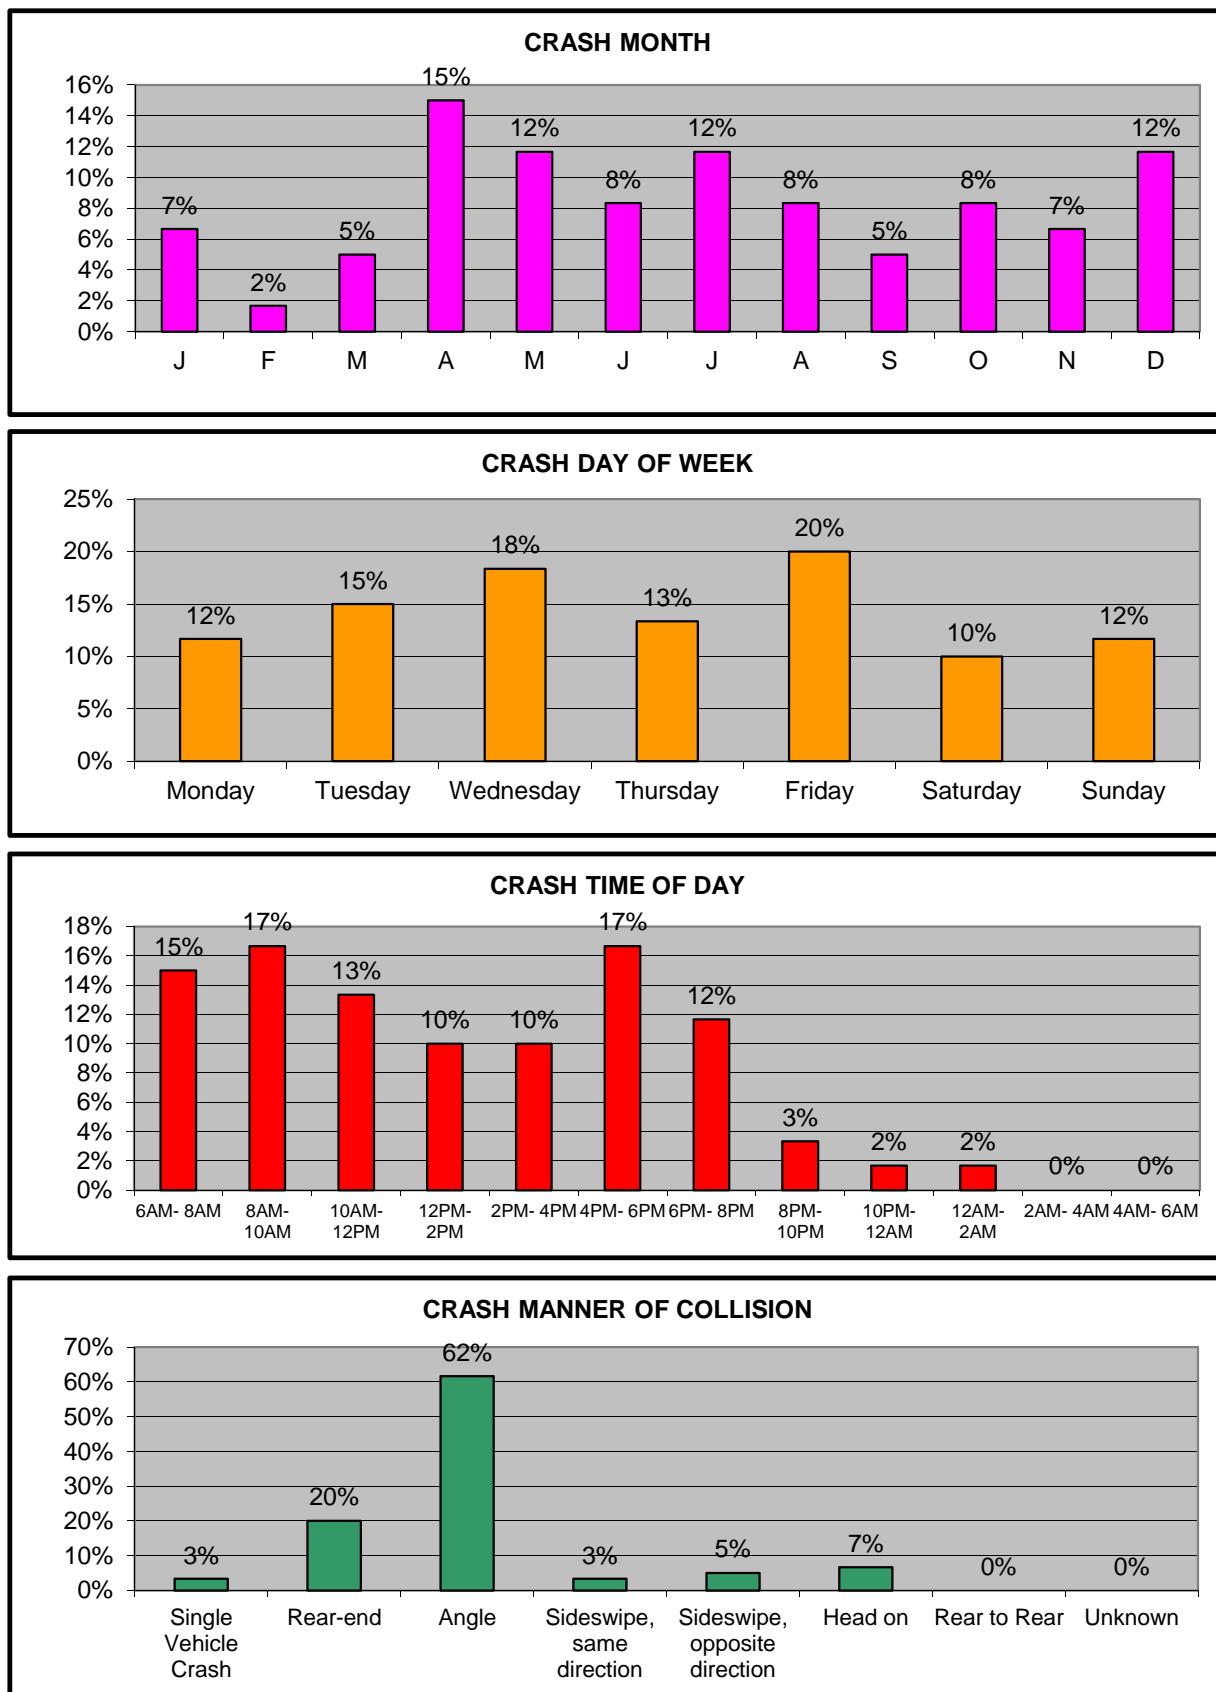
Crash Data Summary Tables and Charts
 Randolph Avenue (Route 28) at Chikatawbut Street, Milton, MA

Summary based on Crash Reports obtained from the Milton Police and State Police.
