ROAD SAFETY AUDIT

Randolph Avenue (Route 28) Corridor from Reedsdale
Road to north of Chickatawbut Road

Town of Milton

February 2024

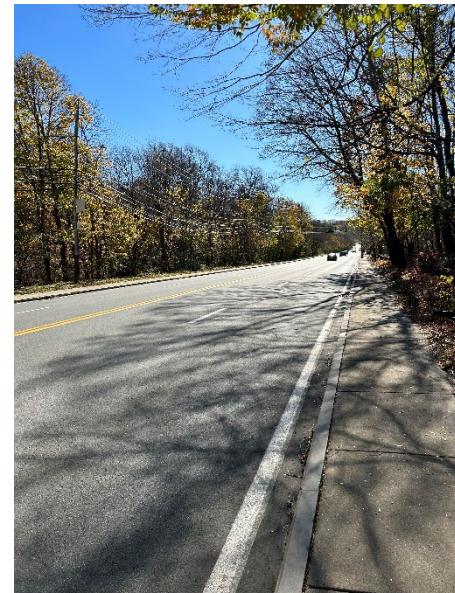
Route 28 provides four lanes of travel – two lanes in each direction. Audit members noted during the site visit that there is a significant downgrade along the corridor in the southbound direction north of Ridgewood Road and in the northbound direction south of Ridgewood Road. Audit members noted that the two lanes provided in each direction and the roadway grades contribute to speeding during periods of low congestion on Route 28, most notably near Ridgewood Road. October 2023 speed information on Route 28, north of Ridgewood Road, showed that vehicles travel with an average speed of approximately 40 mph in either direction but reach up to 68 mph at off-peak times in either direction.

Pictured: Route 28 cross-section.

speeds and eliminate unsafe lane changes. Consider opening pocket lanes or additional through lanes as applicable along the corridor.

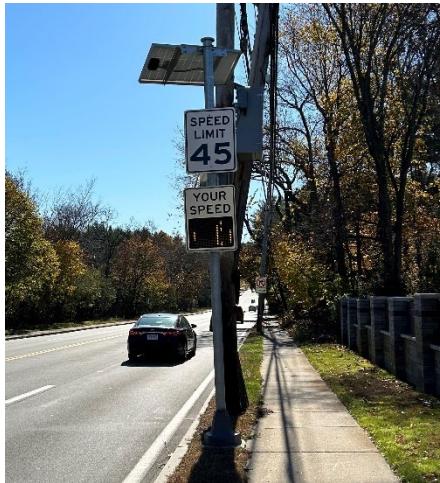
High speeds can result in higher severity crashes. Vehicles traveling at higher speeds require longer time to react and decelerate and may have difficulty stopping or slowing for a turning vehicle, resulting in rear-end collisions. Rear end collisions make up 41% (52 crashes) of the summarized collisions within the study area.

Pictured: Speed limit and speed feedback sign.

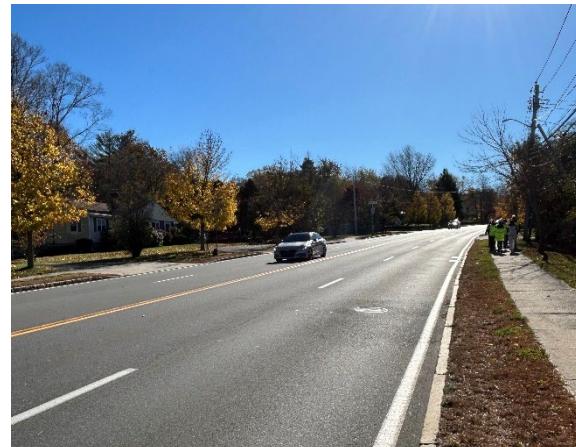
Sight line visibility issues were noted throughout the corridor. Audit members noted horizontal curvature with obstructions along the roadway on Route 28, particularly in the stretch between Ridgewood Road and Hillside Street. Trees located along the horizontal curves of Route 28 limit side-street drivers' visibility of upcoming vehicles. This may lead to a higher prevalence of rear-end crashes in this area as drivers are given a shorter time to react and decelerate in response to slowed or stopped vehicles. The curvature of the roadway may have contributed to nine of the rear-end collisions (corridor crash summary #21, #25, #40, #66, #85, #86, #115, #129, and #152) that occurred in this area.

Pictured: Horizontal curvature of Route 28 south of Ridgewood Road.

1. Evaluate potential to make intersection angular geometry changes that create perpendicular intersections at Route 28 at Highland Street, Ridgewood Road, Nahanton Avenue, Sassamon Avenue, and Hillside Street to improve sight distance at these locations and slow down turning maneuvers from Route 28. Consider utilizing flex posts for a temporary trial of this potential enhancement to determine effectiveness of the perpendicular intersections.
2. Evaluate sight distance along horizontal curves throughout the corridor and provide advanced warning signage for upcoming blind driveways and/or side streets, horizontal alignment signage

with advisory speed plaques, or other applicable signage where sight distance may not be sufficient.

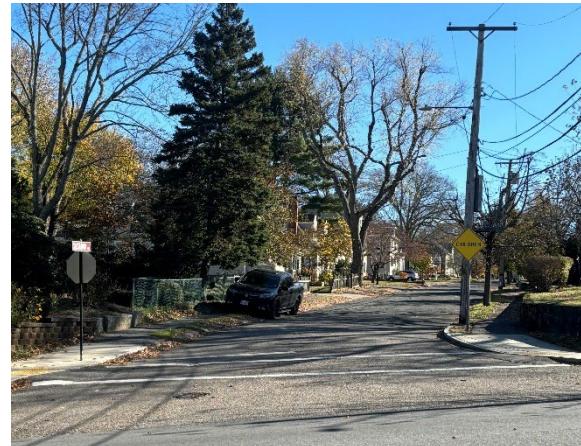
Audit members noted that trees, general vegetation, roadside elements like fences, and the roadway curvature along Route 28 and at certain side-street intersections can restrict the sight lines of drivers on the side streets attempting to access Route 28. The Route 28 intersections that the audit members mentioned with one or a combination of these issues were Heather Drive, Hilltop Street, Highland Street, Ridgewood Road, Nahanton Avenue, Sassamon Avenue, and Hillside Street. Although not every

Pictured: Intersection geometry at Sassamon Avenue.

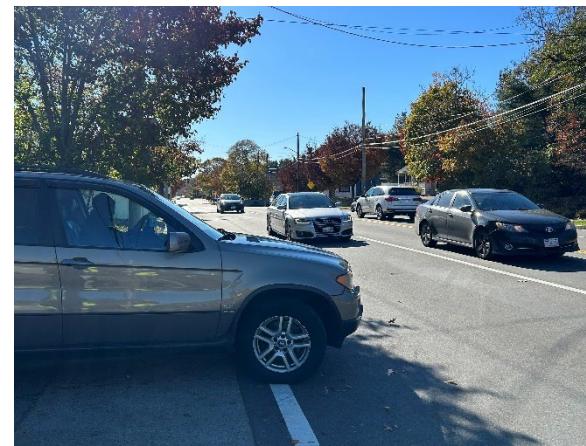
An audit member noted that a tree and other foliage south of the parking lot at 590 Randolph Avenue obstruct sight distance for vehicles attempting to exit at the driveway. During the audit, a vehicle was observed encroaching onto Route 28 while attempting to exit the driveway, likely due to these sight distance concerns. Three collisions (Reedsdale Road crash summary #1, #2, and #20) occurred between vehicles exiting the driveway at 590 Randolph Avenue and vehicles traveling on Route 28. These may have been a result of vehicles exiting the parking lot encroaching onto or prematurely pulling out onto Route 28 due to the sight distance concerns.

Pictured: Driver exiting driveway at 590 Randolph Avenue (Route 28) with sight lines blocked by trees.

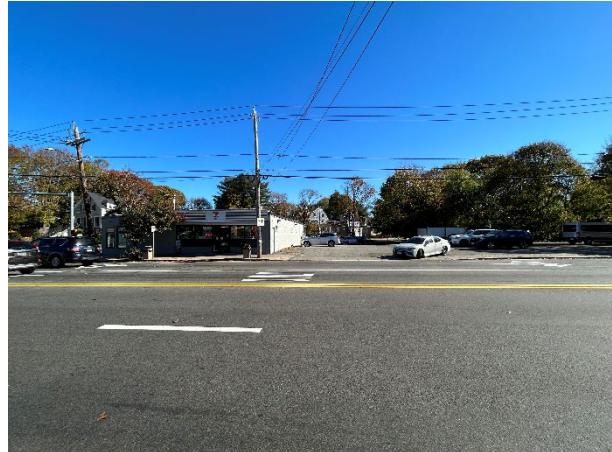
Pictured: Commercial driveway entrance at 590 Randolph Avenue (Route 28).

At 590 Randolph Avenue, courtesy crashes (Reedsdale Road crash summary #1, #2, #19, and #23) occurred between vehicles traveling northbound on Route 28 and vehicles accessing the driveway at 590 Randolph Avenue. At 1126 Randolph Avenue, a courtesy crash (corridor crash summary #99) occurred between a vehicle traveling northbound on Route 28 and a vehicle exiting the driveway at 1126 Randolph Avenue. At 1139 Randolph Avenue, a courtesy crash (corridor crash summary #97) occurred between a vehicle traveling southbound on Route 28 and a vehicle exiting the driveway at 1139 Randolph Avenue (Newcomb Farms). Some courtesy crashes were also reported at intersections along the corridor. Corridor crash summary #77 occurred at Heather Drive, corridor crash summary #90 occurred at Hallen Avenue, and Reed Street crash summary #5 occurred at Reed Street. The four-lane configuration of Route 28 along the corridor likely contributes to the prevalence of courtesy crashes. With two travel lanes in each

During the site walk, audit members specifically called out the driveways at 1139 Randolph Avenue (Newcomb Farms) and 590 Randolph Avenue (7-Eleven), and at 1126 Randolph Avenue (Eagle Farms) as being wider than necessary. A wider driveway may provide various access points for vehicles to turn left into and access any one of these commercial properties. This increases the opportunities for conflict with oncoming traffic. This condition may also make it difficult for opposing traffic on Route 28 to anticipate where that point of conflict will be since there is not a defined location for vehicles to be entering and exiting the driveway. Ten percent (13 crashes) of crashes were angle collisions involving left-turning vehicles and vehicles entering or exiting the commercial driveways. 5% (6 crashes) of these collisions were courtesy crashes, and the other 5% (7 crashes) were not courtesy crashes. The multiple conflict points created by the wide commercial driveways mentioned may contribute to the prevalence of angular collisions at the driveways.

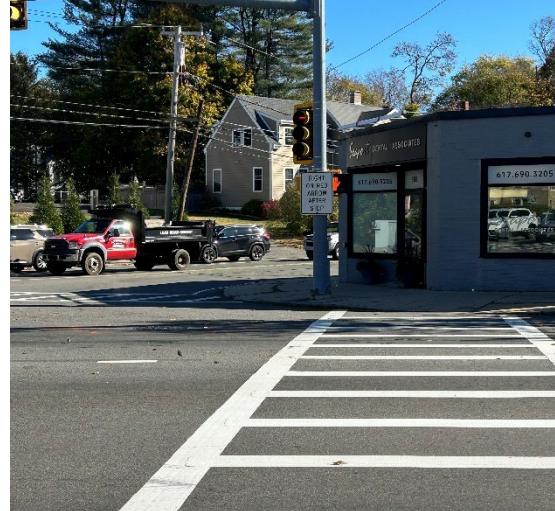
Audit members flagged safety concerns at the Route 28 at Reedsdale Road intersection, which is a four-leg signalized intersection. Several audit members noted that vehicles traveling through this intersection often violate lane movement designations on the approaches. The northbound approach provides an exclusive left-turn lane and a shared left/through/right-turn lane. An audit member mentioned that vehicles have been observed completing a northbound through movement from the exclusive left-turn lane to continue traveling onto Randolph Avenue. Completing this movement would create an unintended conflict point with vehicles in the adjacent left/through/right-turn lane which may be making a left turn or also continuing through. While no collisions of this specific nature were reported during the study time period, Reedsdale Road crash summary #17 did occur due to a lane designation violation. A vehicle was attempting to turn left from Reedsdale Road westbound to Route 28 southbound when a collision occurred with a vehicle attempting to make the same left turn from the designated through/right-turn lane.

Pictured: Posted “right on red arrow after stop” signage on the Reedsdale Road eastbound approach.

concern. Additionally, audit members noted during the site walk that the Reedsdale Road eastbound exclusive right-turn lane permits vehicles to turn right on red by providing a sign that says, “RIGHT ON RED AFTER STOP”. This was raised as a safety issue by audit members because during the site visit audit members noticed vehicles disregarding the sign and making a right turn without stopping to check for a potential conflict with southbound through vehicles and/or westbound left-turn vehicles. A vehicle taking a westbound left-turn from Reedsdale Road onto Route 28 may be difficult for an eastbound right-turning driver to notice as they may be focusing on southbound opposing vehicles. No collisions were reported during the study time period directly involving a Reedsdale Road westbound left turning vehicle and a Reedsdale Road eastbound right

Lane Designation Violations	Evaluate advance lane assignment signage and placement of guide signage at the Reedsdale Road intersection.	Low/Medium	Short-Term	Low	MassDOT/Town of Milton
Lane Designation Violations	Consider installing extension line pavement markings to guide westbound left-turning movements through the Route 28 at Reedsdale Road intersection.	Medium	Short-Term	Low	MassDOT
Lane Designation Violations	Evaluate the allowance of right-turns on red after stop and signal phasing for the Reedsdale Road eastbound exclusive right-turn approach at Route 28.	Medium	Short-Term	Low	MassDOT
Signalized intersection Operations	Evaluate providing Flashing Yellow Arrow (FYA) indications for the Reedsdale Road westbound left-turning movements at the Route 28 intersection.	Medium	Mid-Term	Medium	MassDOT
Signalized intersection Operations	Evaluate signal timings and recall settings at Reedsdale Road and Reed Street/Access Road intersections.	Medium	Short/Mid-Term	Medium	MassDOT

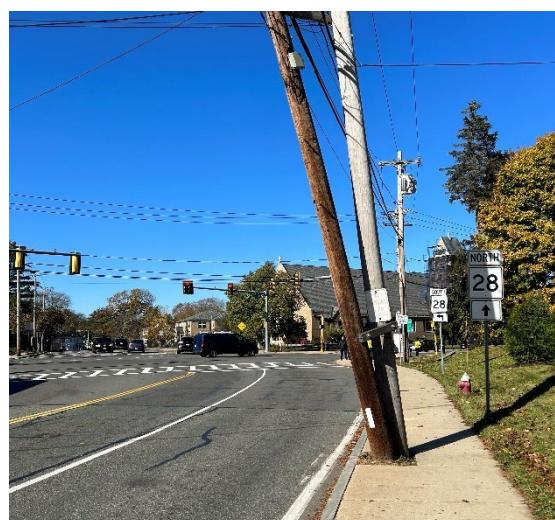
Pictured: Reedsdale Road westbound approach.

During the site walk, the lack of advance signage indicating the lane distinctions was observed. Audit members noted that it may be difficult for drivers approaching the intersection to know the correct lane that they should be in. This may have contributed to the sideswipe collision (Reedsdale Road crash summary #22) reported at the intersection. The audit team also noted the absence of extension line pavement markings indicating the traffic movements within the intersection.

1. Evaluate changing one of the two Reedsdale Road westbound approach lanes to an exclusive left-turn lane and providing a Flashing Yellow Arrow (FYA) for that approach..
2. Evaluate signal timings and recall settings at Reedsdale Road and Reed Street/Access Road intersections.
3. Evaluate signal clearances at the Reed Street and Access Road intersection and the Reedsdale Road intersection.
4. Confirm the presence of vehicle detection on the Access Road approach and consider installation of detection if necessary.
5. Evaluate the condition of the emergency vehicle preemption system at signalized intersections.

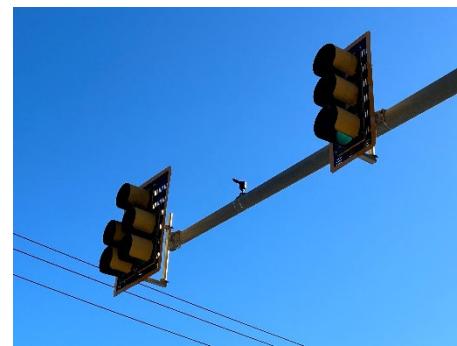
Audit members highlighted the importance of this corridor as an emergency vehicle route due to its proximity to Beth Israel Deaconess Hospital on Reedsdale Road. Audit members familiar with the emergency vehicle operations in the area did not believe the signalized intersections along this corridor were equipped with an emergency vehicle preemption system; however, the site visit verified that they are present at the signalized intersections. Due to their reported low usage, audit members flagged that the emergency vehicle preemption located within the study area may not be in working condition. There were no reported collisions during the study period directly involving an emergency vehicle, but audit members noted that it may pose a safety concern if the emergency vehicle preemption is not working due to the importance of this corridor for emergency vehicle operations.

Pictured: Emergency Preemption System (Opticom) at Reed Street and Access Road intersection.

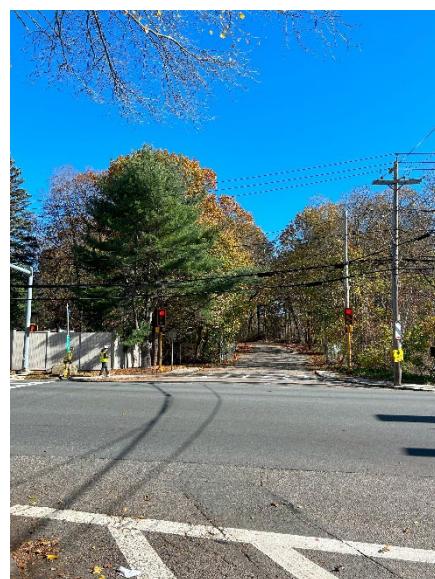
An audit member also noted that a development is proposed to be constructed near this intersection with access to the property located on Access Road. This is expected to increase the volume of vehicles using the Access Road intersection approach both during construction and once the project is complete. During the audit, it

Pictured: Access Road approach.

was noted that it is unclear whether vehicle detection currently exists on this approach. With increased traffic on that approach, it may become necessary to install vehicle detection for vehicles trying to access Route 28 from Access Road.

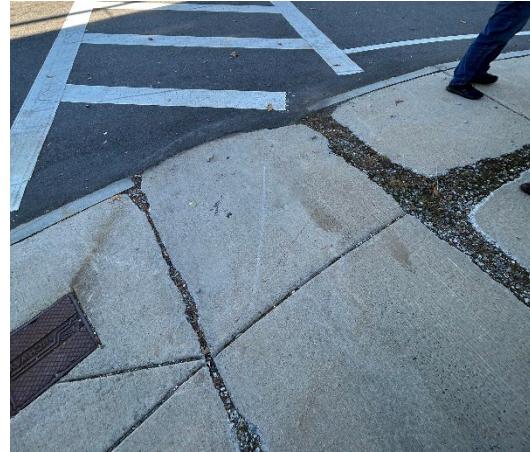
Within the study area, sidewalks are provided for pedestrian use along both sides of Route 28. Painted crosswalks are present crossing most minor streets along the corridor. However, crossings are only provided across Route 28 at the three signalized intersections within the study area (Route 28 at Reedsdale Road, Route 28 at Reed Street and Access Road, and Route 28 at Hillside Street), which means that there is a lack of crossing opportunities along the Route 28 corridor. Audit members noted during the site visit that the existing sidewalks are located directly adjacent to the roadway, are not provided with a grass buffer to provide separation from live traffic, and some portions of sidewalk have appeared to have a more significant cross slope than necessary for rain runoff, thus creating a narrow feel and an unbalanced walking surface.

It was further noted that the shoulders on Route 28 are narrow, putting the pedestrian path of travel close to active travel lanes. The team also noted that overgrown shrubbery along the sidewalks make the facilities feel narrower than they are and obligating pedestrians to walk single file through these areas. On trash pick-up day, trash cans put out on the side of the road may also narrow sidewalks or in some cases completely block them. Both the sidewalk width and proximity to high-speed traffic create an unpleasant walking environment for pedestrians. During the site walk, audit members also noted a break in the sidewalk on Route 28 near Reed Street where the sidewalk abruptly transitions to a patch of grass before

Pictured: Curb ramp at the Reedsdale Road intersection.

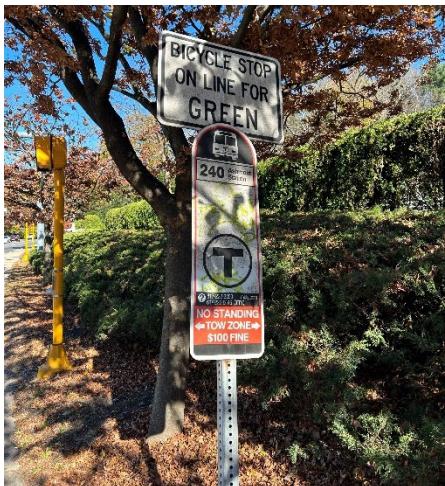
The corridor does not have existing dedicated bicycle infrastructure. During the site visit, the presence of some “bicycle stop on line for green” signage indicating that cyclists should ride in the street alongside vehicles was noted at the signalized intersections. Despite these signs being present, many of them were blocked and corresponding pavement markings were not provided indicating to the cyclists where to stop. Audit members also noted that the high vehicular speeds and volume along the corridor, combined with the lack of shoulders on the roadway, may create a high level of discomfort for cyclists riding alongside vehicles. Of the summarized crashes, one collision was reported along the corridor involving a cyclist (corridor crash summary #22) that resulted in a possible non-fatal injury.

Pictured: Existing bus and bike signage at Hillside Street.

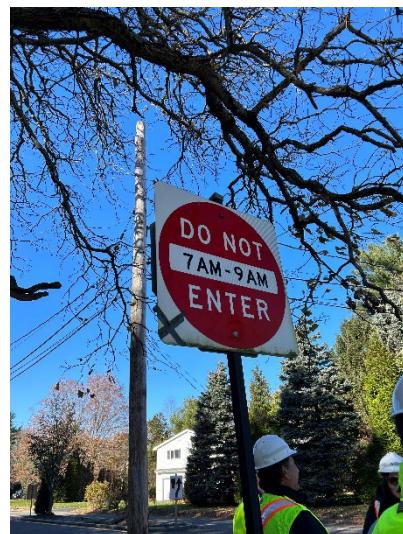
Pictured: Existing “Do Not Enter” Signage on Hallen Avenue.

Hallen Avenue and Reed Street were flagged as cut-through streets utilized by vehicles accessing the nearby hospital, and Pleasant Street was mentioned as being used by cut-through traffic moving in the direction of East Milton Square. Existing signage restricts entrance onto Hallen Avenue and Reed Street from 7 a.m. to 9 a.m. during weekdays, but it was noted that these restrictions are not enforced or adhered to. Audit members also noted during the site visit that the existing signage is primarily posted at the entrance to the restricted roadway and may not be highly visible to vehicles traveling on Route 28. Audit members noted that additional signage was installed on Route 28 within the crash years studied indicating the restricted movements; however, audit members noted that it may not be obvious which intersection the restriction signs are referring to when traveling on Route 28.

Audit members noted that many of these minor streets are narrow and do not provide a double center line or marked shoulders. Therefore, they likely were not designed to handle large volumes of vehicles or regional traffic. Further, increased volume on these side streets, particularly at unsignalized intersections, increases the number of vehicles attempting to make left turns across opposing traffic on Route 28 which may increase the prevalence of angle collisions. Of the summarized angle collisions, 12 directly involved a turning vehicle entering or exiting one of the highlighted minor roadways (Pleasant Street, Reed Street, Hallen Avenue, Ridgewood Road, Nahanton Avenue, Sassamon Avenue, and Eager Road). Of note is one crash (corridor crash summary #33) which resulted in a fatality and involved a vehicle turning onto Hallen Avenue in violation of the Do Not Enter restriction.

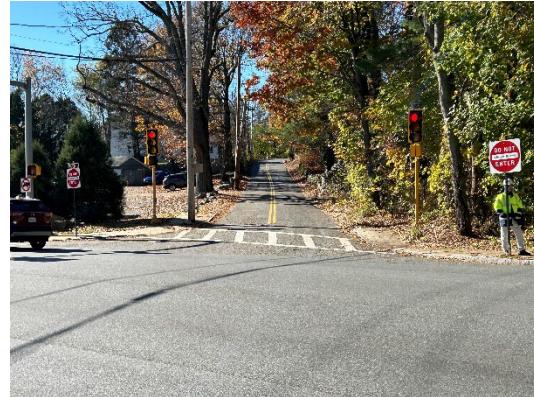
Audit members noted that Reed Street, Highland Street, Ridgewood Road, Nahanton Avenue, Sassamon Avenue, and Hillside Street all intersect Route 28 at a skew. The audit members noted that the acute turning angle for vehicles turning onto one of these minor streets from Route 28 may be a safety concern. The posted speed limit on Route 28 is 45 mph at the location of these intersections along the corridor. Vehicles traveling at this speed may experience difficulty slowing to make an acute turn onto the minor roadway at these intersections. This may have contributed to three single vehicle crashes (corridor crash summary #28 and #150, and Reed Street crash summary #17) which involved out of control turning vehicles. These collisions occurred as vehicles traveling northbound on Route 28 attempted to make an acute turn at one of the previously mentioned intersections when the driver lost control of the vehicle and collided with the corner of the intersection. While crashes of this type were only reported at the intersection of Route 28 at Reed Street, Ridgewood Road, and Highland Street, the audit members noted that a similar concern may apply to all of the highlighted intersections where the minor street intersects Route 28 at a skew.

Pictured: Reed Street eastbound approach.

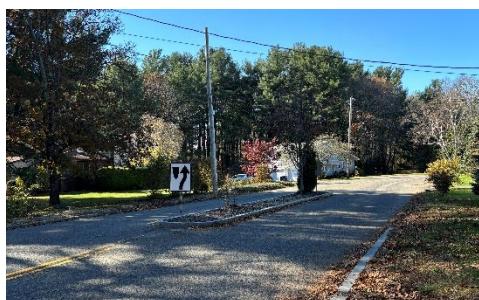
Pictured: Separating island on Hallen Avenue eastbound approach

Audit members noted during the site visit that the separating island on the Hallen Avenue approach is set back away from the intersection approximately 35 feet from the stop line. Audit members noted that this may cause confusion for drivers turning onto Hallen Avenue who may not be able to see the island immediately from Route 28. Although no crashes were attributed to this condition during the study period, audit participants noted that the design is non-standard and may cause driver confusion.

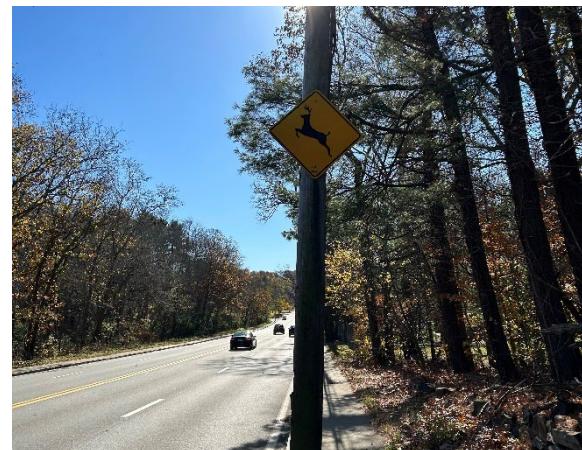
It is also of note that nine of the included collisions (Reed Street crash summary #12, and corridor crash summary #43, #53, #54, #95, #102, #117, #134, and #137) involved a deer entering the roadway, particularly in the stretch of Route 28 between Hallen Avenue and Ridgewood Road. Audit members noted a lack of deer crossing warning signage while completing the site walk. The signage that was present

Pictured: Deer advance warning sign.

was noted to be mounted at a high height which audit members familiar with design guidance noted was higher than advised. Vehicles traveling at high speeds on Route 28 may not have enough reaction time to safely decelerate and avoid a collision with a deer entering the roadway, especially if there is no advance warning allowing them to anticipate deer in this area. The deficiency of adequate advance warning signage may contribute to the prevalence of crashes involving deer in this area.
