Town of Milton Fire Station Space Needs Study

Milton, Massachusetts
November 23, 2015

KAESTLE BOOS
associates, inc

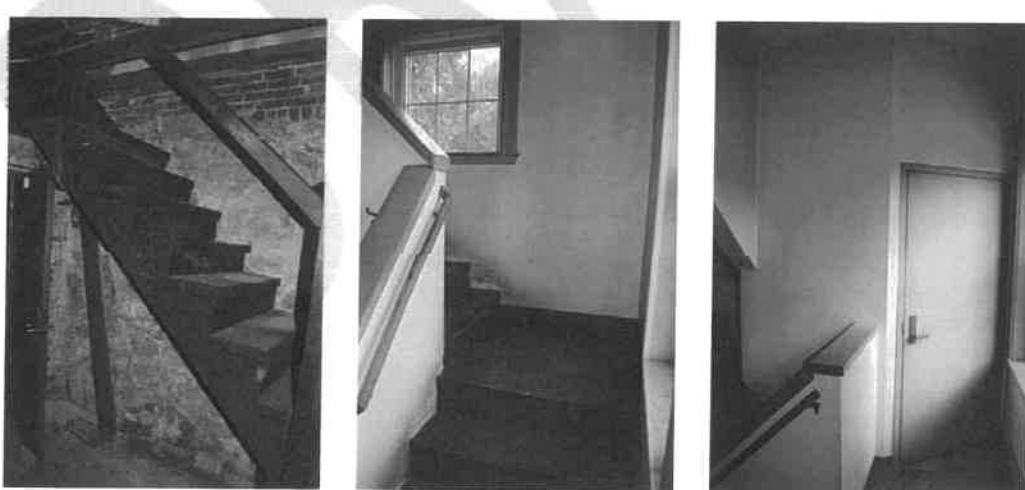
- The existing egress stair in the building is not enclosed in required fire rated construction, does not have risers and treads of required dimensions, does not have railings and guards on both sides of the stair, does not have railings and guards with required height and spacing, does not have required rail extensions, and does not have fire rated doors which comply. All stair conditions must be corrected in accordance with current egress requirements as part of any renovation project.

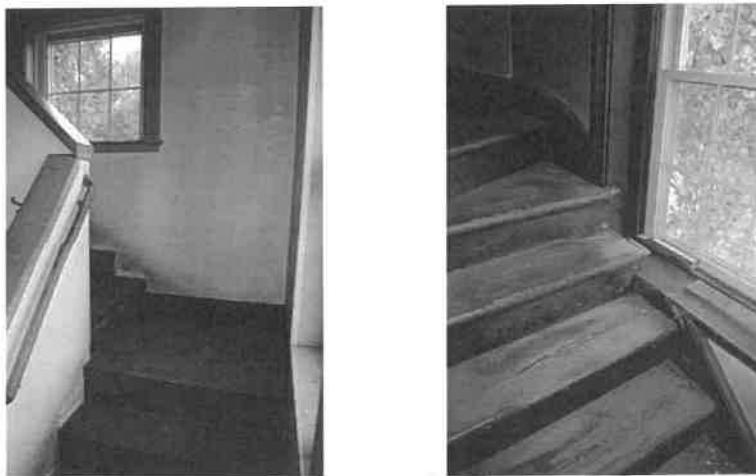
Stair nosings are required to be angled or radiused and not abrupt. Existing wood stair nosings at the connecting stair between the Garage Level and the First Floor have a protruding lip at each tread.

- The stair treads need to be modified to comply. Modification of the treads with tread covers is necessary to reduce the abrupt nosing.

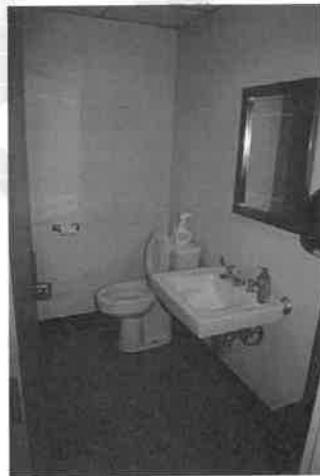
The existing unisex toilet room off of the apparatus bay on the main level does not comply with accessibility requirements and must be modified if civilian staff or disabled staff is allowed to use these facilities. The plumbing code requires separate toilet rooms for men and women; although unisex fixtures are allowed for compliance with AAB, this is not compliant with the plumbing code.

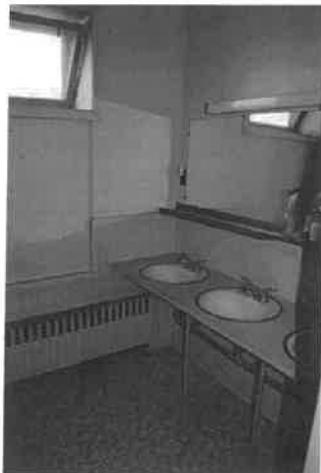
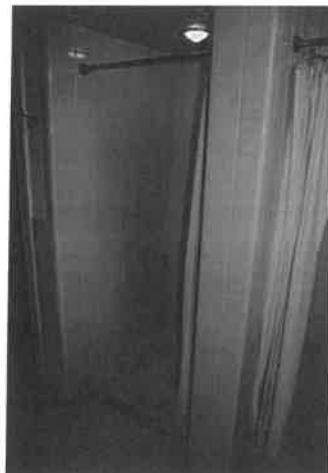
(AAB 31.7) A single unisex toilet/shower room is provided for able-bodied staff only and compliance is not required. However, the plumbing code requires separate toilet/shower rooms for men and women; although unisex rooms are allowed for compliance with AAB, this is not compliant with the plumbing code.

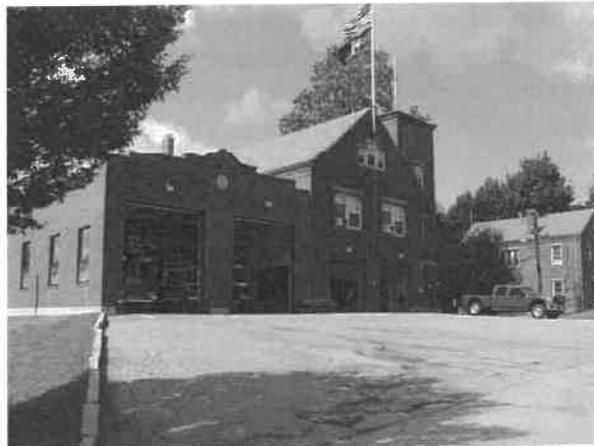
Asphalt conditions are fair to poor, with some patching along the edges of roadways and major patches on the driveway that access the drive through fire bay. The asphalt that forms the fire department's apron has spider cracks and has lost sections of pavement. The site is adequately sloped to allow proper drainage to the catch basins found around the site.

Apron pavement at front of building

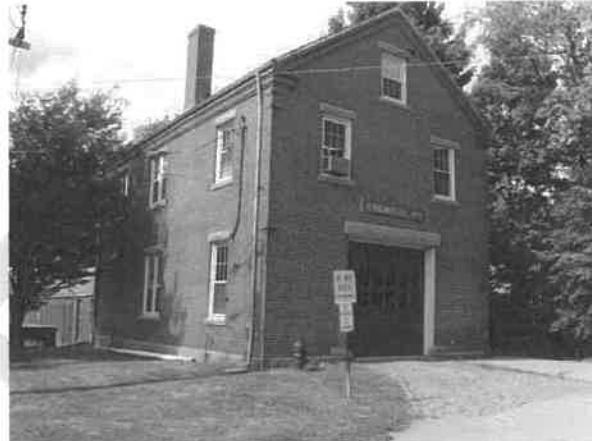
Chemical #1 building with paver apron

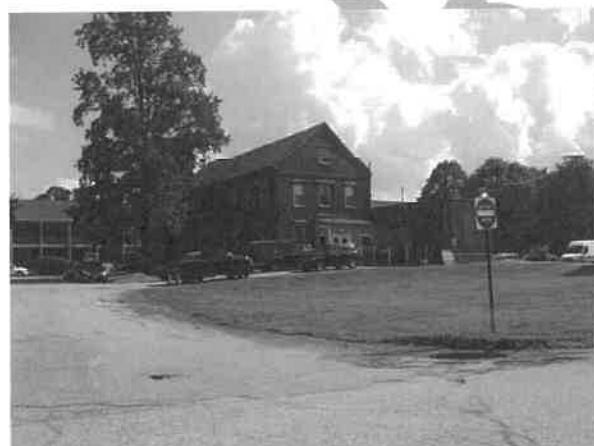
Rear fire station building and open lawn

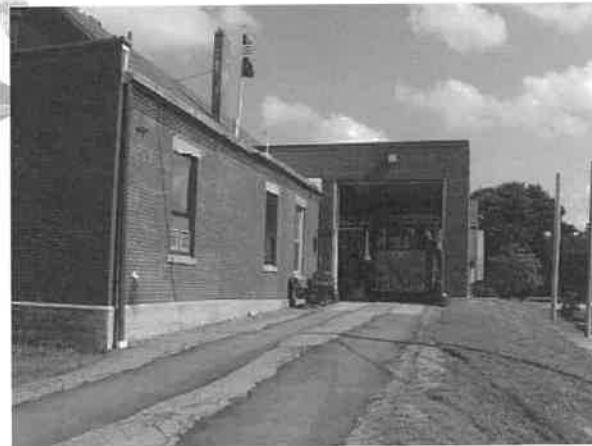
Rear of fire station drive through addition

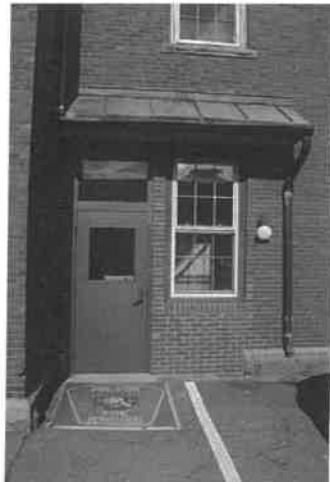
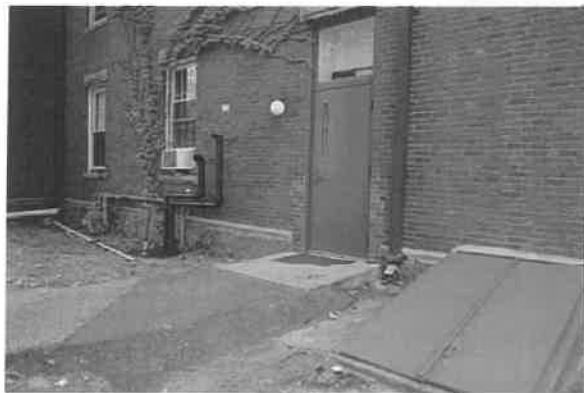
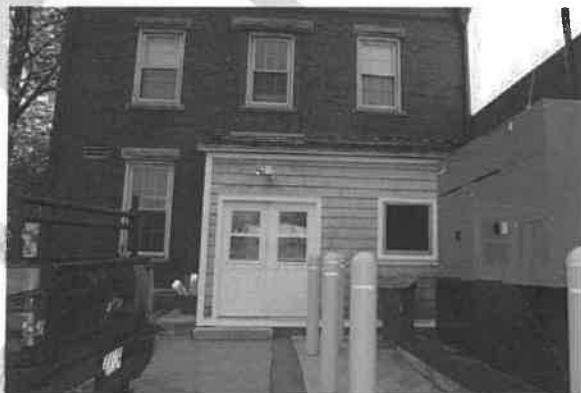
The entrance doors are hollow metal with insulated glass vision panels in hollow metal frames. Doors and frames are painted and are generally in fair condition, but exhibit considerable wear. The thresholds are worn. The seals and caulking are in fair condition.

None of the doors have been outfitted with a “crash-bars”; though many of the doors are typically equipped with lever handles.

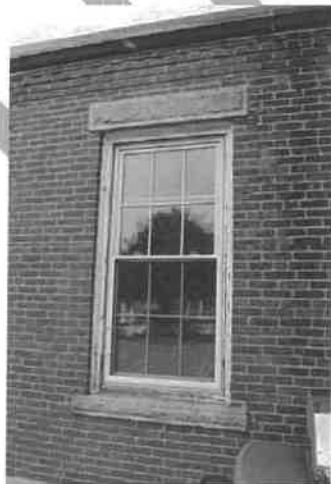
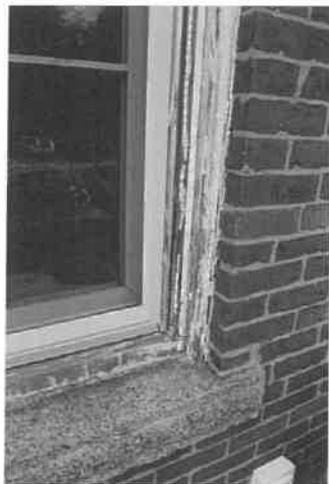
The windows are aluminum replacement double/single hung units with insulated glass and insect screens, set into existing wood frames. The windows were installed in 2003 and are in excellent condition. The existing wood frames need to be scraped, repainted and the perimeter caulking needs to be replaced.

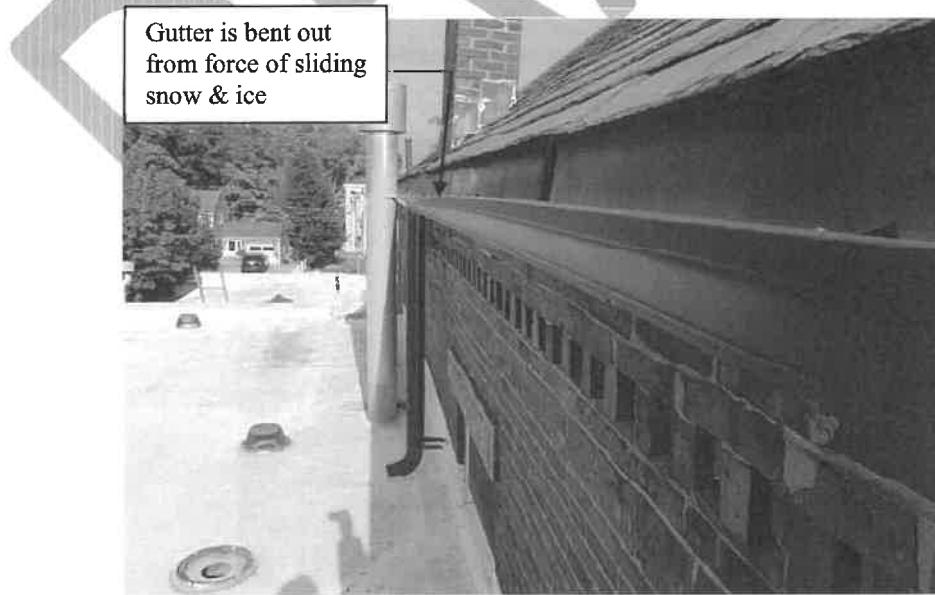
The gutters and downspouts are fabricated in copper. A section of gutter was observed to be bent out, most likely this occurred from the force of sliding ice and snow. This should be repaired before further damage occurs.

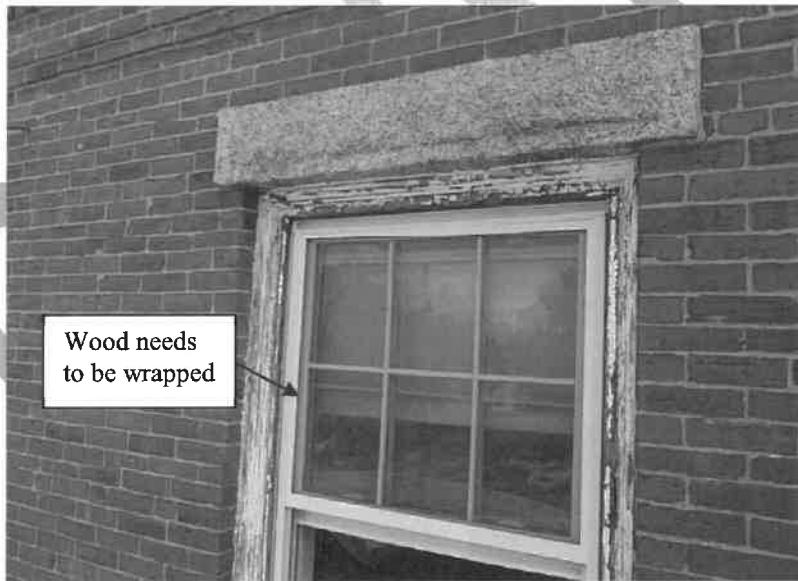
The wood frame windows show evidence of years of neglect. They are soft and spongy indicating water infiltration. They should be wrapped in aluminum break metal before it is too late to save them.

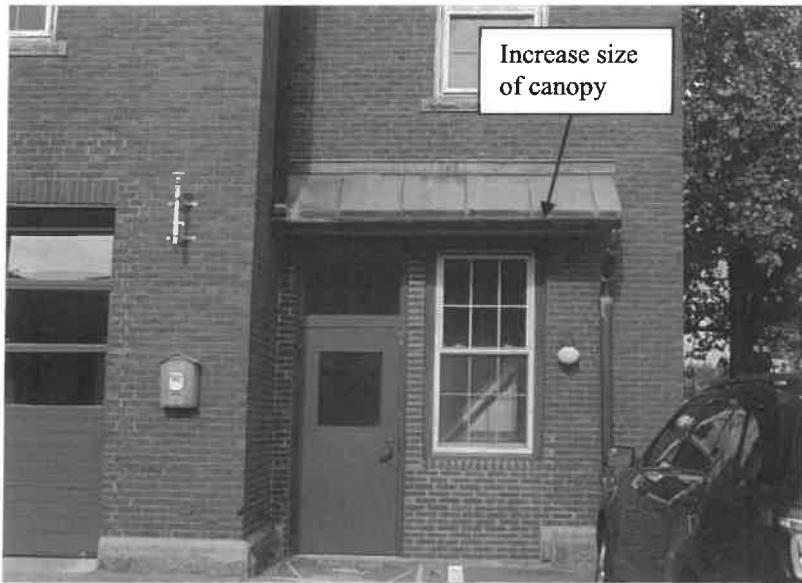
The small standing seam canopy roof over the main entrance is too small to protect pedestrians from falling ice and snow coming off the high roof. It should be removed and replaced with a larger canopy in order to offer greater protection.

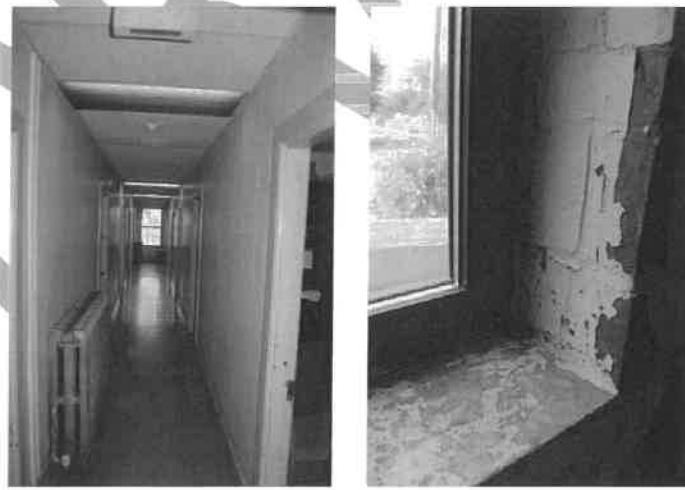
The interior masonry walls are generally in good condition but need minor repairs and repainting. The gypsum walls appear to generally be in fair to poor condition. Due to water infiltration, many of the walls are exhibiting peeling paint, cracks or spalling plaster, and will require much patching and repainting. The wood paneling is dated and needs to be repainted.

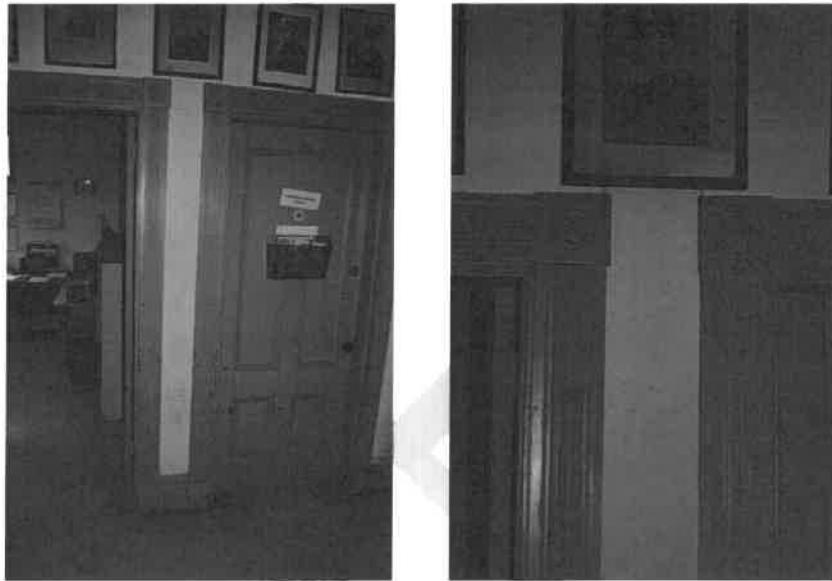
The interior doors vary in material (solid stile and rail wood and metal) and size (30"- 36" wide). Doors frames vary in material as well (wood frame with trim or hollow metal). Most of the doors have not been

outfitted with ADA compliant lever-style handles. The doors/frames and trim are worn and will require new hardware and refinishing.

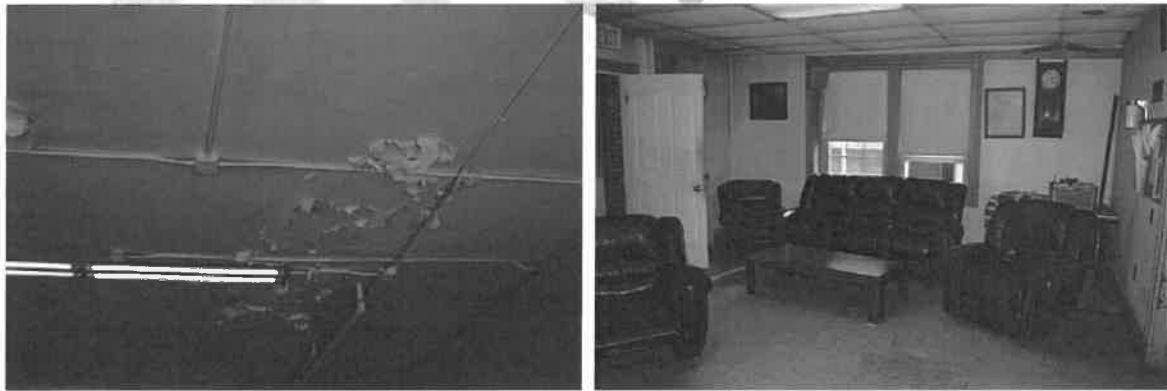
In general, all ceiling grids exhibit signs of rust, and tiles exhibit physical damage from water/moisture. Moisture problems and/or leaks from the roof system may be the cause or contribute to this damage. Many areas of peeling paint and spawling plaster were observed in the apparatus bays.

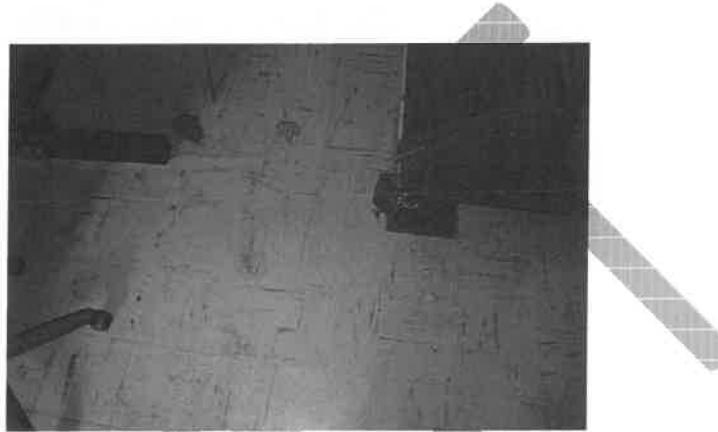
The vast majority of the flooring is VCT, which is utilized in the corridors, work rooms, bunk rooms, kitchen and day room. In general, the VCT is in poor condition and near the end of its useful life and needs be replaced.

VAT was observed in the attic area and needs to be abated. It is suspected that VAT was covered over with VCT on the lower levels. Further investigation is required.

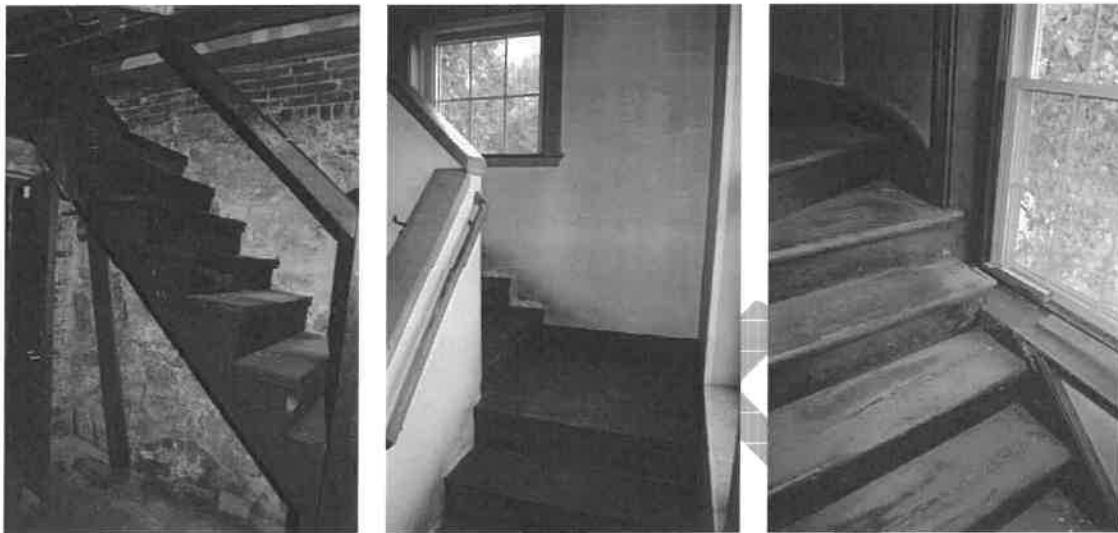
There is one winding stair that provides access to all levels. The stair is wood framed with wood treads and risers. Treads and risers to the basement are rough framed; to the upper level are rubber clad; and to the attic are exposed stained wood. The stairs appear to be structurally sound. Wooden handrails are provided on one side only and are not continuous as required by code. It has non-compliant treads and risers and requires a second handrail to be installed. The stair is not enclosed in a fire rated enclosure as required by code.

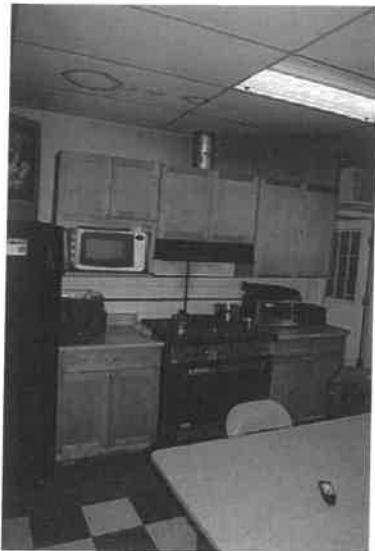
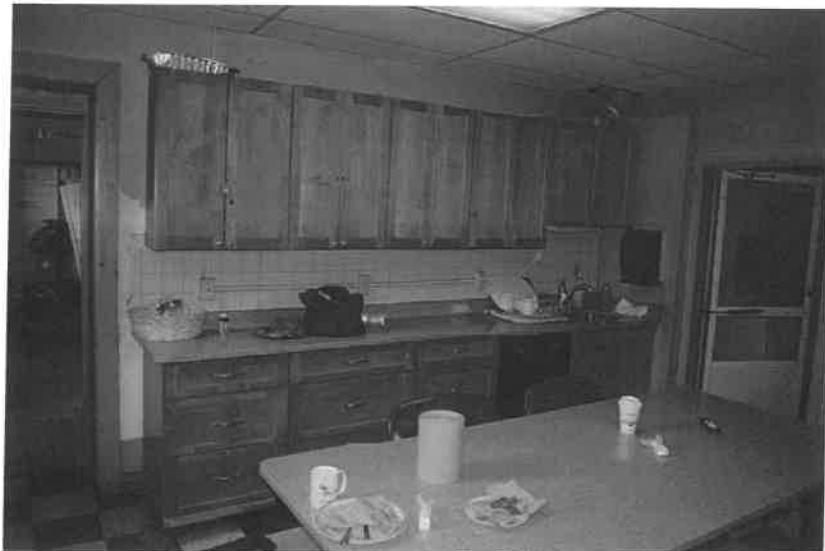
Kitchen

The kitchen is located on the main level and utilizes painted gypsum walls, with vinyl composition tile flooring and suspended acoustical tile ceiling with recessed 2x4 lights. All finishes are in poor condition and need to be replaced. Cabinets and countertops exhibit excessive wear. Appliances appear to be in fair condition. There is no emergency gas shutoff to the gas oven/stove.

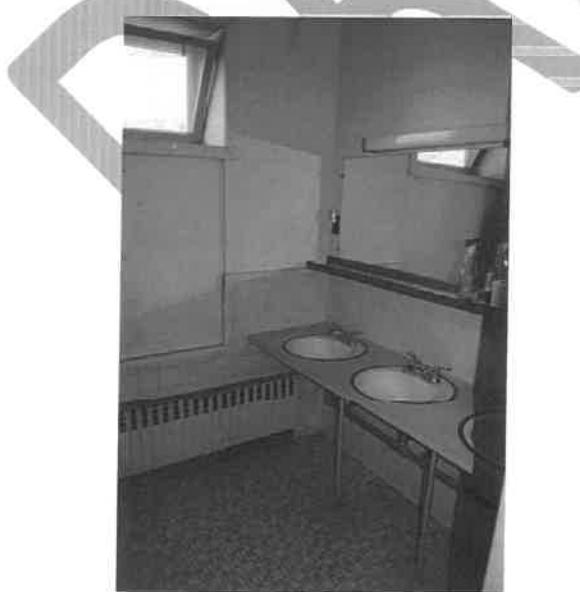
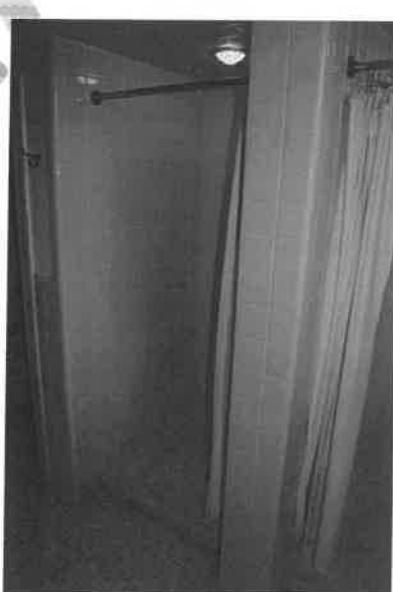
Toilet Rooms

The toilet room on the main level utilizes painted gypsum walls, with vinyl composition tile flooring and suspended acoustical tile ceiling.

The toilet/shower room on the upper floor utilizes ceramic tile wainscoting and painted gypsum walls, with ceramic tile flooring. Shower compartments have ceramic tile walls and ceilings with acrylic bases. All of these finishes are worn and are at the end of their useful life.

The fixtures do not meet ADA requirements. The sinks do not have insulated drain piping or approved lever style faucets handles and thus are non-compliant. The toilets do not have proper grab bars and or clearances. Additionally there are no separate toilet/shower facilities for male and female use.

Our recommendation would be to execute a total renovation of these spaces. The fixtures, partitions and accessories should be replaced with new.

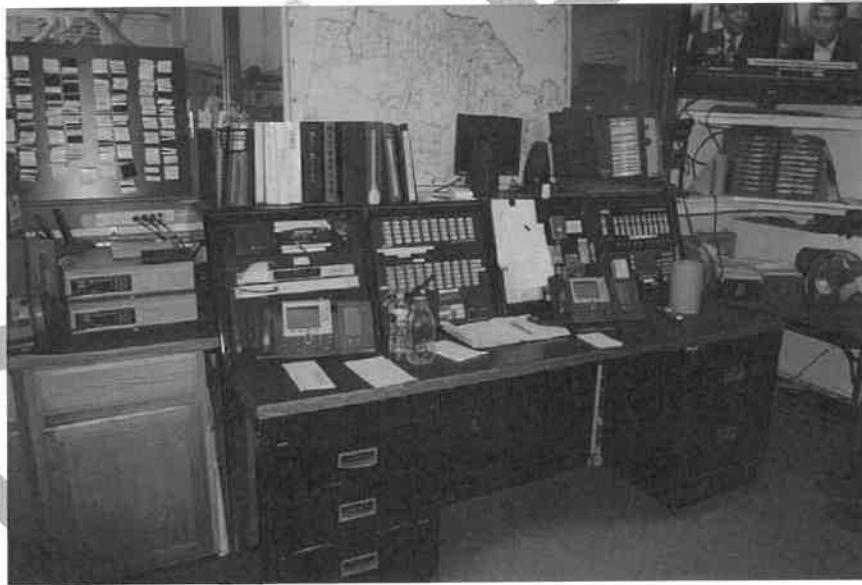
Communications Center

The dispatch center does not comply with NFPA 1221 which sets the design standard for emergency dispatch centers. This code requires two-hour fire separation from the remainder of the building, protection against civil unrest and an isolated air handling system among many other requirements. Neither an isolated air handling system nor two-hour fire separation assemblies were not evident. Additionally, this room appears to be used for a variety of other programmatic functions including report preparation and multi-purpose room. These functions are not conducive to providing an appropriate environment for dispatchers to communicate with citizens in emergency circumstances.

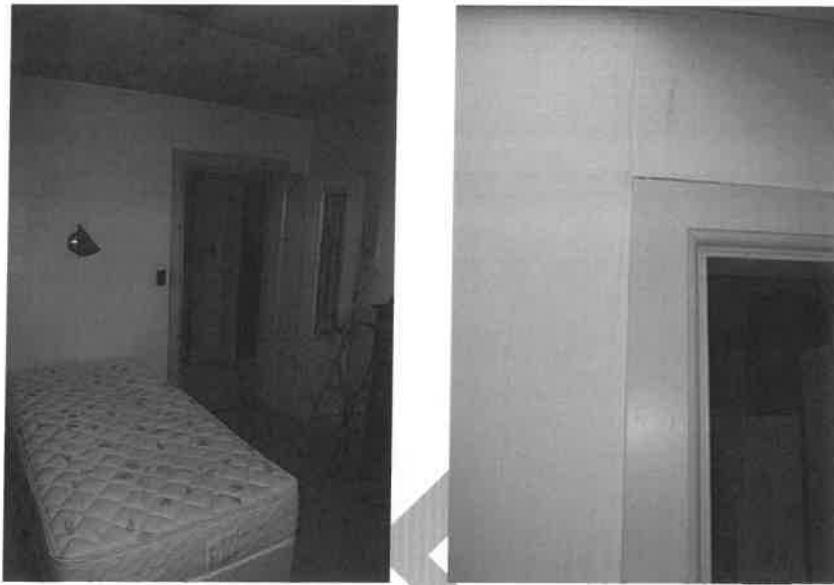
Bunk Rooms

There are eight (8) private bunk rooms located on the upper level. They utilize painted wood paneled walls, suspended 2x4 acoustical tile ceiling in a metal ceiling grid with recessed lights and VCT floor tile. All the finishes are in poor condition and need to be replaced.

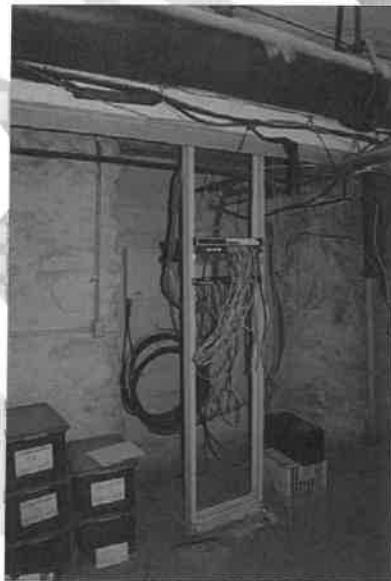
Head End Room

The stations computer network head equipment is located in the basement. The space is not secured nor is it climate or dust controlled.

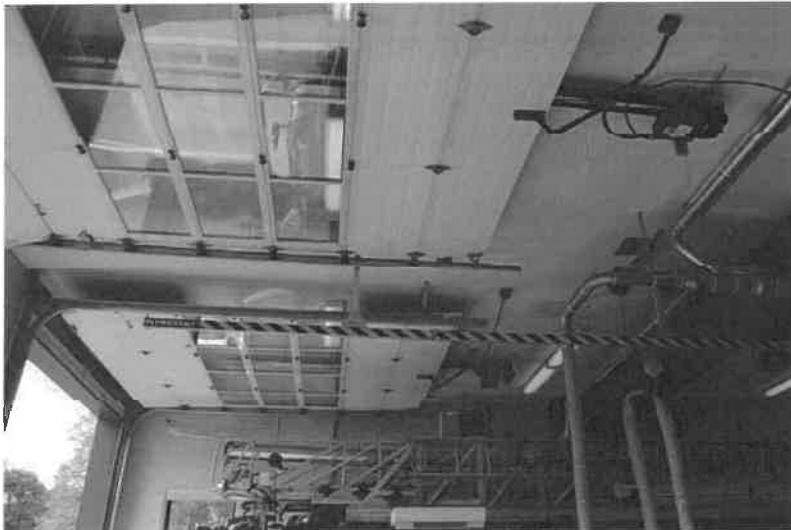
Apparatus Bays

The apparatus bays utilize painted cmu and gypsum board walls, plaster ceiling and stained/painted concrete floors. All of the finishes are in fair to poor condition. The ceiling exhibits signs of water damage, most likely the result of current and/or past roof leaks. The overhead door openings are too narrow & short and barely allow passage of the current apparatus. The circulation space around the apparatus is too narrow per recognized fire station facility design standards.

The apparatus doors are insulated metal clad pre-finished sectional overhead doors, which were installed in 1987 and are in good condition.

The vehicle exhaust system is installed within the last 10 years and is in excellent condition.

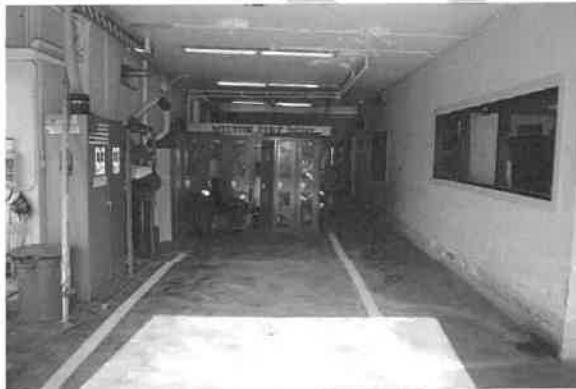
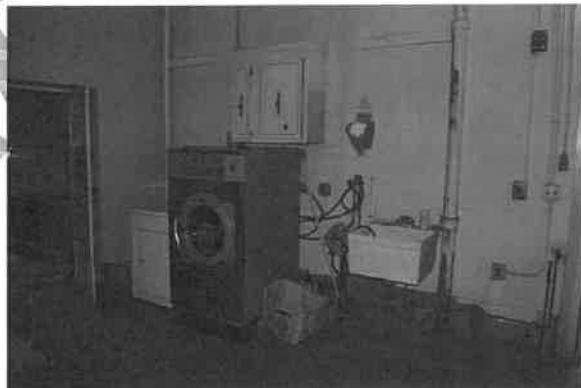
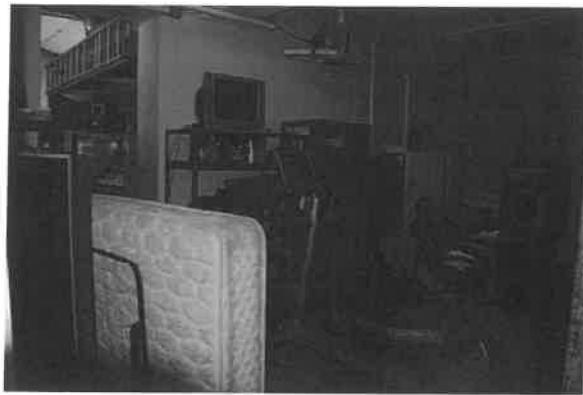
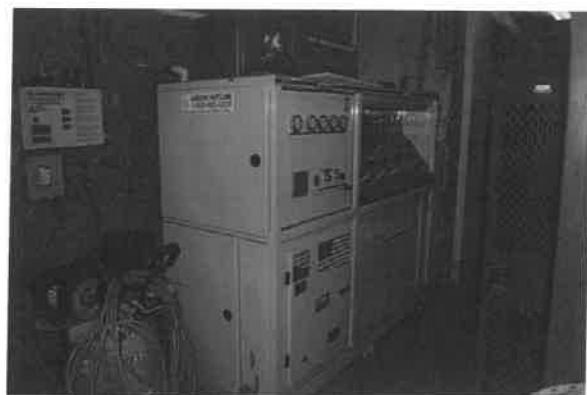
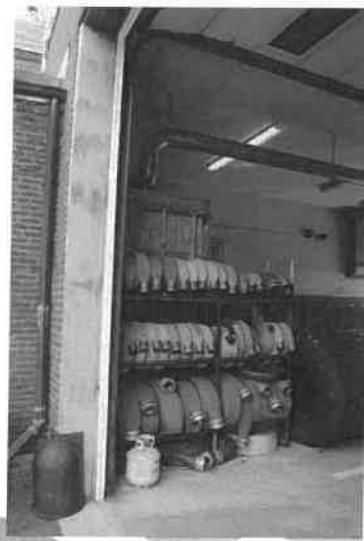
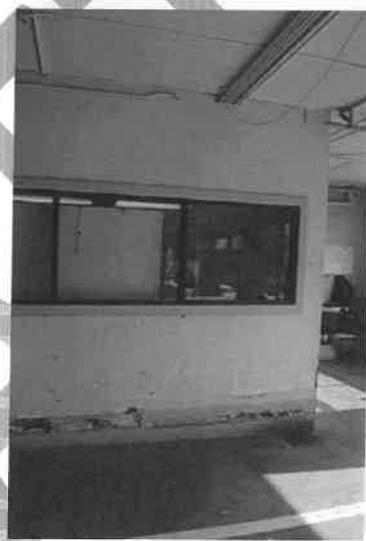
There is a fire pole from an upper level corridor. that has been abandoned.

Additionally the bays house the turnout gear lockers, SCAB fill station, fitness area, decontamination area, laundry, hose/supply storage and work areas. All of these spaces should be in their own spaces

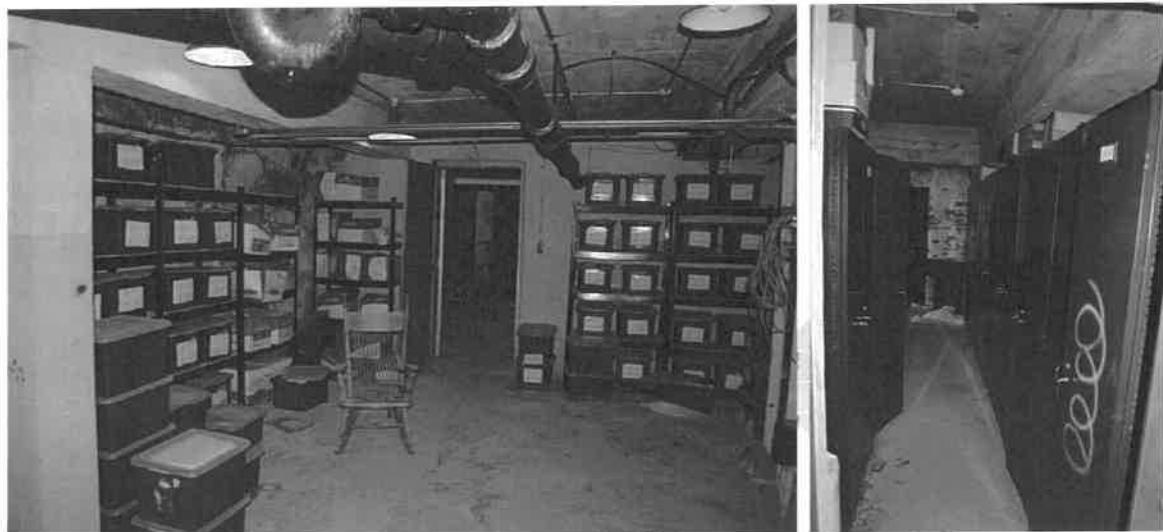
Storage Facilities

There appears to be inadequate storage facilities for archival records, training materials, department equipment, and supplies.

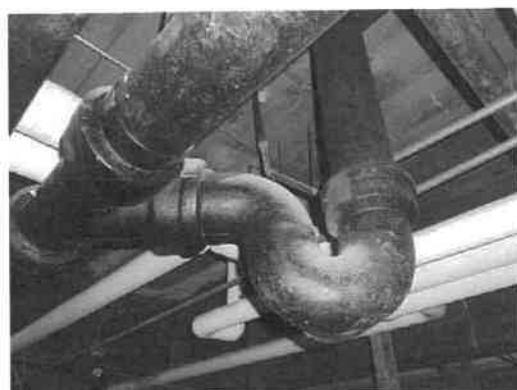
Cast Iron Bell & Spigot

Sanitary, waste and vent piping is generally cast iron bell and spigot with areas of new work having no-hub cast iron pipe. The piping appears to be in good condition.

In general, existing cast iron drainage piping can be re-used and is sized appropriately. We recommend video inspection of existing drains to confirm integrity.

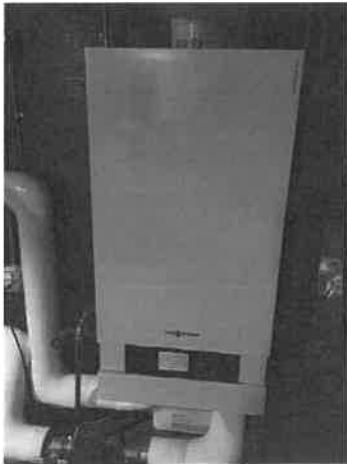
High Efficiency Boiler

The building is heated by one (1) wall mounted gas-fired high efficiency condensing boiler located in the basement of the building. This boiler along with four inline pumps and expansion tank was just recently installed (2015) and in excellent condition. The boiler is manufactured by Viessmann (Model Vitodens 200, 262 MBH output for hot water and 285 MBH max input). The boiler is provided with a direct vent option which utilizes separated combustion flues. One flue is utilized for combustion air and the other is for the combustion gases. Each system utilizes polypropylene material and exits the building through an exterior wall where it terminates with an elbow and screen. The boiler has its own burner management control system which utilizes outdoor air reset and high turn down modulation for high efficiencies.

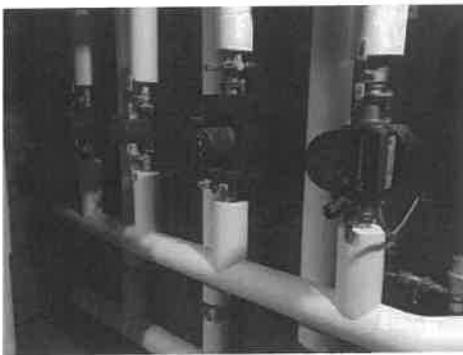
Inline Pumps

The hot water circulates throughout the building through the use of three inline pumps manufactured by Grunfos, these pumps are of the self-sensing type which allows the pump speed to modulate based on the buildings demand. One inline pump is utilized just for the unit heaters located in the basement, the other two operate as a primary/standby system. There is one more inline pump associated with the heating hot water system and this pump is utilized for the indirect domestic water storage tank. Currently the heating hot water system is used to provide domestic hot water for the building. Control of all these pumps is performed by a three zone switch relay manufactured by Taco, model SR503.

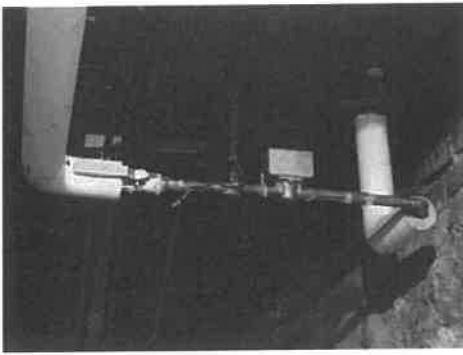
The piping system associated with the heating hot water boilers and pumps is all new and recently installed. The material is schedule 40 black steel with Victaulic fittings. The boiler utilizes a low loss header system which was provided by the boiler manufacturer. This allows multiple independent zones to be circulated to the boiler plant. All the piping located near the boiler itself is insulated with new fiberglass insulation with PVC fitting covers. The piping throughout the rest of the building is original and is not insulated completely, some locations are exposed and have no insulation or the fiberglass insulation is damaged. The piping from an outwards appearance seems to be in fair condition however, a section of piping should be removed to examine the internal condition of the piping system and ensure that there is no corrosion or scaling.

Typical Piping with No Insulation

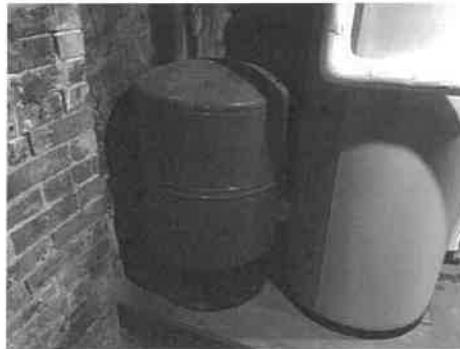
Expansion Tank

Hot water expansion is completed through the use of a vertical non-insulated bladder style expansion tank. This tank was also recently replaced and in excellent condition. However, it is not insulated and should be to help reduce the systems heat loss.

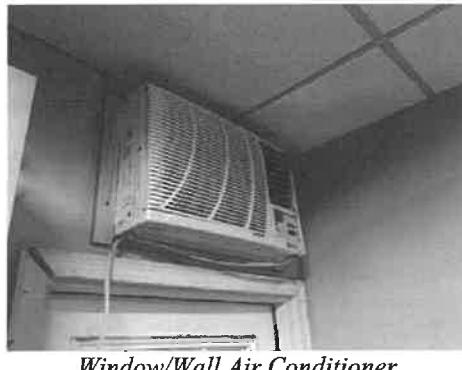
Window/Wall Air Conditioner

There is no central air conditioning system in the Fire Station. Window air conditioning units are located throughout the fire station mostly located in windows however, the break room does have one installed in an interior partition wall which has the apparatus bay garage on the other side. As for ventilation air, there are no mechanical ventilation units. The building utilizes operable windows as its means for ventilation, this is allowed by code however the actual requirements required by the code do not appear to be achieved with the current windows. A review of the current windows and square footage would need to occur to ensure that the operable portion of the window equals four percent of the floor area.

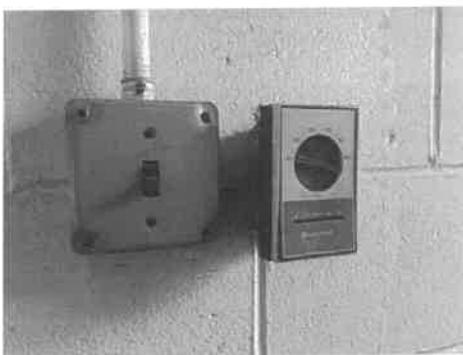
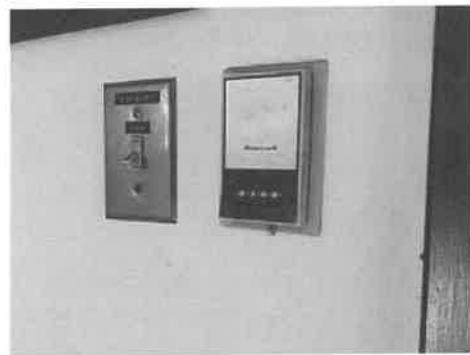
Automatic temperature controls for the building is minimal, some equipment such as the unit heaters in the apparatus bay and the wall mounted fin tube in the office area are controlled with standalone electronic thermostats. These standalone thermostats are tied directly into each unit and are antiquated. These thermostats were provided by the equipment manufacturer. Other areas of the building that are heated with cast iron radiators and are equipped with thermostat control valves. However many of them are not functional, and in some cases missing. The overall control system appears to be malfunctioning and the controllability of the system is less than desirable. We would recommend removing the stand alone electronic systems and replacing them with a direct digital control system throughout.

Standalone Thermostat

Electronic Standalone Thermostat

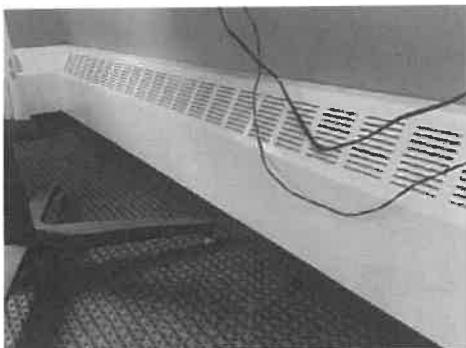
Office Fine Tube

The office area, break room and sleeping quarters utilize a mix of heating equipment. The office and dispatch area on the first floor utilizes wall mounted hot water fin tube radiation which is controlled via a wall mounted standalone thermostats. The breakroom and the rooms in the rear of the building on the first floor have hot water cast iron radiators which do not have any means of temperature control associated with them. These pieces of equipment run wild and generally overheat the spaces. The second floor sleeping quarters also utilizes hot water cast iron radiators for the hall way and general lounge area. There is one wall mounted standalone thermostat located in the main corridor. This thermostat controls several cast iron radiators in the main hall and general lounge area. Each individual room is heated through wall mounted fin tube radiation and is controlled with an individual wall mounted standalone thermostat. Overall the cast iron radiators and wall mounted fin tube radiation is damaged, missing components, and antiquated. The systems require a complete replacement.

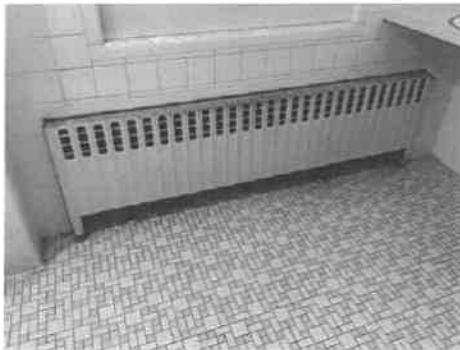
Typical Cast Iron Convector

There is no mechanical exhaust system for the shower or toilet rooms which is not code compliant. Operable windows provide natural ventilation to these spaces. Floor mounted convectors are located in the bathrooms on the second floor. The convectors are antiquated and are in need of replacement.

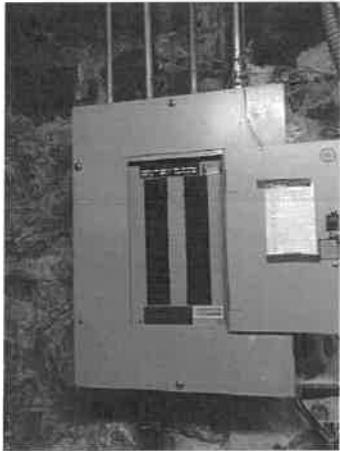
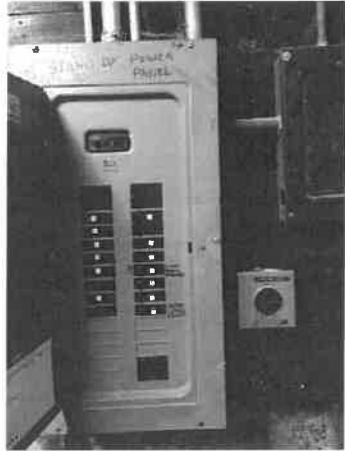
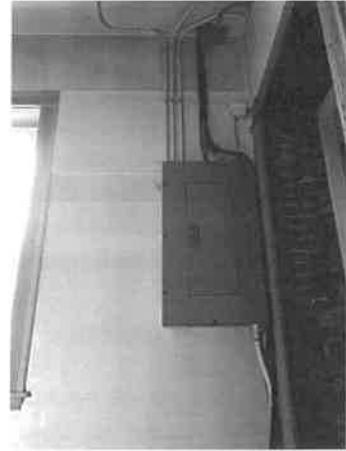
Sub-panel

There is a step down transformer to service 120/240 volt, single phase loads in the building. The Distribution System is in poor condition and inadequately sized for a renovation program.

- The electrical service is marginal for this facility and the voltage and phase is not suitable for a public safety facility. The entire service should be replaced with a 120/208V, 3Ø, 4W service adequately sized and housed in a code compliant space.
- Electrical power will be brought into the site via underground medium voltage cables from the utility company network. A pad mounted step-down transformer will be located at grade adjacent to the building. Service entrance and distribution switchgear will be located in the Electrical Room near the Mechanical Room, along with lighting and power distribution panels.

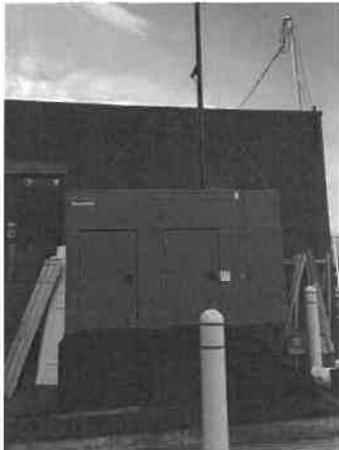
Generator

An exterior diesel generator has been recently installed. The generator is manufactured by Cummings Onan, rated at 60 kW, 75 kVA @ .8 PF, serial number 5088230-03. It is mounted in a weatherproof sound attenuated enclosure. The generator feeds a single automatic transfer switch located in the Main Electrical Room. It is unclear as to what is fed from the emergency generator.

The emergency generator and the automatic transfer switch are in good condition; however, the life safety lighting is fed from the generator and is not compliant with today's codes. Exit signs are in fair condition; however, are not installed in all required locations.

- The generator is housed in a sound attenuating weather proof enclosure with critical grade exhaust silencer, and automatic starting and safety controls. The generator shall include two (2) service breakers and transfer switches: one (1) for life safety equipment, one (1) for other than life safety equipment. The generator will be sized for 100% of all lighting and power loads. All air-handling units will be provided with emergency power to maintain ventilation and heating for the duration of 48 hours.
- Exit signs will be replaced with energy efficient, long life LED type.

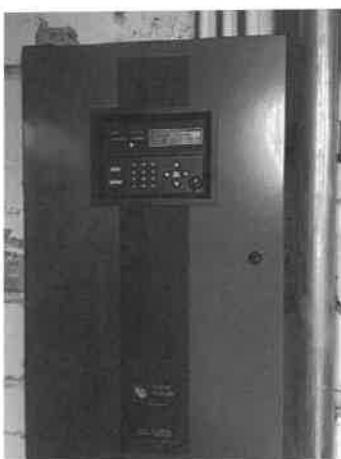
FACP

The building has a 10 zone microprocessor based fire alarm control panel manufactured by Silent Knight by Honeywell, Model SK-5208. The panel seems to be in good condition however the notification devices and detection devices vary from poor to good depending upon when they were installed.

- Fire Alarm System should be replaced with an addressable, ADA compliant system with full coverage.
- A Fire Alarm and Detection System will be provided with 60 hour battery back-up. The system will be of the addressable type, where each device will be identified at the control panel and remote annunciator by device type and location to facilitate search for origin of alarms.

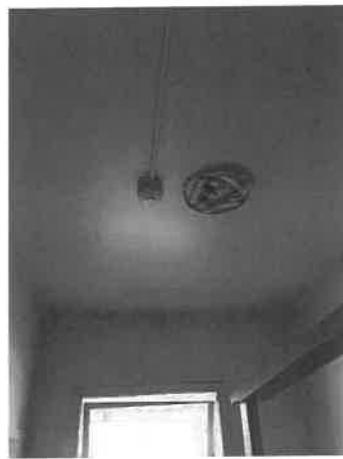
Heat Detector

There are a combination of heat detectors and smoke detectors located throughout the building. The Dorms do not meet the latest codes with respect to notification, they do not have low-frequency horns in sleeping areas. Self-contained Kidde wall mounted CO detectors are located in the Corridor outside the Dorms. Horn strobe coverage is inadequate.

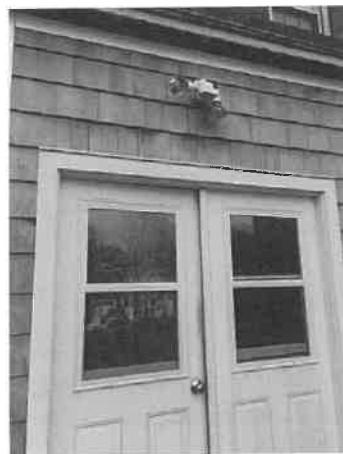
Exterior Lighting

Exterior lighting consists of building mounted halogen lamps with integral motion sensors. Fixtures are in poor condition and are not dark sky compliant.

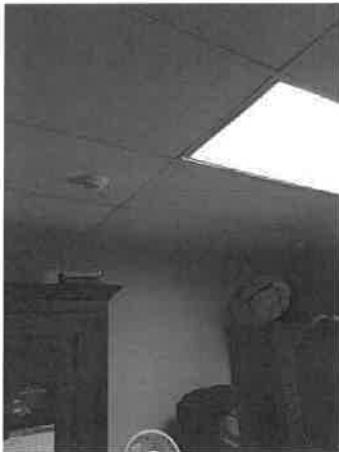
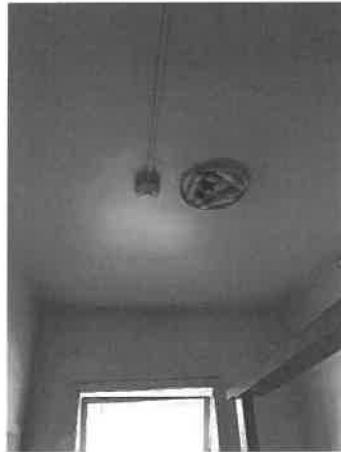
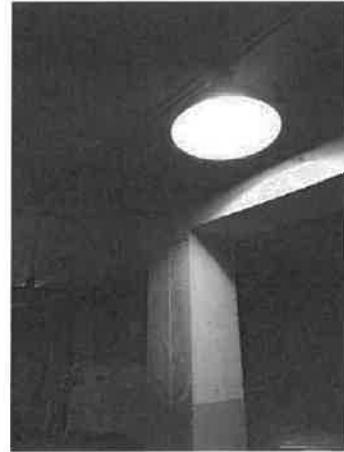
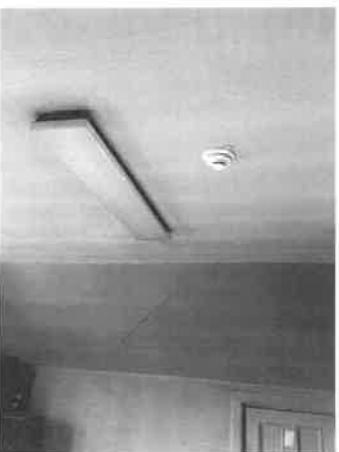
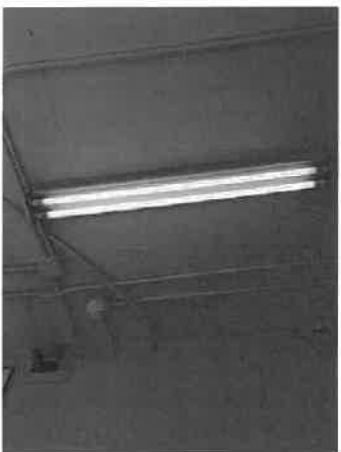
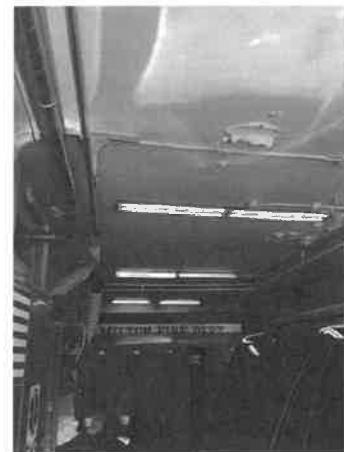
Lighting in general is in poor condition, lacks proper controls, and light levels are too low in most spaces.

All lighting should be replaced in a renovation program.

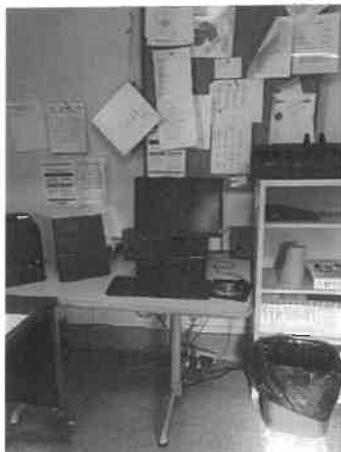
Extension Cords

Receptacle coverage is minimal and inadequate in various spaces. Extension cord use was noted due to scarcity of the outlets.

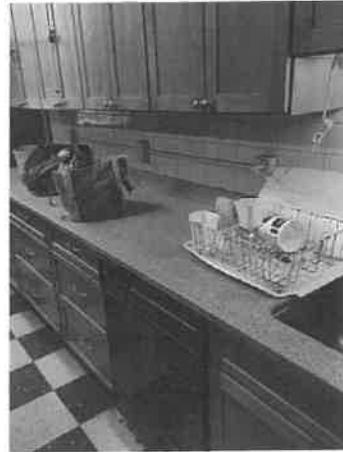
Kitchen Receptacles

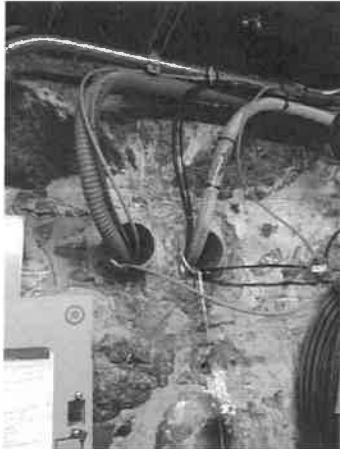
The telephone service, CATV, and town fiber run overhead in the street and enter the building underground in the basement. The fiber is terminated on a wall mounted fiber optic cabinet in the basement and connects to the building's data rack. The data rack is located in poor environmental conditions in the basement which will lead to shortened life of the equipment.

Fiber and Cable Service

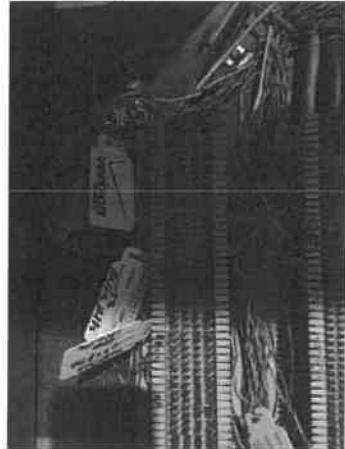
The telephone service also enters the basement. The wiring has been modified many times over the years leaving lots of dead wiring making it difficult to follow.

Telephone Service

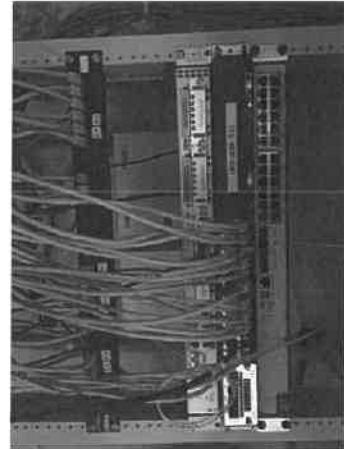
The building data/phone infrastructure consists of a single 24 port Cat5e patch panel in the basement connecting to Cisco switches that are plugged into a local APC UPS.

Tel/Data Rack

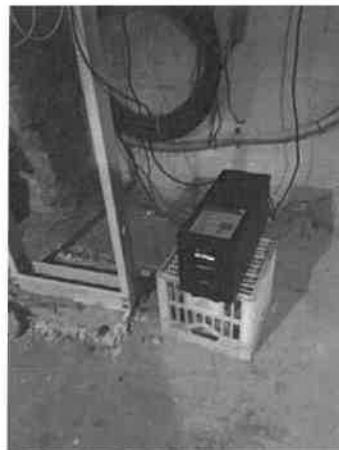
UPS

- A three phase centralized UPS System will be provided. The system will provide conditioned power to sensitive electronic loads for Communications Equipment Room and Communications/Watch Room. The UPS will bridge over power interruptions of short duration and allow an orderly shutdown of servers, communication systems, etc. during a prolonged power outage. The UPS System will also be connected to the stand-by generator.

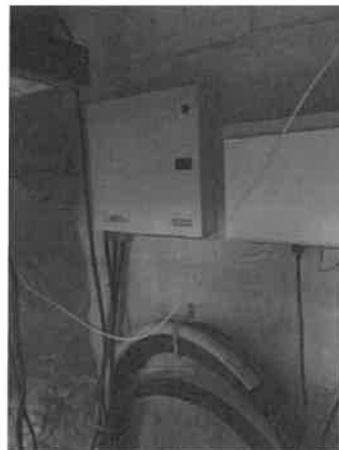
Fiber Enclosure

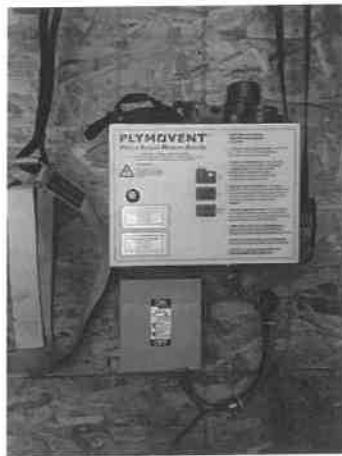
Plymovent Vehicle Exhaust System exists; control panel is located in the Apparatus Bay and is in good condition.

Plymovent Control Panel

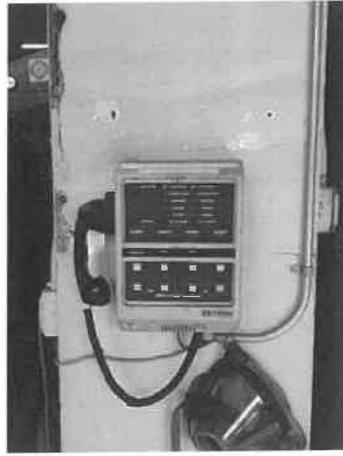
Zetron Model 6 for incoming alarms is located outside the Watch Room and is in good condition.

Zetron Model 6
