Town of Milton Fire Station Space Needs Study

Milton, Massachusetts
November 23, 2015

KAESTLE BOOS
associates, inc

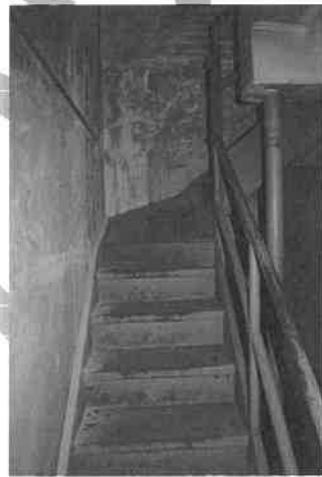
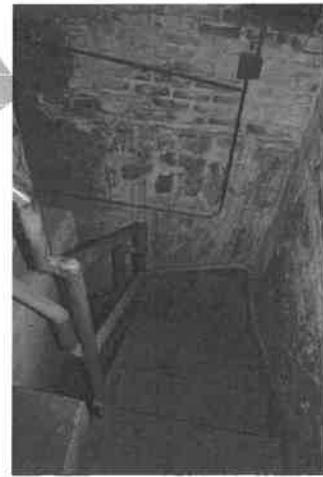
- The existing egress stair in the building is not enclosed in required fire rated construction, does not have risers and treads of required dimensions, does not have railings and guards on both sides of the stair, does not have railings and guards with required height and spacing, does not have required rail extensions, and does not have fire rated doors which comply. All stair conditions must be corrected in accordance with current egress requirements as part of any renovation project.

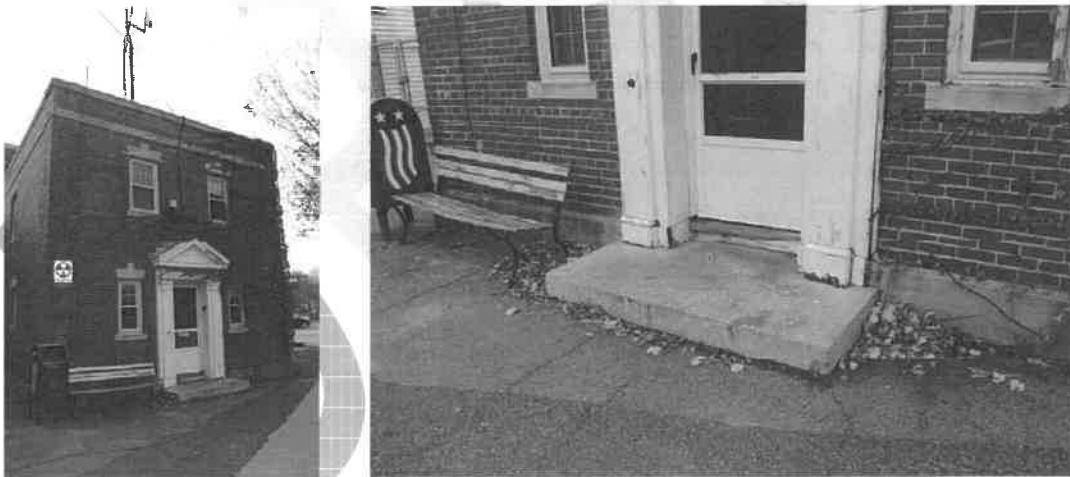
- Access to the building from the exterior is non-compliant at the Ground Level public entrances.

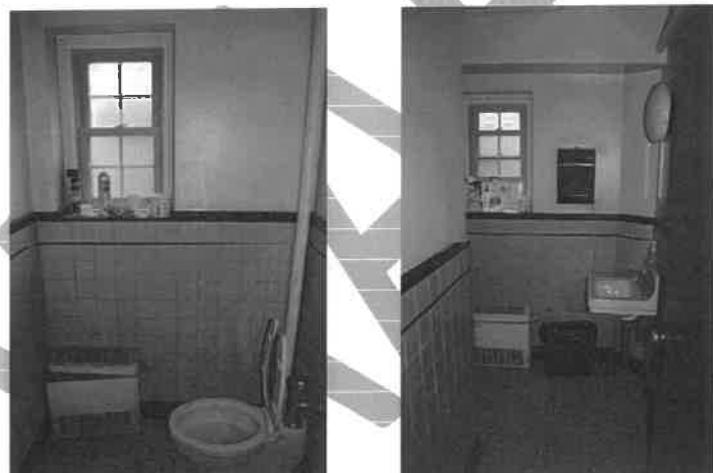
The existing male and female toilet rooms off of the public lobby on the main level does not comply with accessibility requirements and must be modified if civilian staff or disabled staff is allowed to use these facilities.

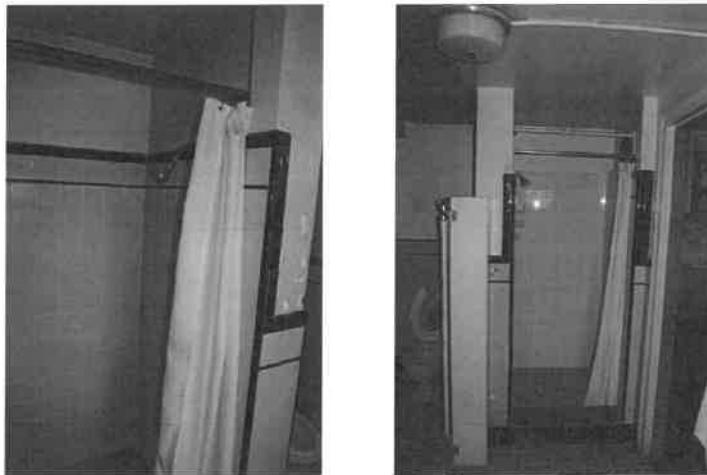
(AAB 31.7) A single unisex toilet/shower room is accessed from the common bunk room and a private toilet/shower room accessed through the shift commanders bunk room is provided for able-bodied staff only on the upper level, where compliance is not required. However, the plumbing code requires separate toilet/shower rooms for men and women; although unisex rooms are allowed for compliance with AAB, this is not compliant with the plumbing code.

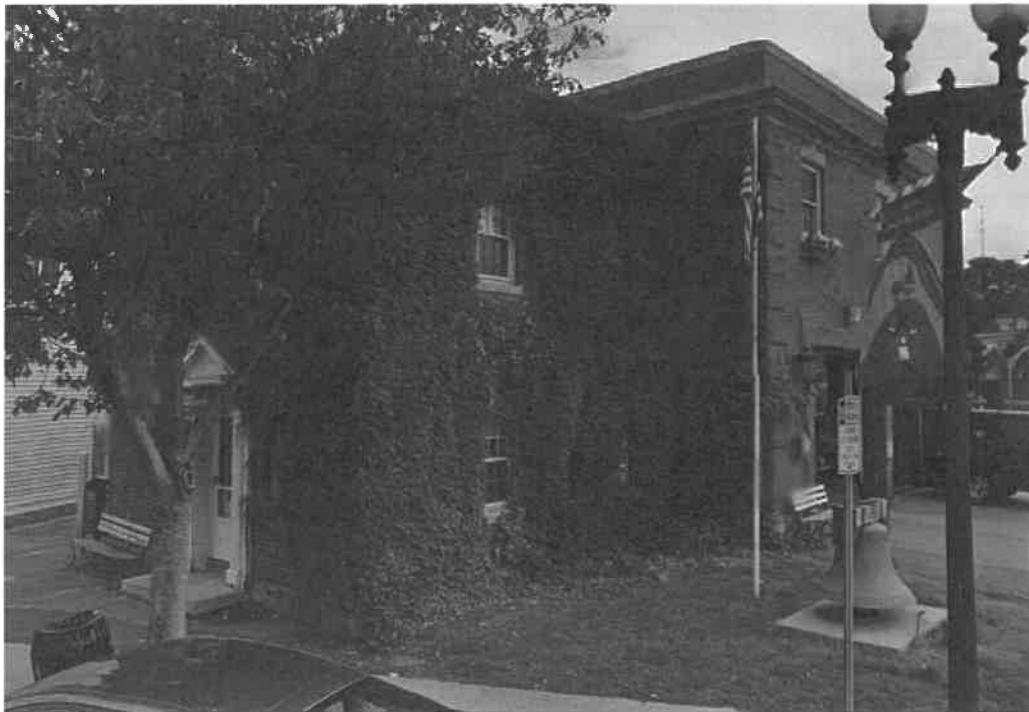
Ivy covered north wall.

- Remove all ivy from face of building to stop additional damage to the mortar joints, which will allow infiltration of water into the walls causing damage to the interior surfaces and spalling of the exterior brick.

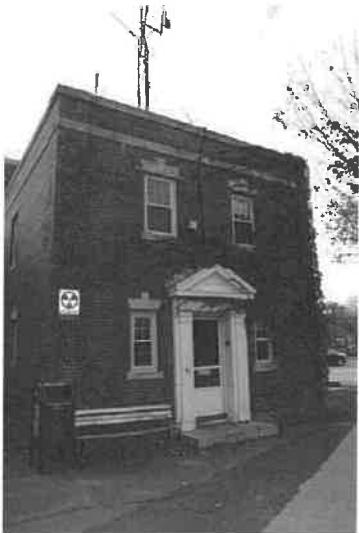
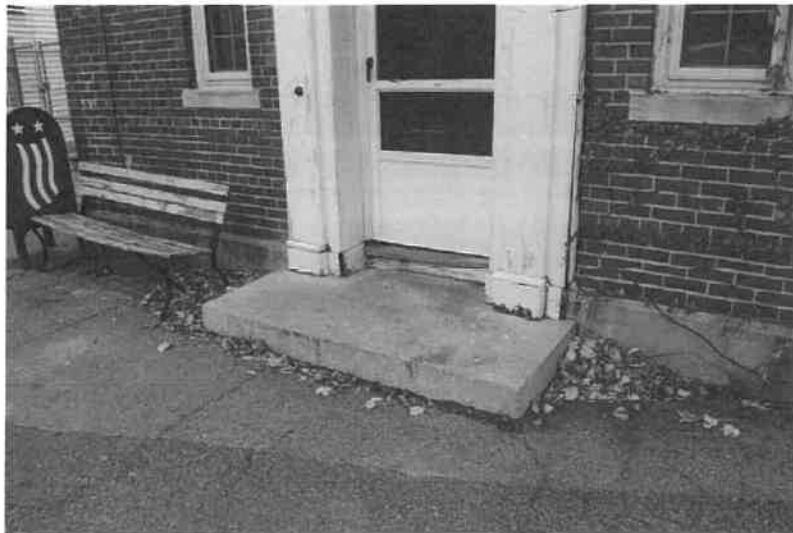
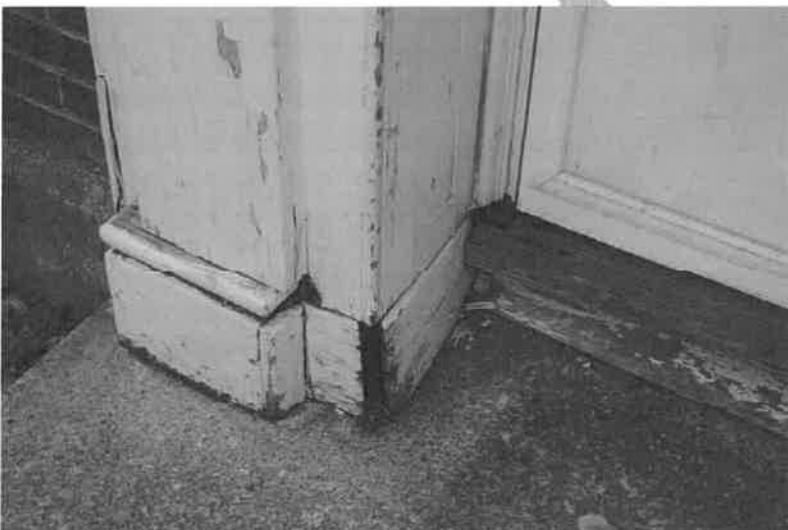
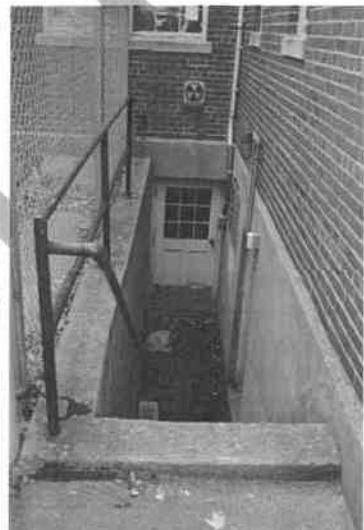
The entrance door is painted wood stile and rail door with true divided lites, with an aluminum storm door. Doors and frames are generally in poor condition, and exhibit considerable wear. The wood threshold is worn and rotting. The seals and caulking are in poor condition. The lock set is failing as is the weather stripping (light visible at door bottom). The door has not been outfitted with a “crash-bars”; or equipped with lever handles.

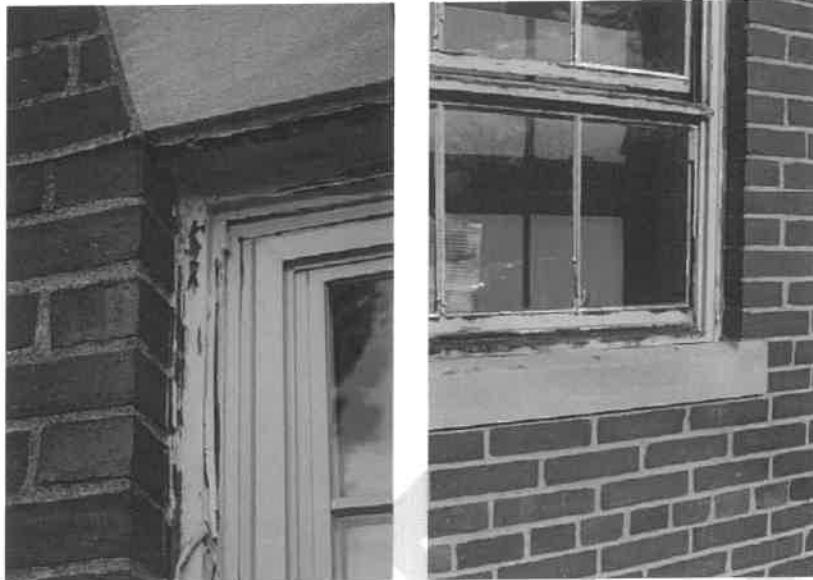
Most of the windows are pre-finished aluminum replacement double hung units with insulated glass and insect screens, set into existing wood frames, and are approximately 10 years old and are in excellent to good condition. The painted wood frames appear to be sound but need to be scraped and repainted, as well as have the perimeter caulking replaced. Many of the steel lintels are displaying what appears to be surface rust and must be refinished. In the basement and apparatus bays the original steel framed single pane windows remain. They exhibit surface rust and falling or missing glazing compound and perimeter caulking need to be repaired/repainted. Typically, this type and age of steel window has asbestos in the glazing compound. This needs to be investigated as part of a thorough hazardous materials survey of the facility.

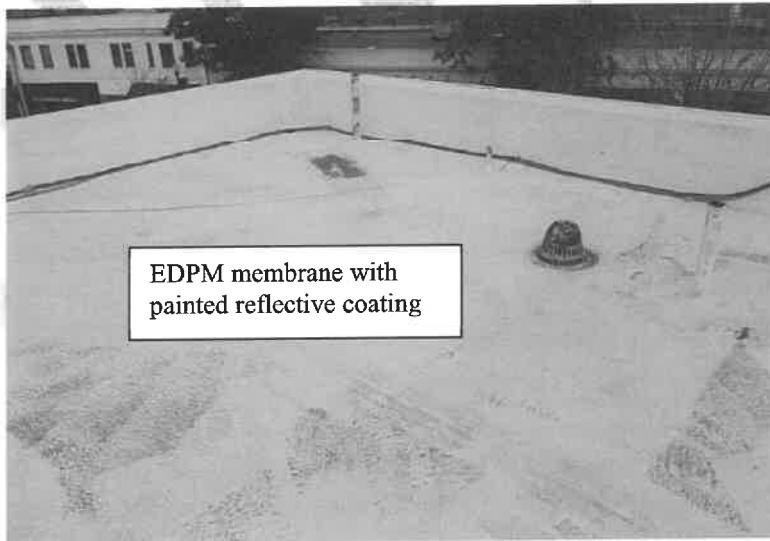
The high roof on the 2 story main building consists of single-ply EPDM rubber roof coated with a white reflective paint which is wearing thin in a number of locations. In addition the roof is soft and spongy indicating a water saturated layer of insulation trapped beneath the membrane. This is an indication of roof leaks and the presence of moisture can become breeding grounds for mold and mildew.

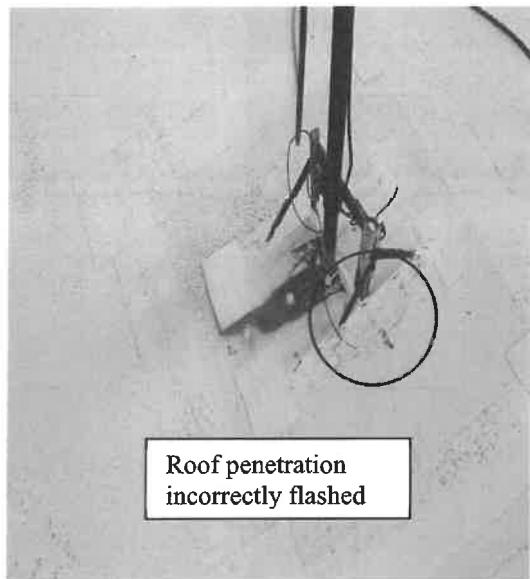
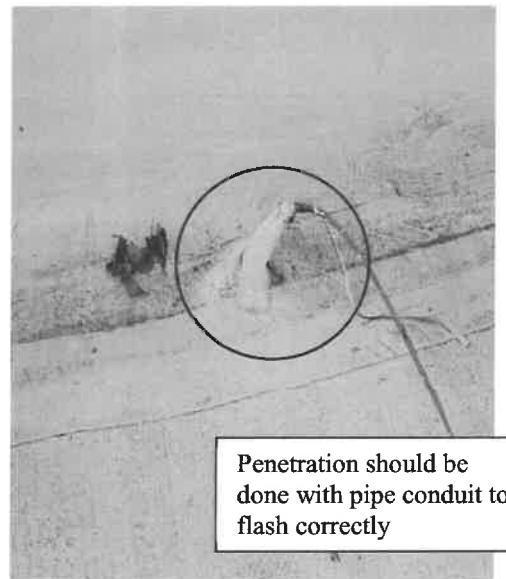
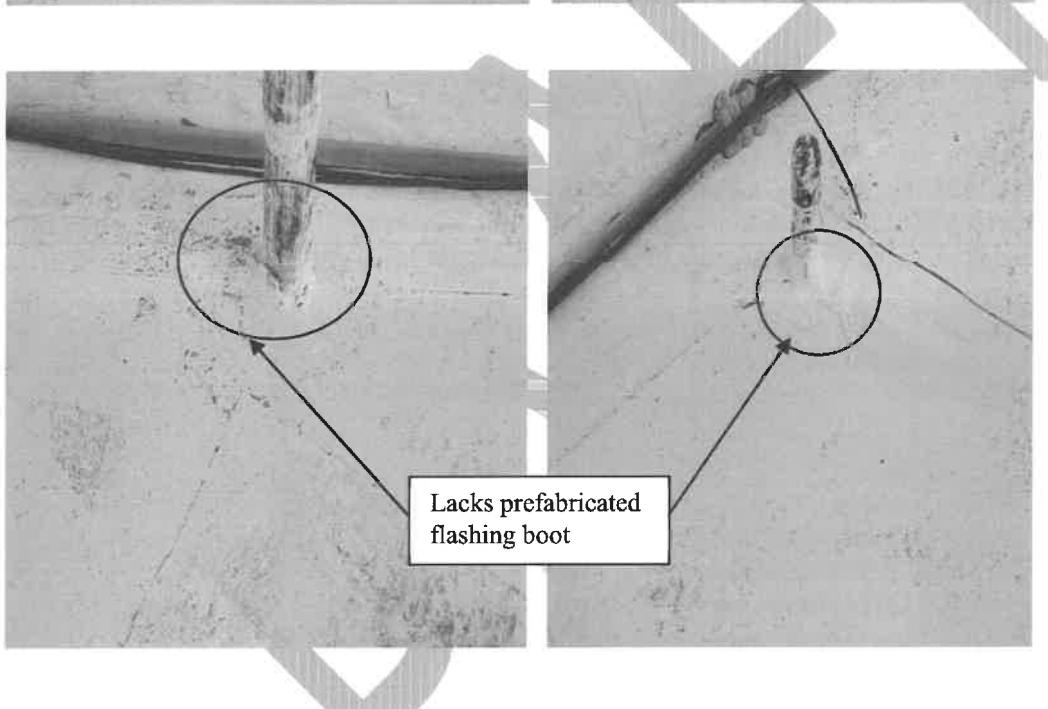
The high roof contains a number of roof penetrations that are incorrectly flashed which are most likely the sources for the water infiltration issues.

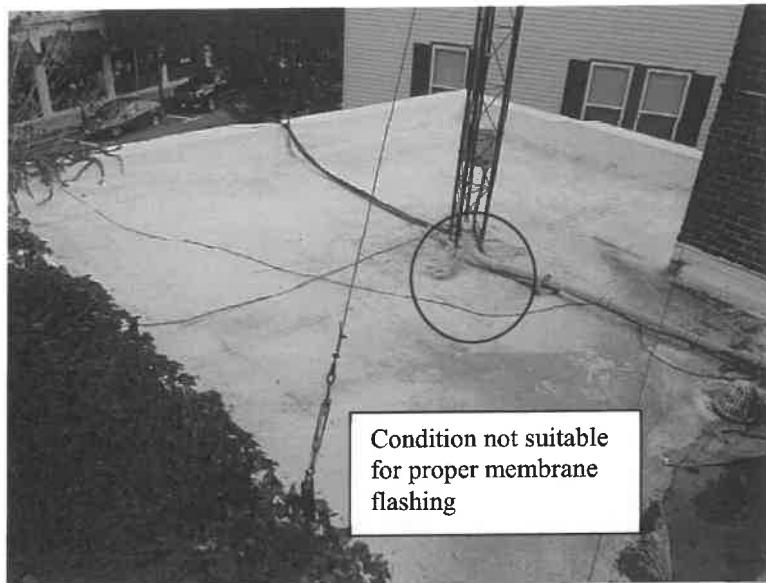
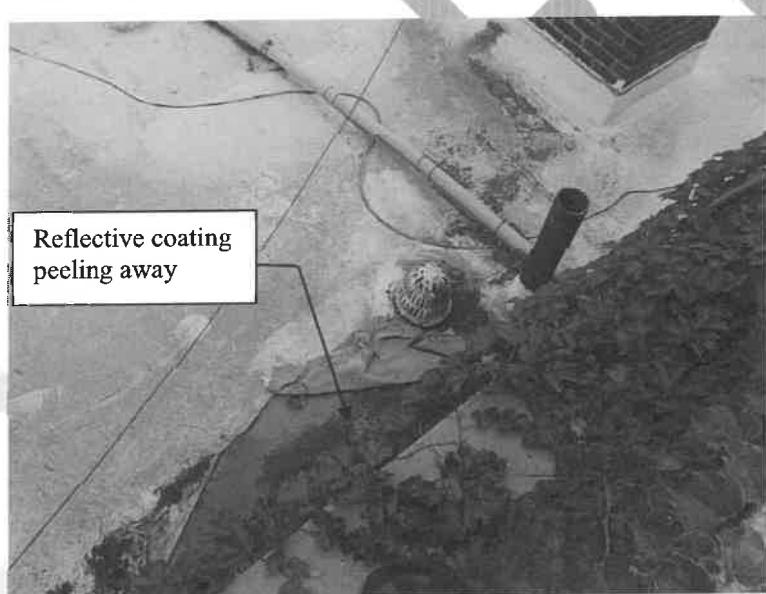
The lower roof off to the side also consists of a single-ply EPDM rubber membrane with a coating of white reflective paint. The roof contains the base for a high antenna which most likely is not flashed correctly. In addition, the white coating was observed to be peeling off the membrane.

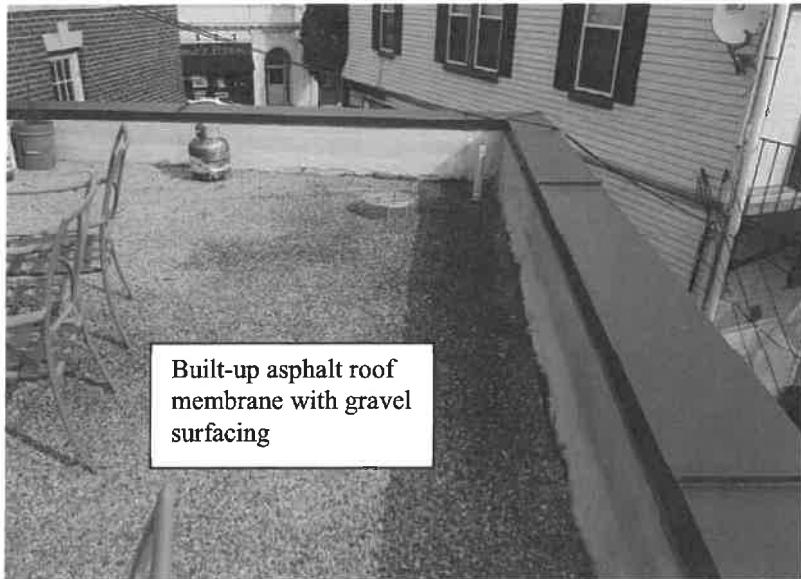
The one story wing at the rear of the facility contains a built-up asphalt roof with gravel surfacing that appears to be more than 20 years old.

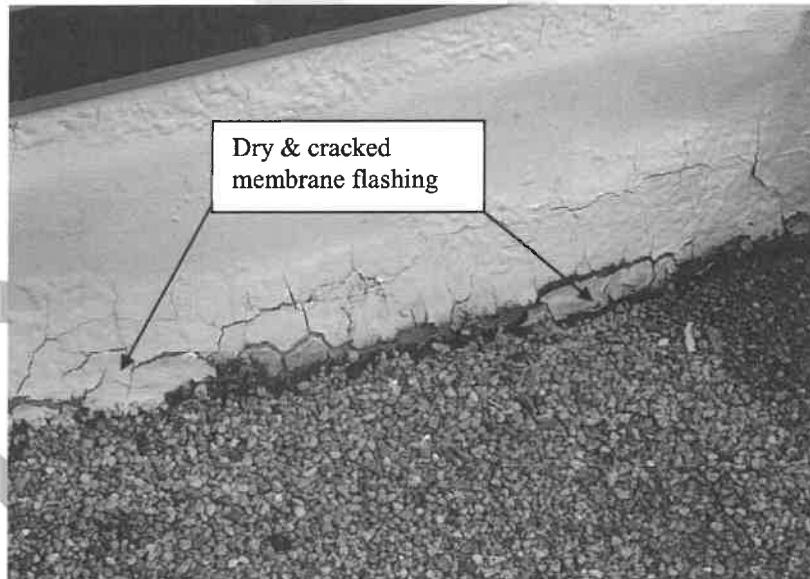
The roof membrane flashings are old cracked due to its age and are most likely leaking.

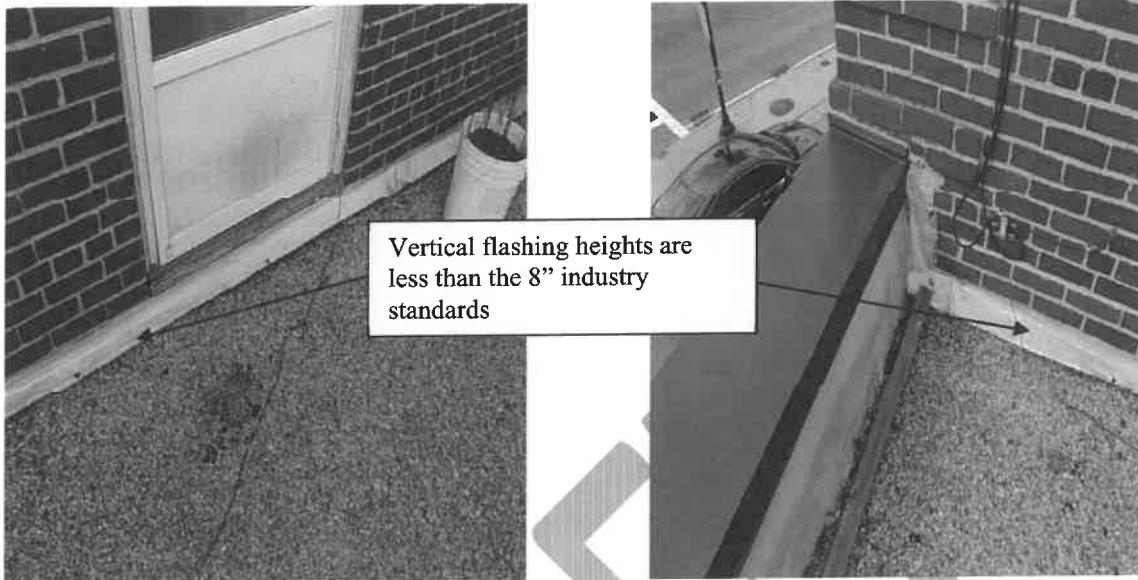
The flashings at the roof to wall transitions are less than the required 8" and are not acceptable roofing flashing details per industry guidelines.

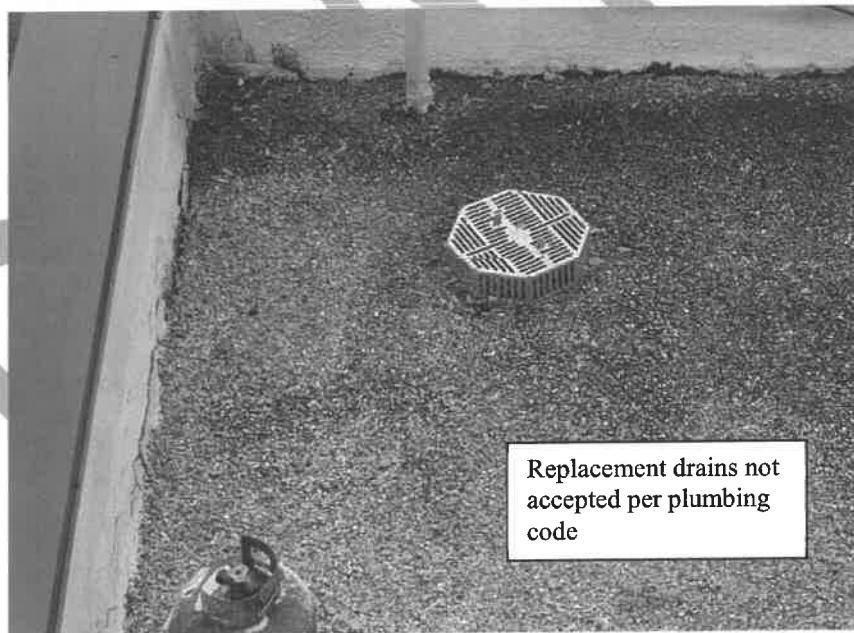
The drains are not the original drain bowl. They are replacement drains that are installed into the drain pipe with a sleeve which reduces the ~~diameter~~ and capacity of the pipe and are not accepted per the plumbing code.

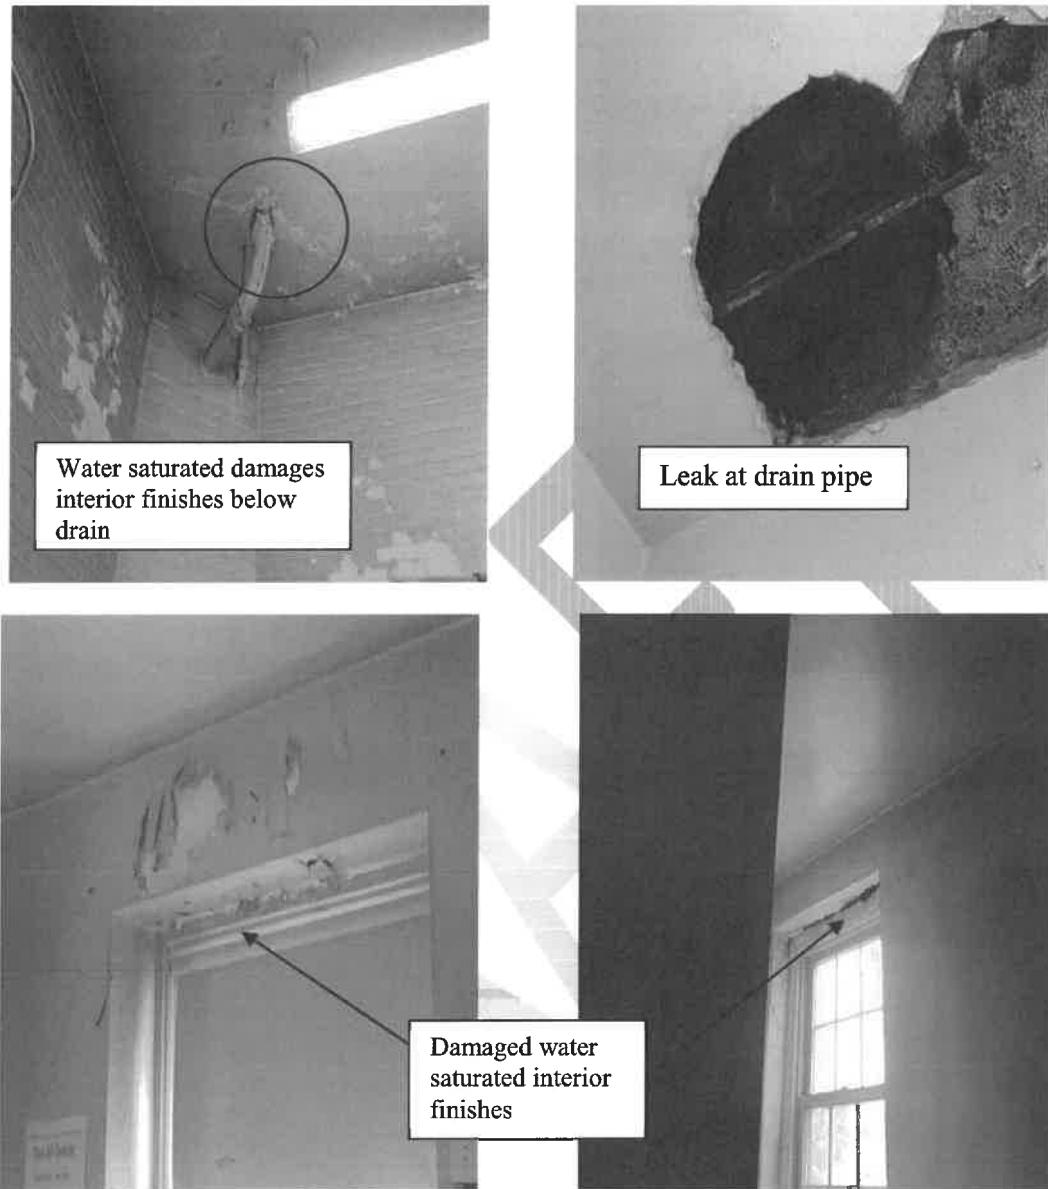
The inside of the facility contains ample evidence of roof leaks due to the numerous failed interior finishes.

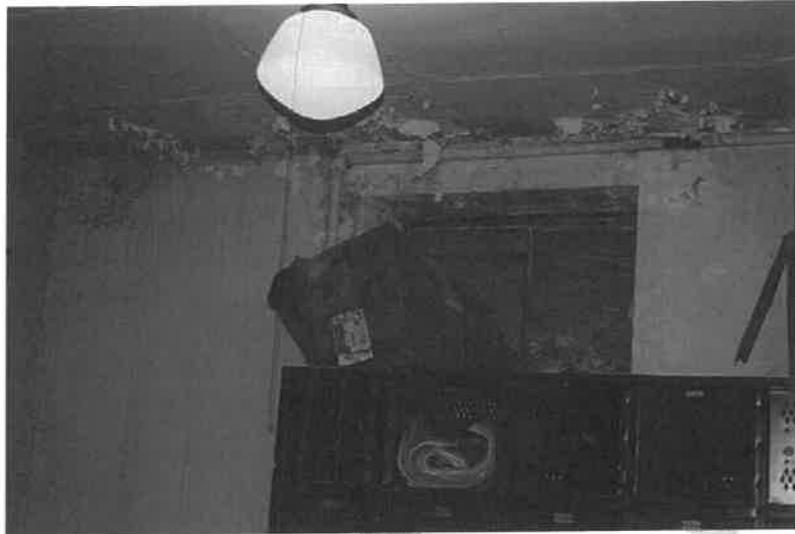
The basement level has a combination of concrete, cmu and stud and gypsum walls. Many of the concrete foundation walls exhibit signs of water infiltration. The main level utilizes painted stud and gypsum wall board in most areas with CMU in fire support areas, while the upper level utilizes wood studs with wood paneling that is painted.

The interior masonry walls are generally in good condition but need minor repairs and repainting. The gypsum walls appear to generally be in fair to poor condition. Due to water infiltration, many of the walls are exhibiting peeling paint, cracks or spawling plaster, and will require much patching and repainting.

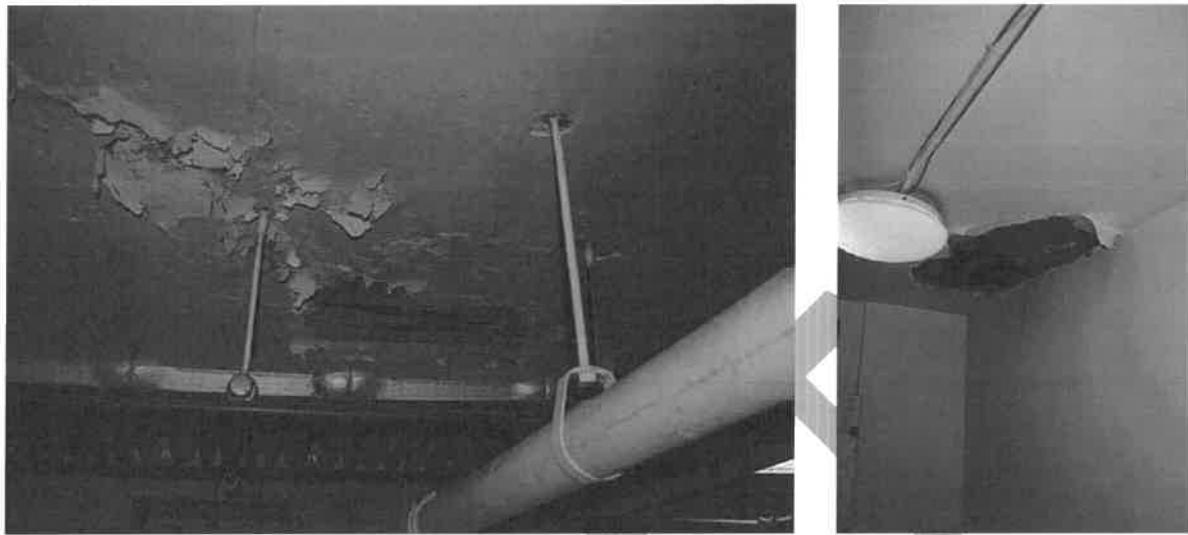
In general, many ceilings exhibit signs of physical damage from water/moisture. Moisture problems and/or leaks from the roof system may be the cause or contribute to this damage. Many areas of peeling paint and spawling plaster were observed in the apparatus bays.

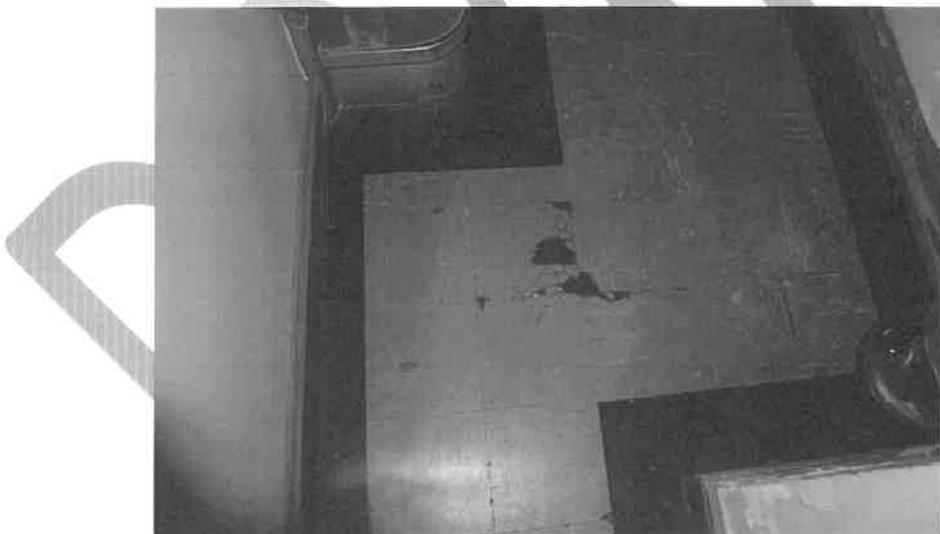
The flooring materials in the building are a combination of vinyl composite tile (VCT), vinyl asbestos tile (VAT), ceramic tile and exposed sealed concrete.

The vast majority of the flooring is VAT, which is utilized in the corridors, work rooms, bunk rooms and day room. In general, the VAT is in poor condition and needs be abated as part of an overall building hazardous materials abatement plan.

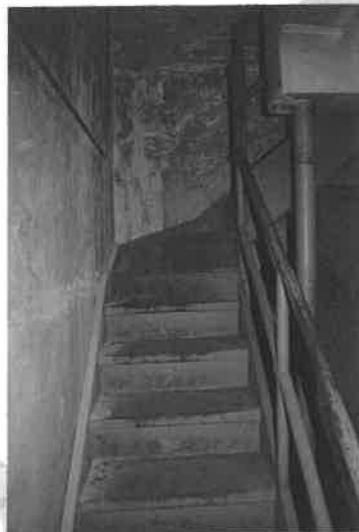
Stairs

There is one winding stair that provides access to all levels. The stair is steel framed with concrete filled steel pan treads and steel risers. Treads and risers to the basement and upper level are painted steel and exposed concrete. The risers exhibit some surface rust and need to be refinished. The stairs appear to be structurally sound. Steel pipe handrails are provided on one side only and are not continuous as required by code. It has non-complaint treads and risers, is too narrow and requires a second handrail to be installed. The stair is not enclosed in a fire rated enclosure as required by code.

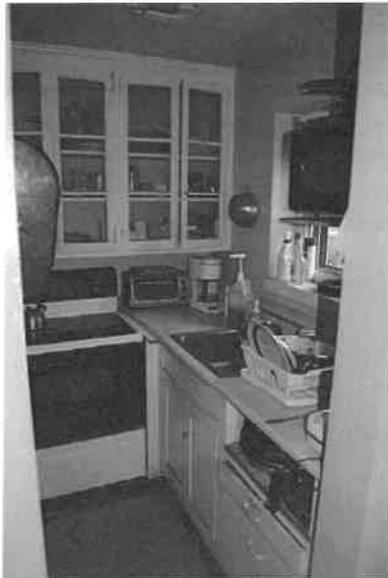
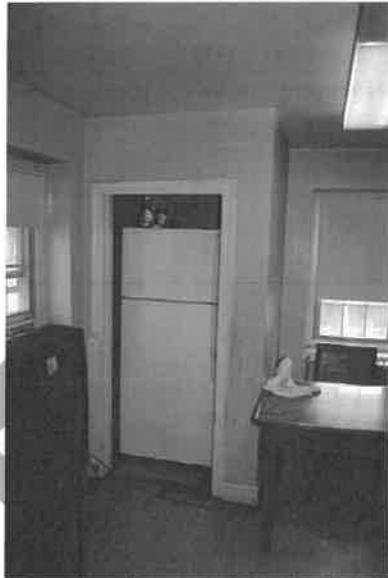
The kitchen is located on the upper level and utilizes painted gypsum walls, with vinyl composition tile flooring and gypsum board plastered ceiling with surface mounted lights. It is extremely small to the point of almost being unusable. The electric stove is in fair condition. The refrigerator is located in an old closet which is located off of the dining room. All finishes are in poor condition and need to be replaced. Cabinets and counter tops are minimal and are in poor condition. There is a wood exterior door with an

aluminum storm door from the dining area to the low roof. Wood trim and threshold are deteriorating and need to be refinished or replaced.

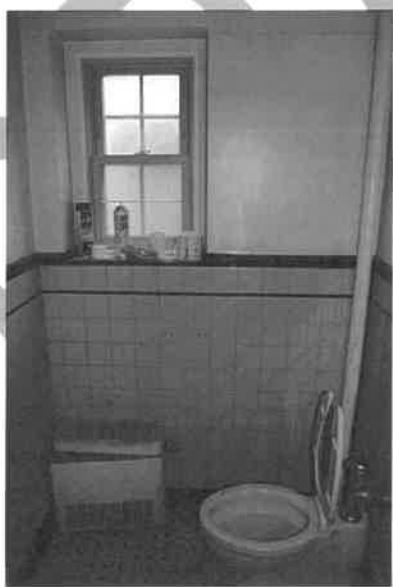
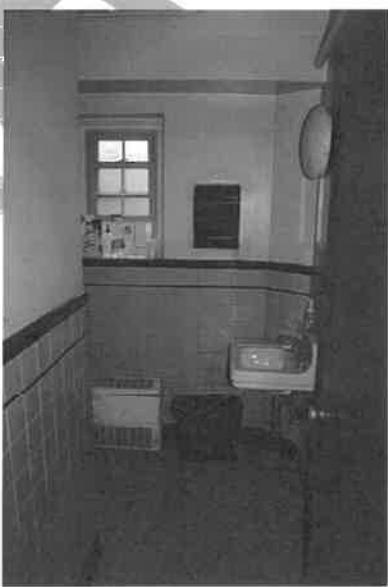
Toilet Rooms

There is a male and female toilet room on the main level. They both utilize painted gypsum walls, with ceramic tile flooring and painted plaster ceilings.

The fixtures do not meet ADA requirements. The sinks do not have insulated drain piping or approved lever style faucets handles and thus are non-compliant. The toilets do not have proper grab bars and or clearances. Additionally there are no separate toilet/shower facilities for male and female use.

Our recommendation would be to execute a total renovation of these spaces. The fixtures, partitions and accessories should be replaced with new.

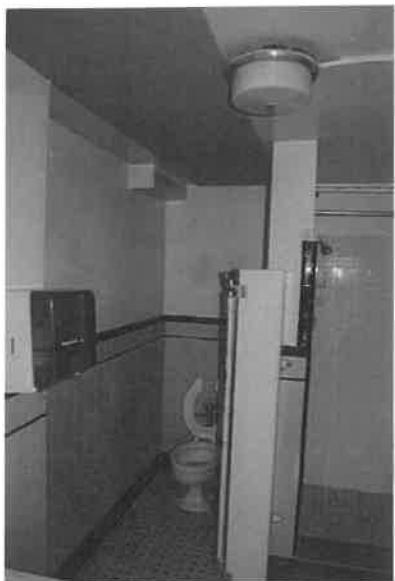
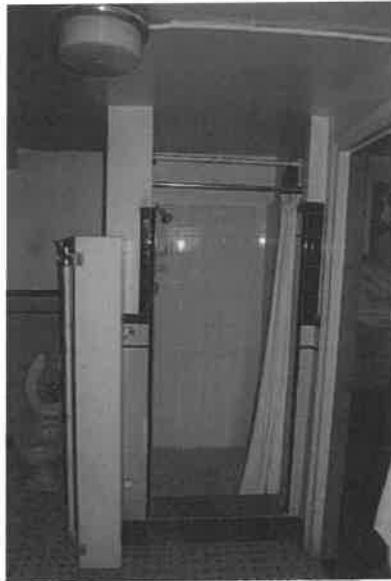
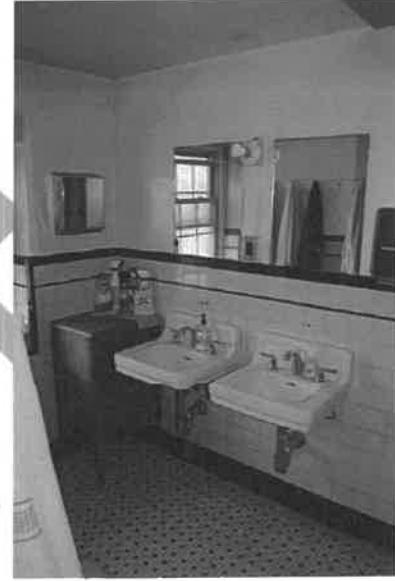
There is one toilet/shower room on the upper floor accessed from the large dormitory style bunk room, and one accesses from the lieutenants bunk room. Both toilet/shower rooms utilize ceramic tile wainscoting and painted gypsum walls, with ceramic tile flooring. The shower compartments have

ceramic tile wainscoting (approx. 7' high) and painted gypsum walls, with ceramic tile flooring. All of these finishes are worn and are at the end of their useful life.

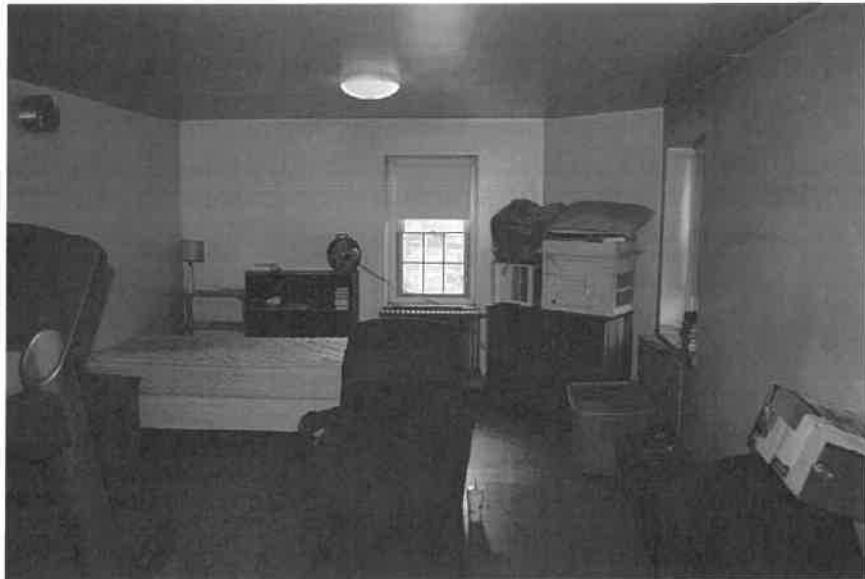
Bunk Room

One unisex dormitory style bunk room (two beds) is located on the upper level. It utilizes painted gypsum board and plaster walls, plastered ceiling and VAT floor tile. All the finishes are in poor condition, especially the VAT flooring which is cracked and missing pieces.

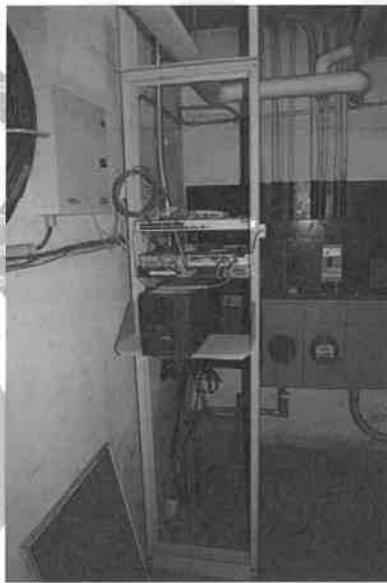
Head End Room

The stations computer network head equipment is located in the basement. The space is not secured nor is it climate or dust controlled.

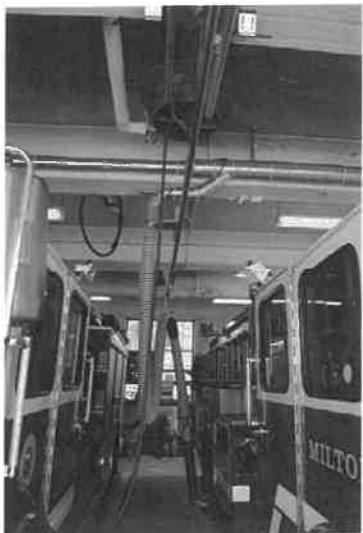
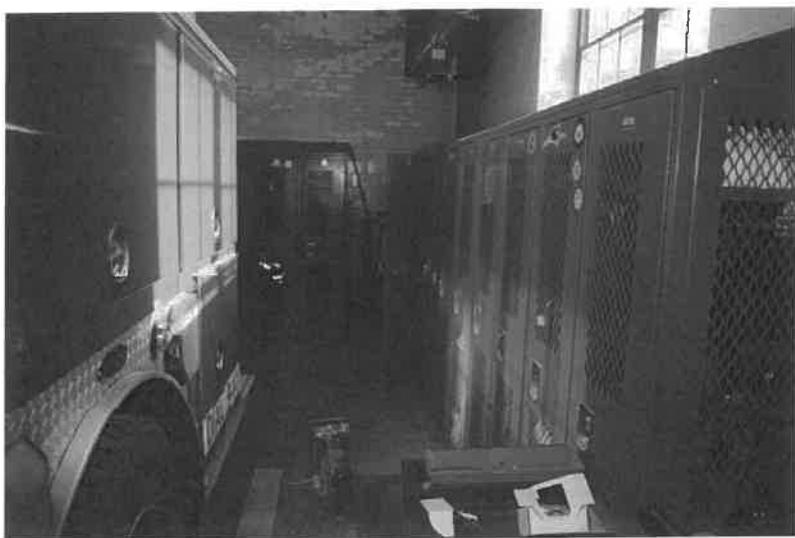
Apparatus Bays

The apparatus bays utilize glazed cmu wainscoting (approx. 6'-6" high) with painted brick above; exposed concrete beam and slab ceiling and stained/painted concrete floors. All of the finishes are in fair to poor condition. The ceiling exhibits signs of water damage, most likely the result of current and/or past roof leaks. The overhead door openings are too narrow & short and barely allow passage of the current apparatus. The circulation space around the apparatus is too narrow per recognized fire station facility design standards.

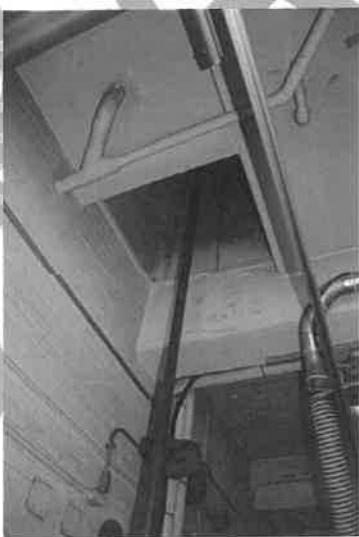
There is a fire pole that is operational from an upper level corridor. It lacks proper weather seals which would prevent vehicle exhaust and cold air to infiltrate the upper floor from the apparatus bays when the bay doors are open. It also does not have OSHA approved access at the upper level.

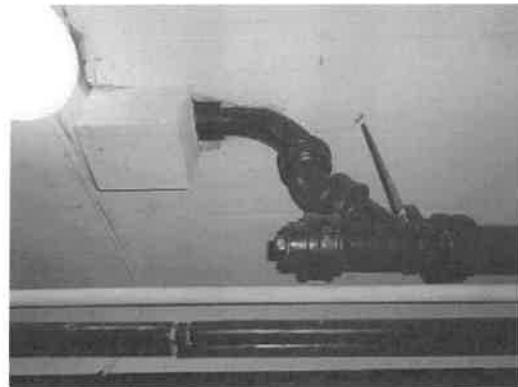
Cast Iron Bell & Spigot

Sanitary, waste and vent piping is generally cast iron bell and spigot. The piping appears to be in fair condition.

In general, existing cast iron drainage piping can be re-used if sized appropriately. We recommend video inspection of existing drains to confirm integrity.

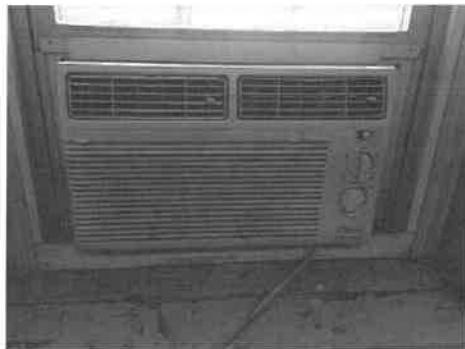
Typical Window Air Conditioner

There is no central air conditioning system in the Fire Station. Window air conditioning units are located throughout the fire station. As for ventilation air, there are no mechanical ventilation units. The building utilizes operable windows as its means for ventilation, this is allowed by code however the actual requirements required by the code do not appear to be achieved with the current windows. A review of the current windows and square footage would need to occur to ensure that the operable portion of the window equals four percent of the floor area.

Provide heating, ventilation and air conditioning requirements throughout the building through the use of new gas-fired rooftop units and supplemental terminal heating equipment such as radiant ceiling panels or wall mounted fin tube radiation.

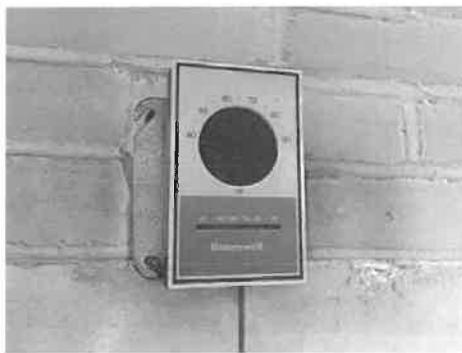
Automatic temperature controls for the building is minimal, some equipment such as the unit heaters in the apparatus bay are controlled with standalone electronic thermostats. These standalone thermostats are tied directly into each unit and are original to the building. These thermostats were provided by the equipment manufacturer. Other areas of the building that are heated with steam convectors and steam cast iron radiators are equipped with thermostatic control valves, however many of them are not functional and in some cases damaged. The overall control system appears to be malfunctioning and the controllability of the system is less than desirable. We would recommend removing the stand alone electronic system and replacing it with a direct digital control system throughout.

Typical Standalone Thermostat

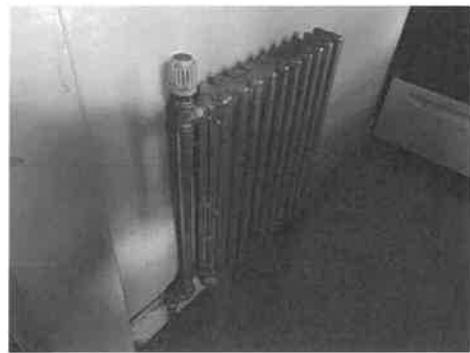
Typical Thermostatic Control Valve

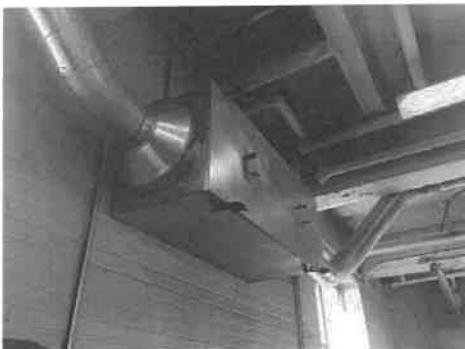
Plymovent Filter System

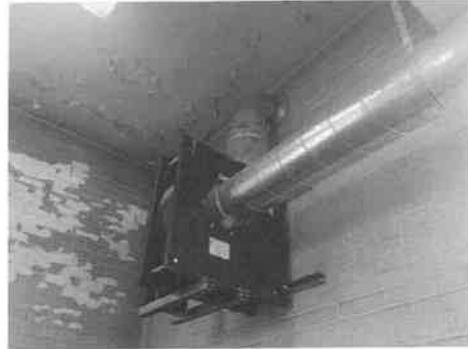
Plymovent Exhaust Fan

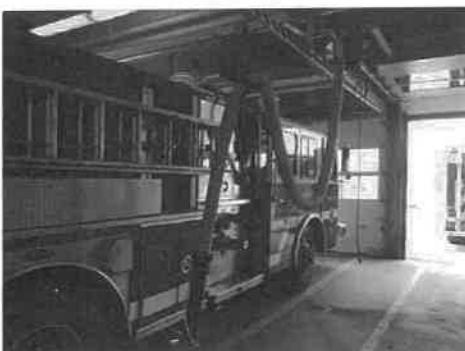
Plymovent Track System

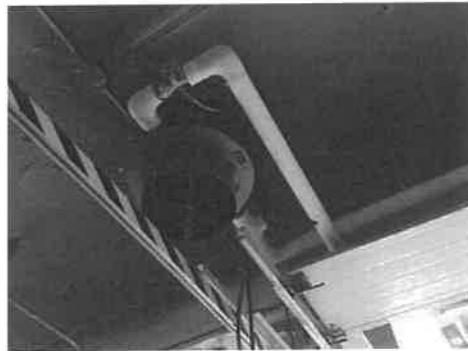
Garage Unit Heaters

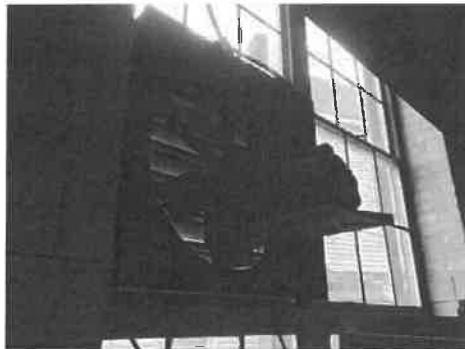
Propeller Style Exhaust Fan

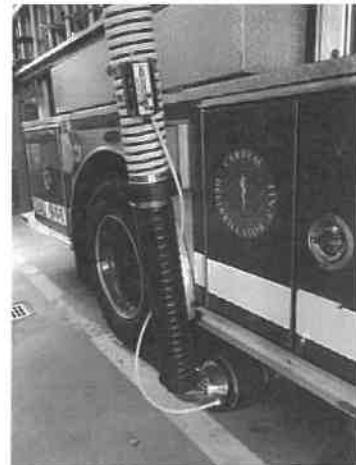
Tail Pipe Connection

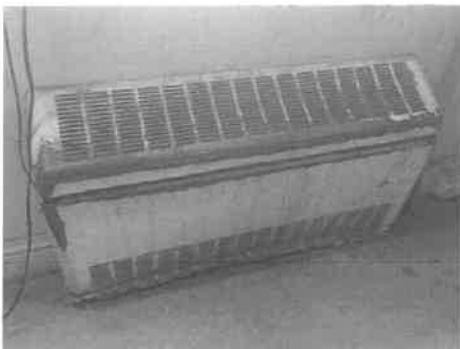
The office area and sleeping quarters utilize wall mounted steam convectors and cast iron radiators. Some are controlled via a unit mounted thermostatic control valve while others have no control at all. Majority of these units are damaged, dirty and non-functional. Majority of them do not have any type of control associated with them and those that do utilize thermostatic control valves that are unit mounted. These pieces of equipment run wild and generally overheat or do not provide enough heat for the spaces. Overall the terminal heating system throughout the building is damaged, missing components, and antiquated. The systems require a complete replacement.

Typical Convector

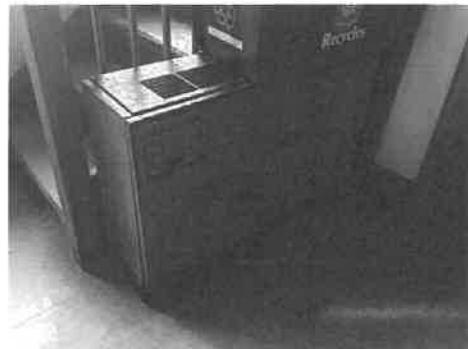
Typical Fan Assisted Convector

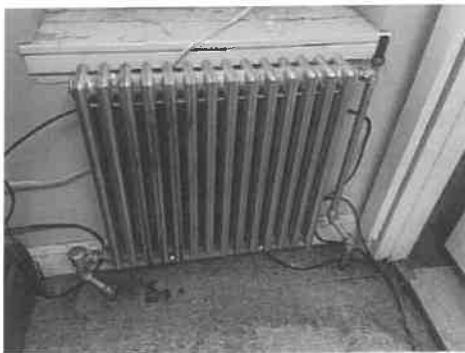
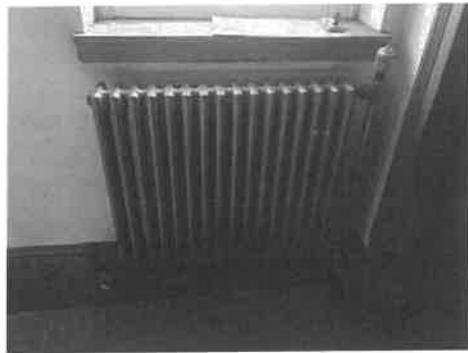
Typical Cast Iron Radiator

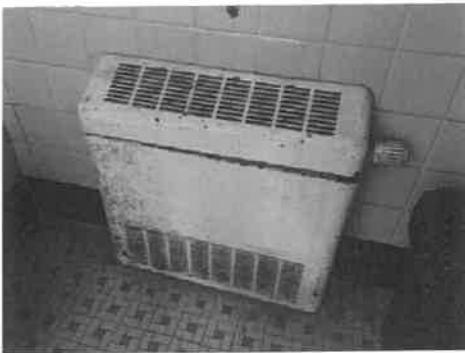
There is no mechanical exhaust system for the shower or toilet rooms which is not code compliant. Operable windows provide natural ventilation to these spaces. Floor mounted convectors are located in the bathrooms. The convectors are original to the building and showing signs of corrosion, they are in need of replacement.

Typical Convector in Bathroom

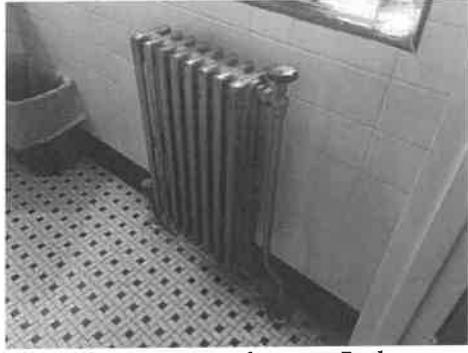
Typical Cast Iron Radiator in Bathroom

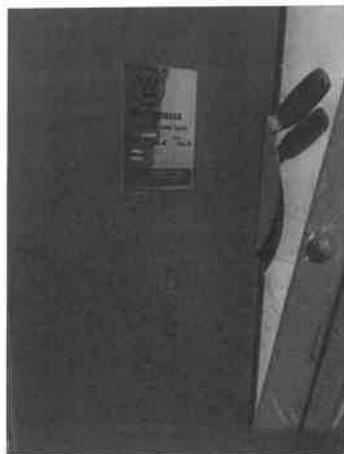
The Distribution System is in poor condition and inadequately sized for a renovation program.

Main Switch

- The electrical service is marginal for this facility and the voltage and phase is not suitable for a public safety facility. The entire service should be replaced with a 120/208V, 3Ø, 4W service adequately sized and housed in a code compliant space.
- Electrical power will be brought into the site via underground medium voltage cables from the utility company network. A pad mounted step-down transformer will be located at grade adjacent to the building. Service entrance and distribution switchgear will be located in the Electrical Room near the Mechanical Room, along with lighting and power distribution panels.

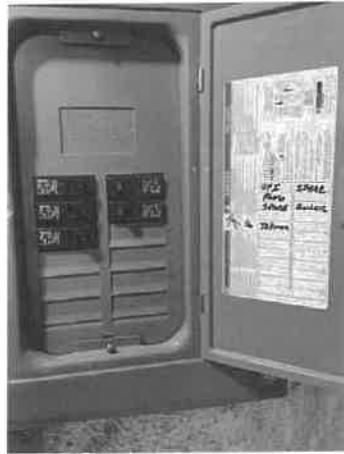
Sub-panel

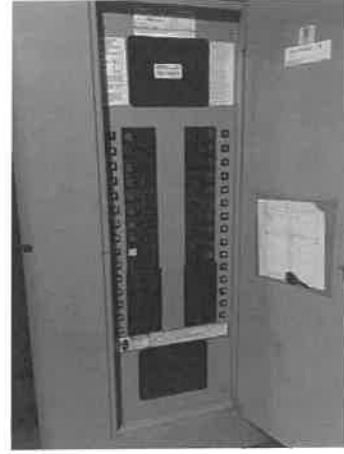
Updated Panel

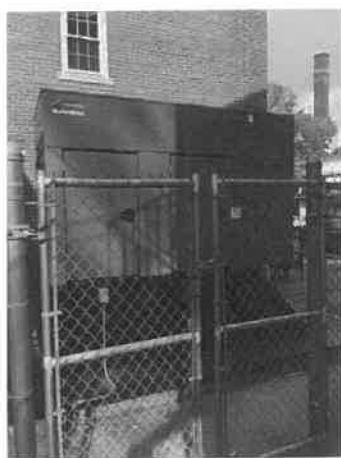
The emergency generator and the automatic transfer switch are in excellent condition. The life safety lighting is accomplished using emergency battery units that are in fair condition. Exit signs are in fair condition; however, are not installed in all required locations.

Generator

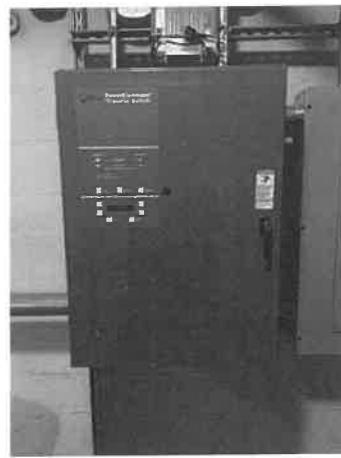
Transfer Switch

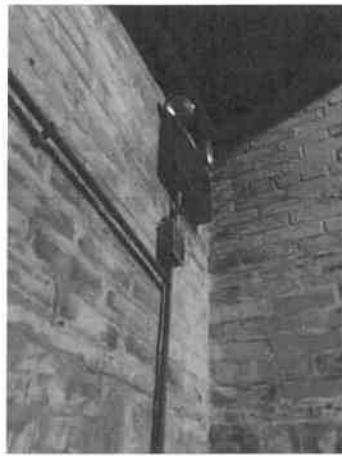
Emergency Battery Unit

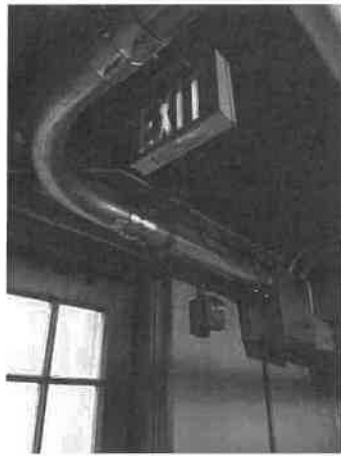
Exit Sign

- The generator is housed in a sound attenuating weather proof enclosure with critical grade exhaust silencer, and automatic starting and safety controls. The generator shall include two (2) service breakers and transfer switches: one (1) for life safety equipment, one (1) for other than life safety equipment. The generator will be sized for 100% of all lighting and power loads. All air-handling units will be provided with emergency power to maintain ventilation and heating for the duration of 48 hours.
- Exit signs will be replaced with energy efficient, long life LED type.

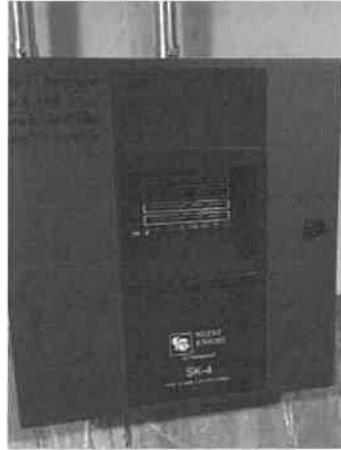
The building has a 4 zone microprocessor based fire alarm control panel manufactured by Silent Knight by Honeywell, Model SK-4. The panel seems to be in good condition; however, the notification devices and detection devices range from fair to poor.

FACP

- Fire Alarm System should be replaced with an addressable, ADA compliant system with full coverage.
- A Fire Alarm and Detection System will be provided with 60 hour battery back-up. The system will be of the addressable type, where each device will be identified at the control panel and remote annunciator by device type and location to facilitate search for origin of alarms.
