Town of Milton Fire Station Space Needs Study

Milton, Massachusetts
November 23, 2015

KAESTLE BOOS
associates, inc

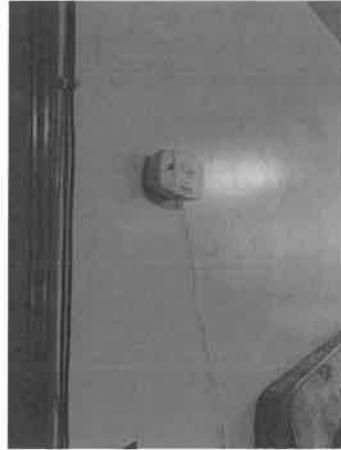
There is a combination of heat detectors and smoke detectors located throughout the building. The dorms do not meet the latest codes with respect to notification and they do not have low-frequency horns in sleeping areas. Self-contained Kidde wall mounted CO detectors are located in the Corridor outside the dorms.

C.O. Detector

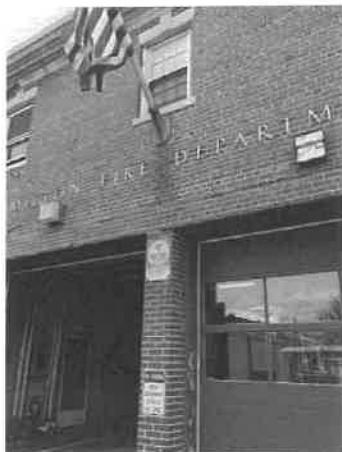
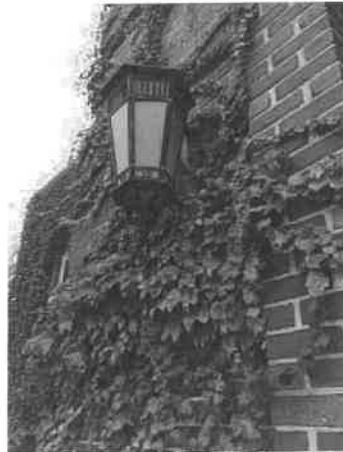
Exterior lighting consists of building mounted HID flood lights. Fixtures are in poor condition and are not dark sky compliant. There are also decorative fixtures in fair condition.

Exterior Lighting

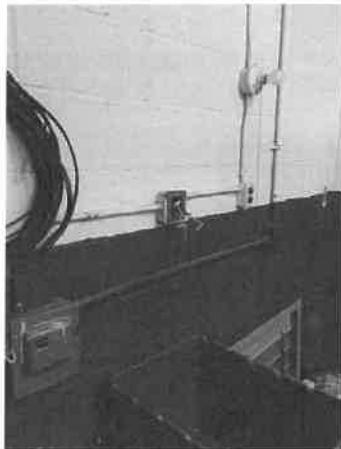
Lighting in general is in poor condition, lacks proper controls, and light levels are too low in most spaces.

Incandescent Light

All lighting should be replaced in a renovation program.

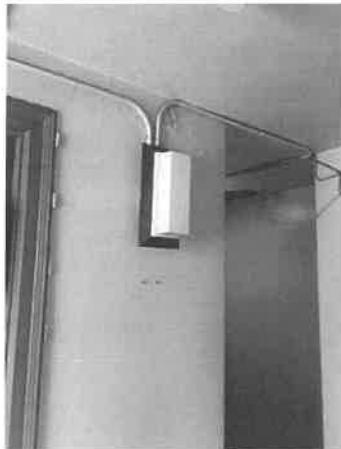
Corridor Alarm Lighting

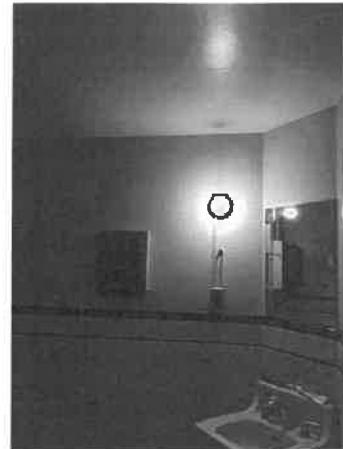
Bathroom Lighting

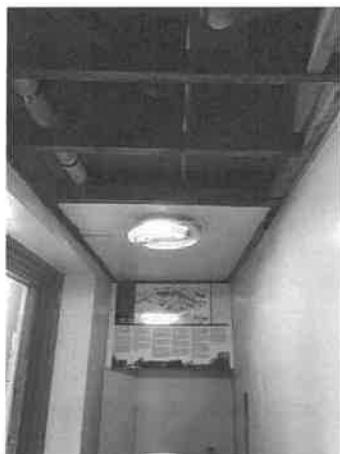
Corridor Lighting

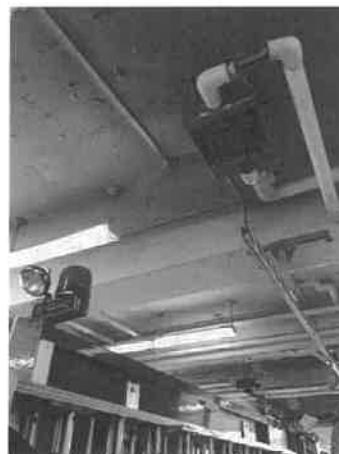
Apparatus Bay Lighting

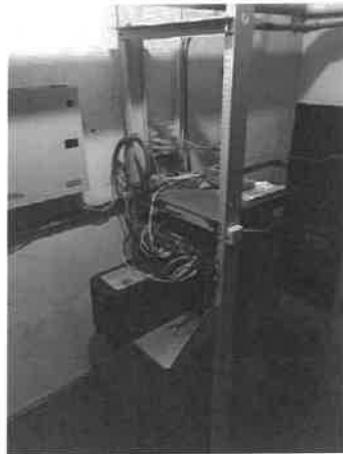
The telephone service, CATV, and town fiber run overhead in the street and enter the building underground in the basement. The fiber is terminated on a wall mounted fiber optic cabinet in the basement and connects to the building's data rack. The data rack is located in poor environmental conditions in the basement which will lead to shortened life of the equipment.

Tel/Data Rack

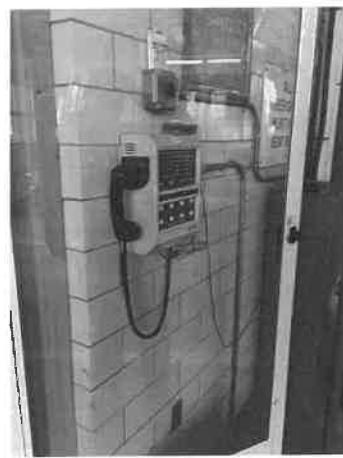
Zetron Model 6 for incoming alarms is located outside the Watch Room and is in good condition.

Zetron Model 6

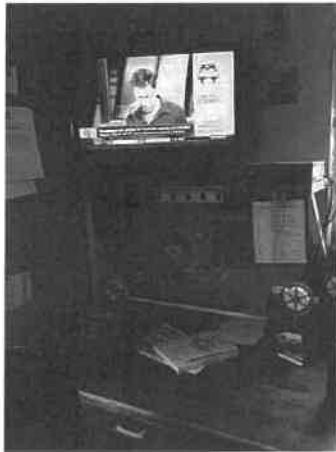
Antiquated technology is used to monitor City fire alarms.

Tape Alarm System

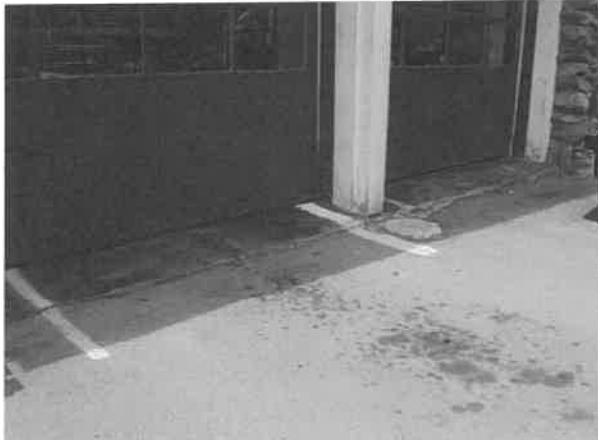
Aprons and pavement at front of building

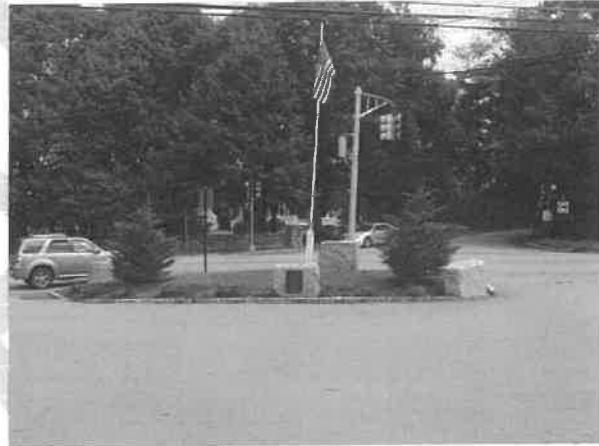
There are no handicapped entrances to the building and no marked or signed handicapped parking. A small landscaped area in front of the station has two evergreen plantings, cobble stone edging, several granite blocks for protection, a memorial and a flagpole.

Front landscaped area

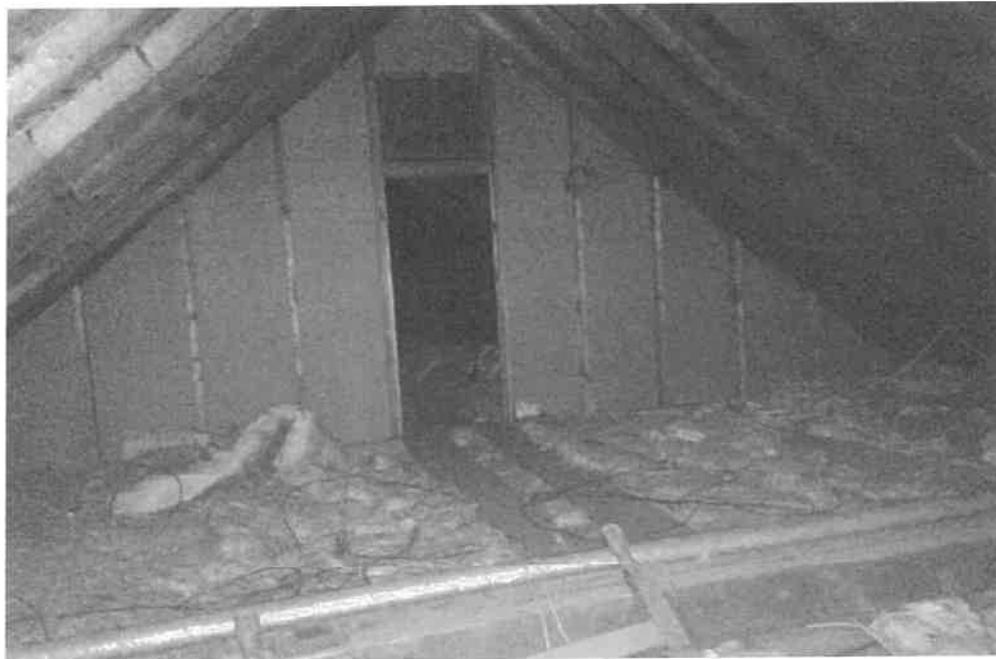
Roof framing visible from attic

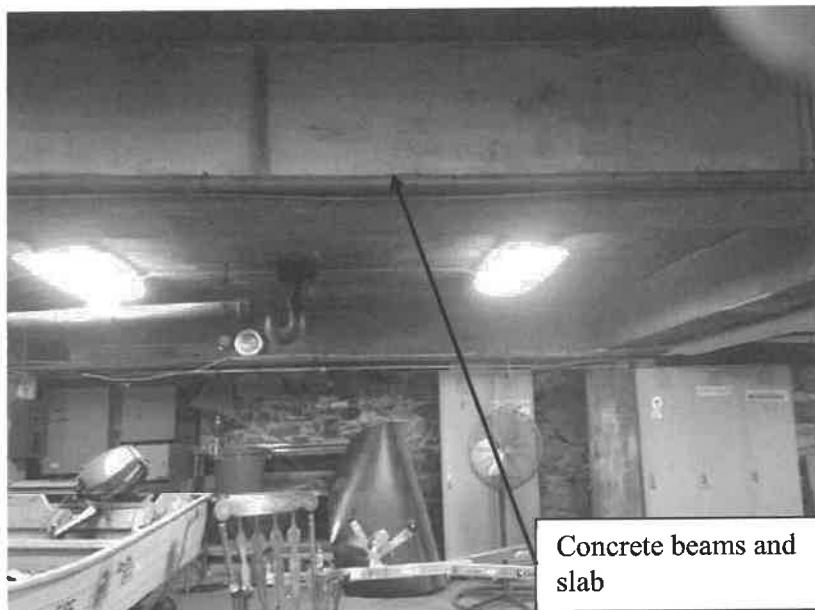
Reinforced concrete slab and beams supporting the Apparatus Bay floor.

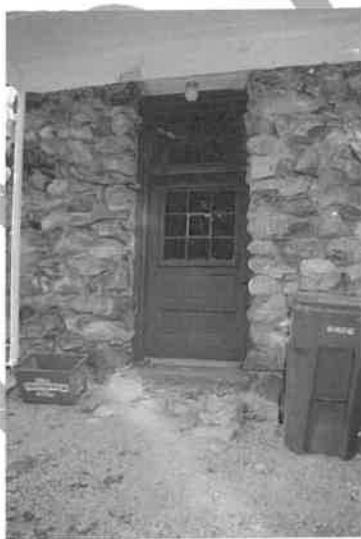
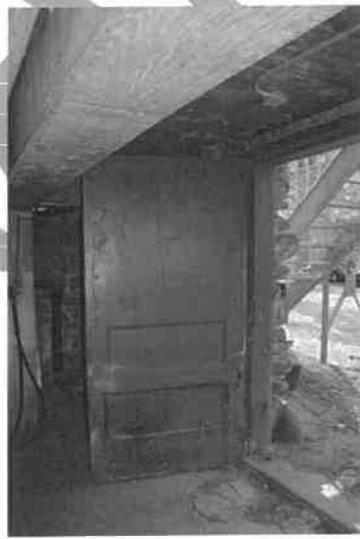
The entrance door is painted wood stile and rail door with true-divided lites. Doors and frames are generally in fair condition, and exhibit considerable wear. The seals and caulking are in poor condition. The lock set is failing as is the weather stripping. The doors have not been outfitted with a “crash-bars”; or equipped with lever handles.

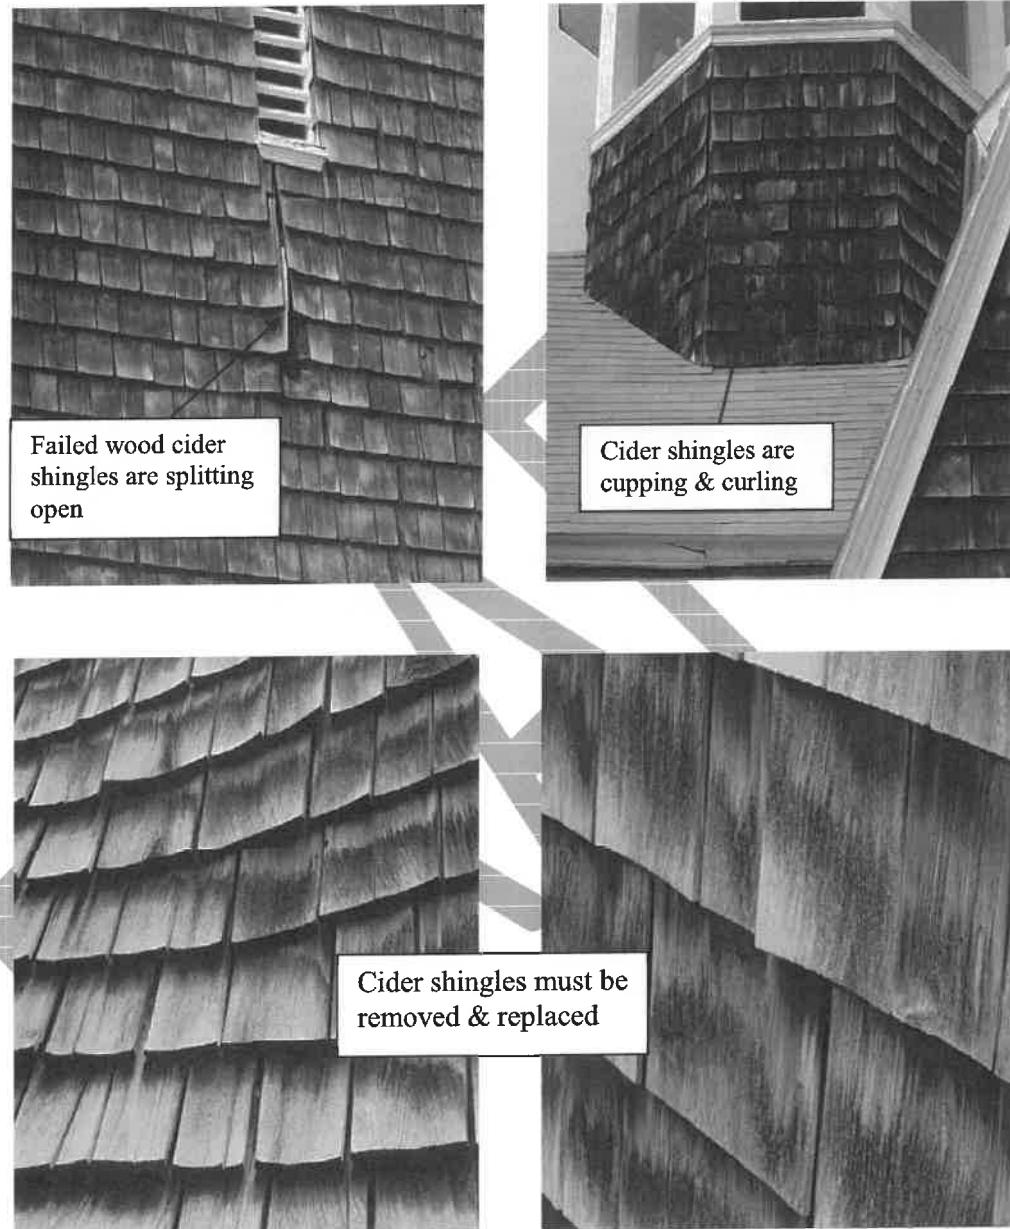
The wood cedar shingles on the gable ends are failing. They are cupping and curling, in some cases they have split open completely. This condition allows water to easily enter the facility causing possible

growth of mold and mildew inside the facility. This condition should be addressed by removing and installing new material.

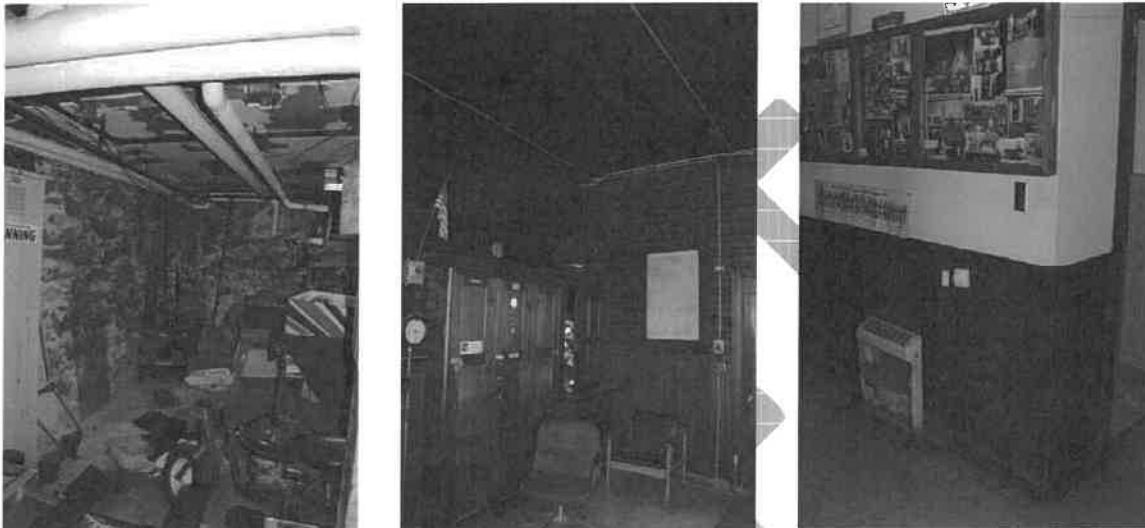
The basement level is stone foundation wall. There are many locations that exhibit signs of water infiltration. It was reported that the east end of the building frequently allows water into the basement, preventing storage of materials on the floor. The main level utilizes wood stud and stained wood siding, while the upper level utilizes wood studs with wood wainscoting and painted plaster above in most areas.

The interior wood paneling is exhibiting considerable ware and is generally in sound condition, requiring minor repairs in some locations. All of the siding requires refinishing. The gypsum walls appear to generally be in good to fair condition. Minimal cracks were observed in the plaster which will require repair and repainting.

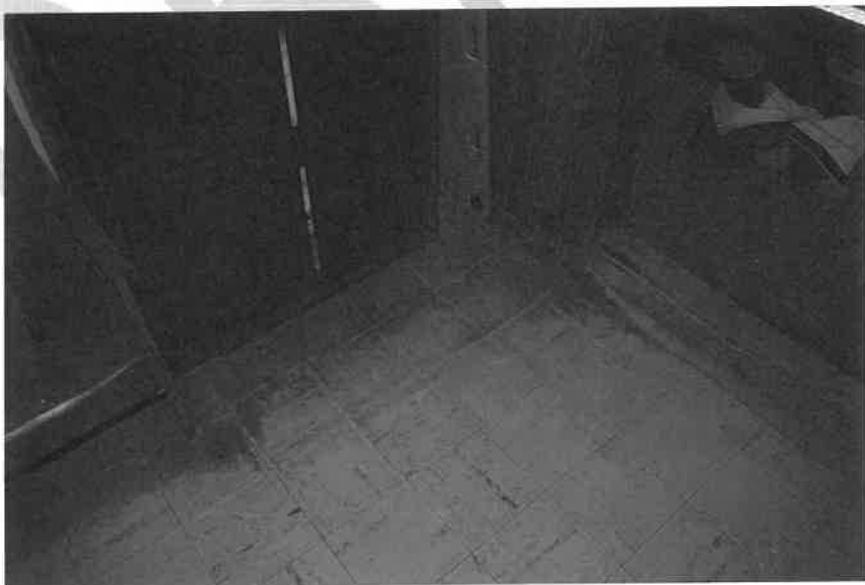
The flooring materials in the building are a combination of vinyl asbestos tile (VAT), ceramic tile, stained and exposed sealed concrete. The vast majority of the flooring is VAT, which is utilized in the corridors, work rooms, kitchen, bunk rooms and day room. In general, the VAT is in poor condition and needs be abated as part of an overall building hazardous materials abatement plan.

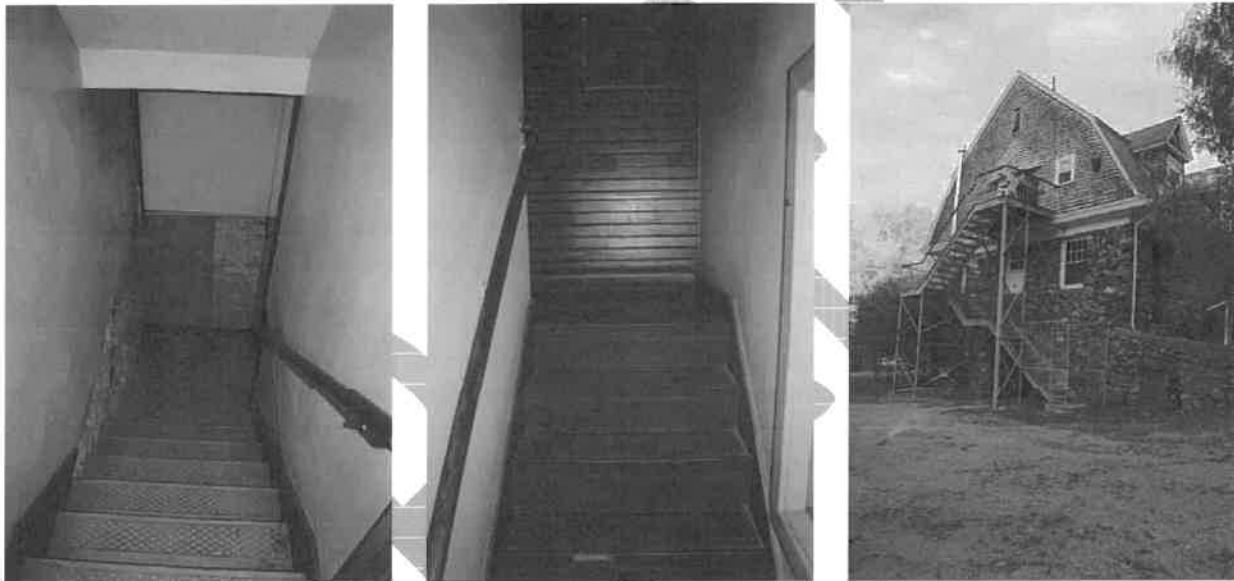
There is one switch back stair that provides access to all levels. The stair is wood framed with wood treads and risers. Treads and risers to the basement and upper level are rubber clad. The stairs appear to be structurally sound. Wooden handrails are provided on one side only and are not continuous as required by code. It has non-complaint treads and risers, is too narrow and requires a second handrail to be installed. The stair is not enclosed in a fire rated enclosure as required by code.

At the rear of the building there is an exposed galvanized steel grate fire escape, that provides a second egress from the upper level. It does not have handrails and has open risers. It is in excellent condition.

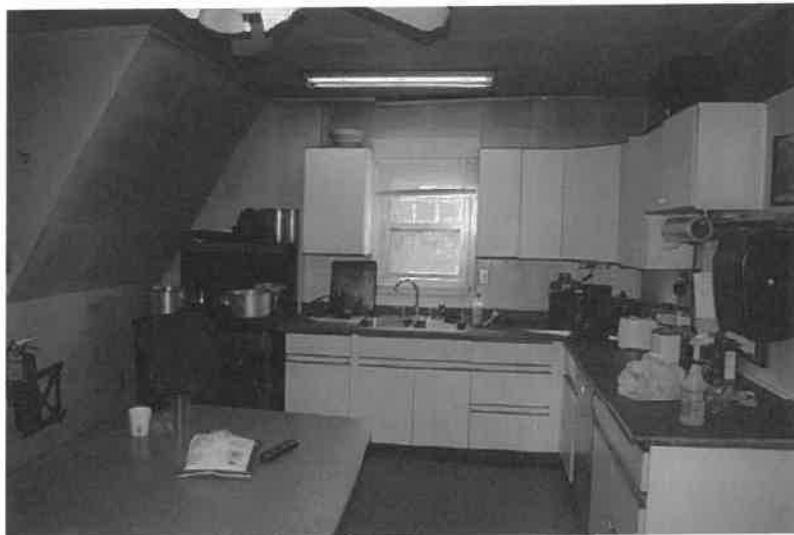
The kitchen is located on the upper level and utilizes painted gypsum walls, with vinyl asbestos tile flooring and gypsum board ceiling with surface mounted lights. All finishes are in poor condition and need to be replaced. Cabinets and counter tops exhibit excessive wear. Appliances appear to be in fair condition. There is no emergency gas shutoff to the gas oven/stove.

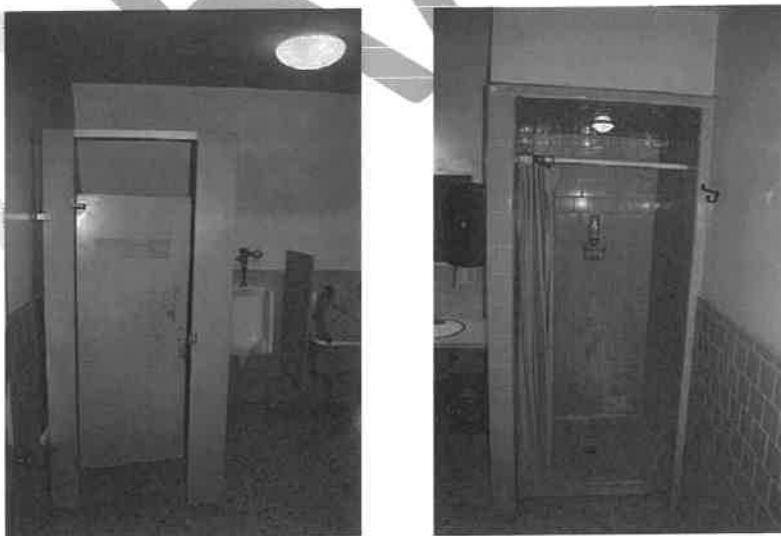
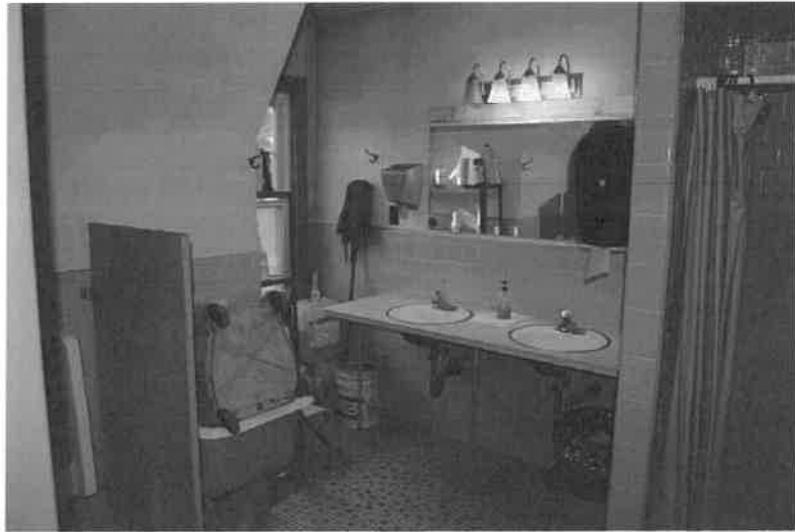
There is one toilet/shower room on the upper floor accessed from the main corridor, and utilizes ceramic tile wainscoting (approx. 4' high) and painted gypsum walls, with ceramic tile flooring. The shower compartment has ceramic tile walls and ceiling with an acrylic base. All of finishes are worn and are at the end of their useful life. A janitors 'slop sink' is also in the room.

The fixtures do not meet ADA requirements. The sinks do not have insulated drain piping or approved lever style faucets handles and thus are non-compliant. The toilets do not have proper grab bars and or clearances. Additionally there are no separate toilet/shower facilities for male and female use.

Our recommendation would be to execute a total renovation of these spaces. The fixtures, partitions and accessories should be replaced with new.

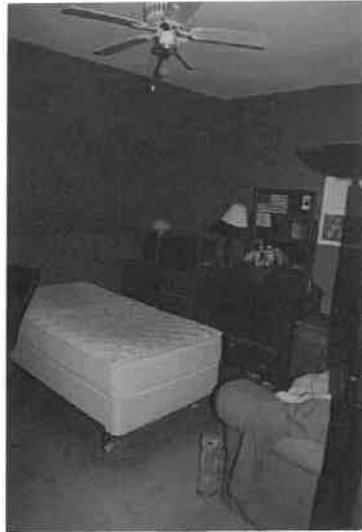
There are three private bunk rooms located on the upper level. They utilize painted gypsum board and plaster walls, plastered ceiling and VAT floor tile. All the finishes are in poor condition, especially the VAT flooring which is cracked and missing pieces.

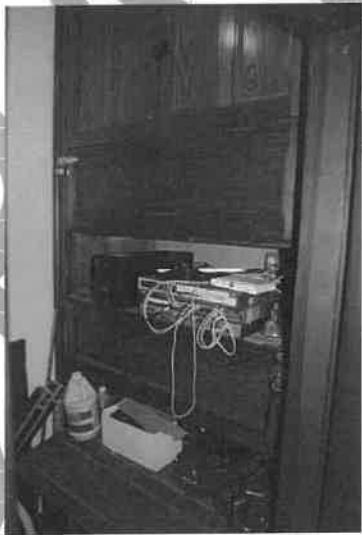
Head End Room

The stations computer network head equipment is located on the upper level in a closet located off the main corridor. The space is not secured nor is it climate or dust controlled.

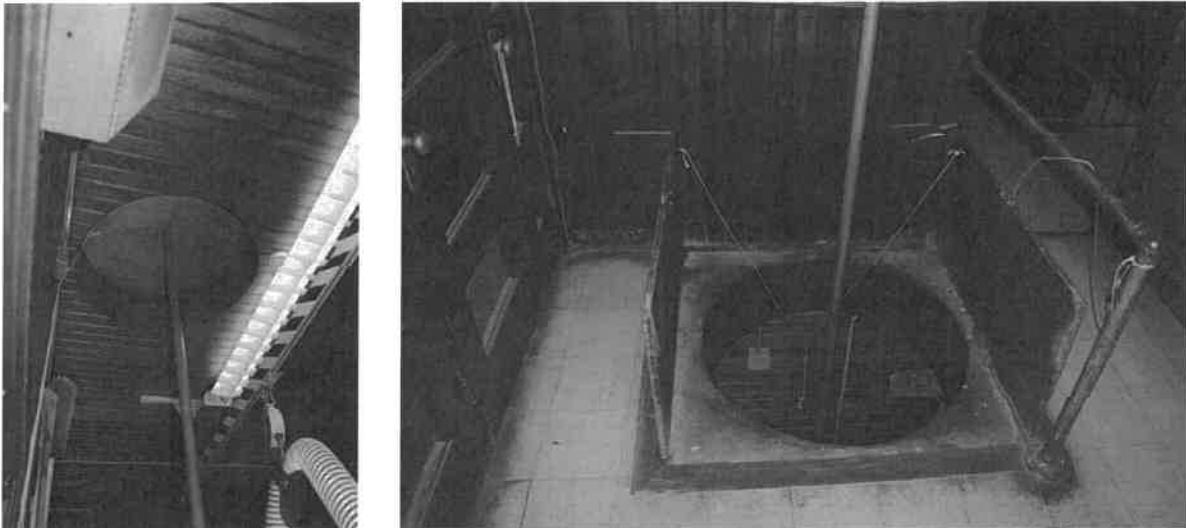
There is a fire pole that is operational from an upper level corridor. It lacks proper weather seals which would prevent vehicle exhaust and cold air to infiltrate the upper floor from the apparatus bays when the bay doors are open. It also does not have OSHA approved access at the upper level.

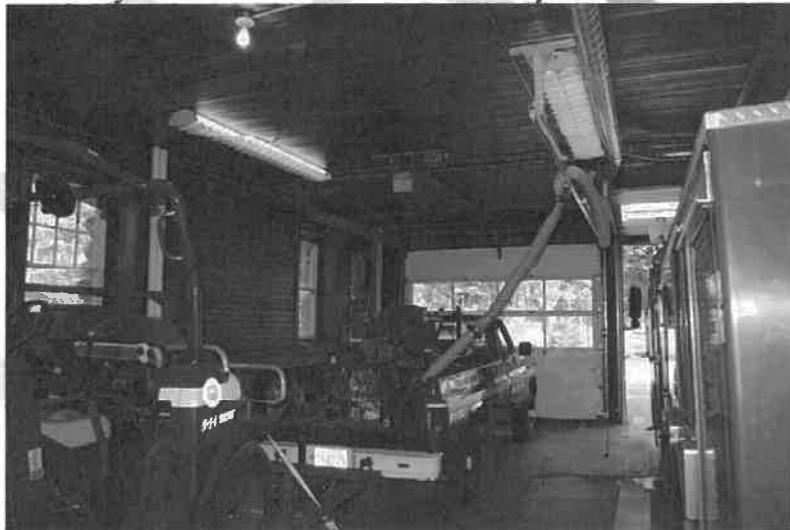
The vehicle exhaust system is installed within the last 10 years and is in excellent condition.

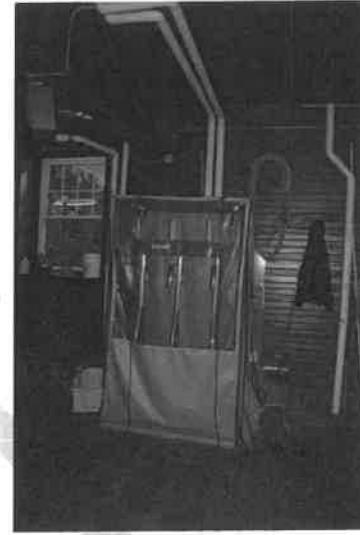
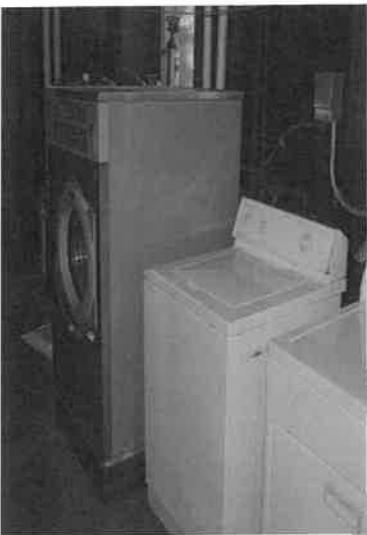
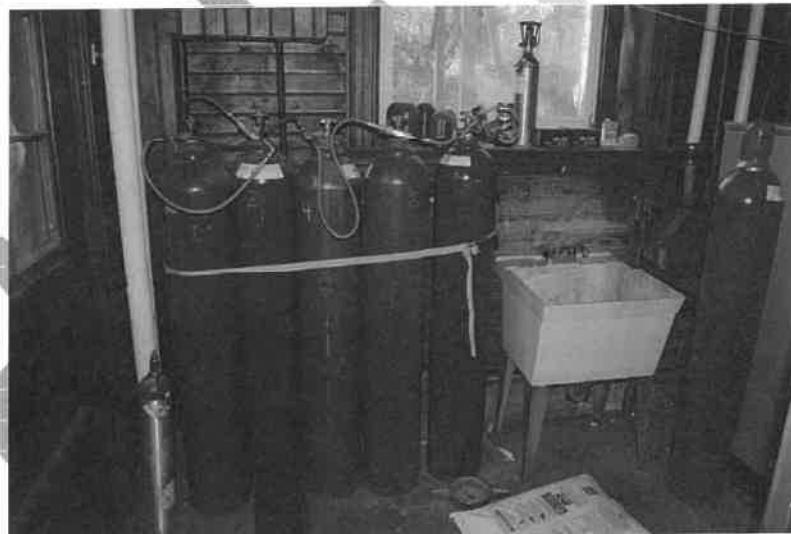
Additionally the bays house the turnout gear lockers, oxygen fill station, decontamination area, laundry, hose/supply storage and work areas. All of these spaces should be in their own spaces

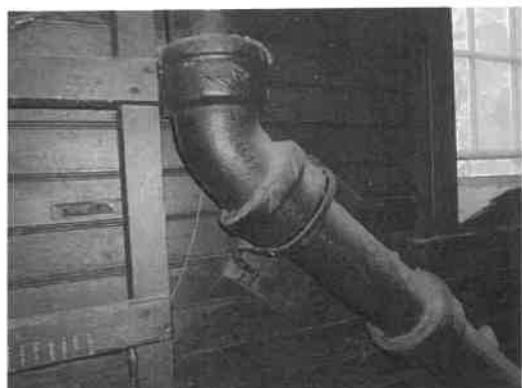
Cast Iron Bell & Spigot

Sanitary, waste and vent piping is generally cast iron bell and spigot. The piping appears to be in good condition.

In general, existing cast iron drainage piping can be re-used if sized appropriately. We recommend video inspection of existing drains to confirm integrity.

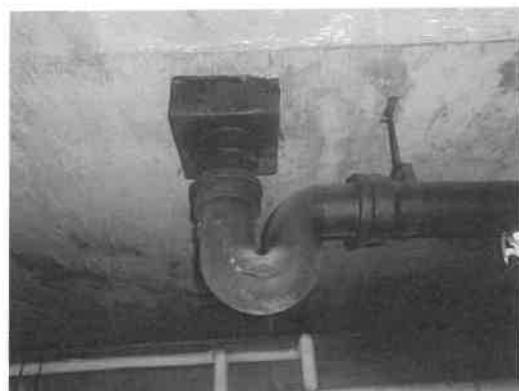
Apparatus Bay Floor Drain & Trap Piping

Apparatus bay floor drains are directed through an oil/sand separator.

Maintenance to the existing Oil/Sand Separator is required.

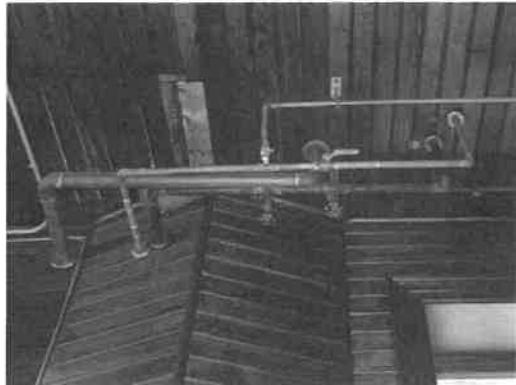
Un-insulated Water Piping

Domestic water piping is copper tubing with sweat joints. The majority of the copper piping is not insulated.

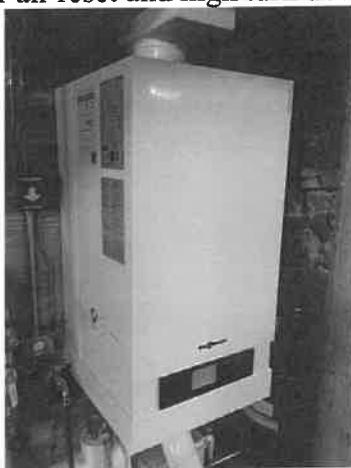
High Efficiency Boiler

The building is heated by one (1) wall mounted gas-fired high efficiency condensing boiler located in the basement of the building. This boiler along with four inline pumps and expansion tank was just recently installed and is in excellent condition. The boiler is manufactured by Viessmann (Model Vitodens 200, 262 MBH output for hot water and 285 MBH max input). The boiler is provided with a direct vent option which utilizes separated combustion flues. One flue is utilized for combustion air and the other is for the combustion gases. Each system utilizes polypropylene material and exits the building through an exterior wall where it terminates with an elbow and screen. The boiler has its own burner management control system which utilizes outdoor air reset and high turn down modulation for high efficiencies.

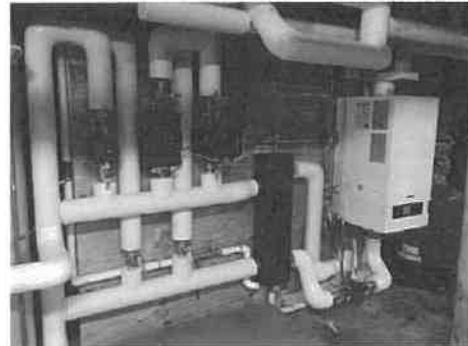
New Hot Water Piping

The piping system associated with the heating hot water boiler and pumps is all new and recently installed. The material is schedule 40 black steel with Victaulic fittings. The boiler utilizes a low loss header system which was provided by the boiler manufacturer. This allows multiple independent zones to be circulated to the boiler plant. All the piping located near the boiler itself is insulated with new fiberglass insulation with PVC fitting covers. The piping throughout the rest of the building is original and is not insulated completely, some locations are exposed and have no insulation or the fiberglass insulation is damaged. The piping from all outwards appearance seems to be in fair condition however, a section of piping should be removed to examine the internal condition of the piping system and ensure that there is no corrosion or scaling.

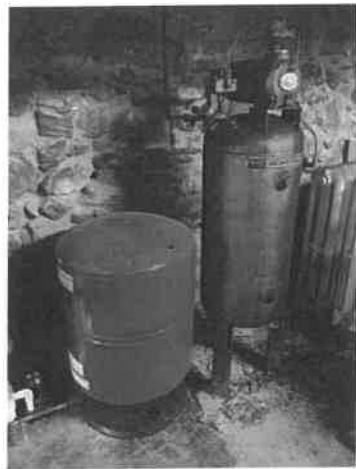
Expansion Tank

Hot water expansion is completed through the use of a vertical non-insulated bladder style expansion tank. This tank was also recently replaced and in excellent condition. However, it is not insulated and should be to help reduce the systems heat loss.

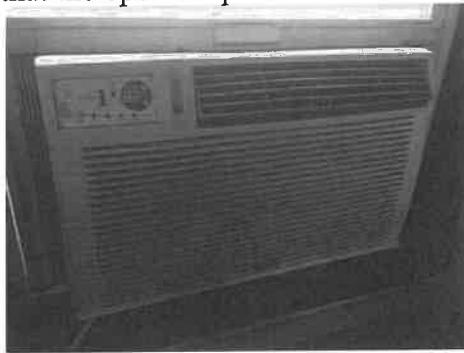
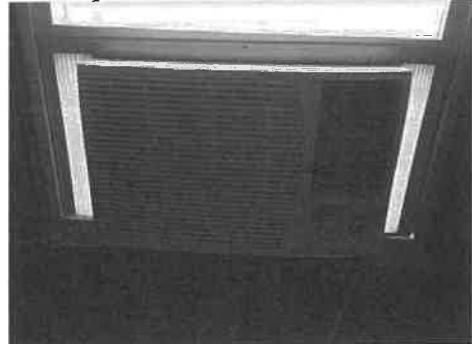
Typical Window Air Conditioner

There is no central air conditioning system in the Fire Station. Window air conditioning units are located throughout the fire station. As for ventilation air, there are no mechanical ventilation units. The building utilizes operable windows as its means for ventilation, this is allowed by code however the actual requirements required by the code do not appear to be achieved with the current windows. A review of the current windows and square footage would need to occur to ensure that the operable portion of the window equals four percent of the floor area.

Provide heating, ventilation and air conditioning requirements throughout the building through the use of new gas-fired rooftop units and supplemental terminal heating equipment such as radiant ceiling panels or wall mounted fin tube radiation.

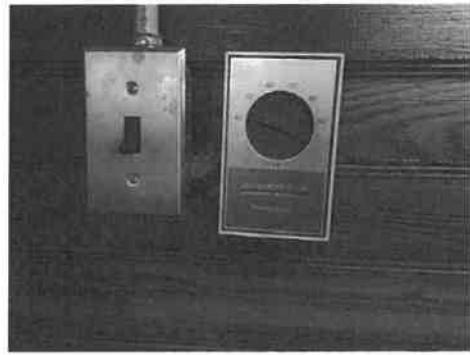
Standalone Thermostat

Automatic temperature controls for the building is minimal, some equipment such as the unit heaters in the apparatus bay are controlled with standalone electronic thermostats. These standalone thermostats are tied directly into each unit and are antiquated. These thermostats were provided by the equipment manufacturer. Other areas of the building that are heated with hot water convectors are equipped with thermostatic control valves however many of them are not functional and in some cases damaged. The overall control system appears to be malfunctioning and the controllability of the system is less than desirable. We would recommend removing the stand alone electronic system and replacing it with a direct digital control system throughout.

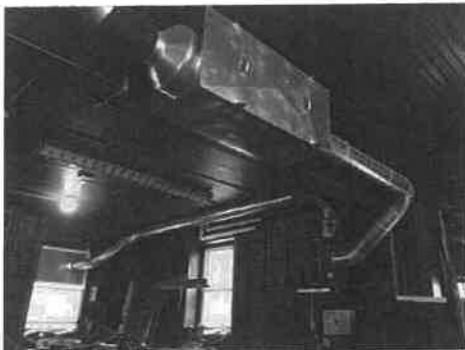
Plymovent Filter & Fan System

A vehicle exhaust air capture system is installed in the apparatus bay. The system is manufactured by Plymovent and consists of vent-set exhaust fan and filter. All the components are located in the apparatus bay. The ducted system consists of a track system which has flexible hoses which attach to the vehicle exhaust pipe, from there it goes to the main ductwork located high within the apparatus bay and then exits the exterior of the building and discharges high above the roof. The system utilizes a galvanized steel sheet metal distribution system and rubber flex hoses which have compressed air associated with them for easy connection and disconnection of the tail pipe connector. In general, the vehicle exhaust air system appears to be in good condition. The apparatus bay is also equipped with an wall mounted propeller exhaust fan for general exhaust which is activated through a wall switch. Hot water unit heaters are utilized to heat the apparatus bay. The apparatus bay unit heaters are antiquated and currently do not provide sufficient heat for the two bay garage. Controllability of these unit heaters is through standalone wall mounted thermostats.

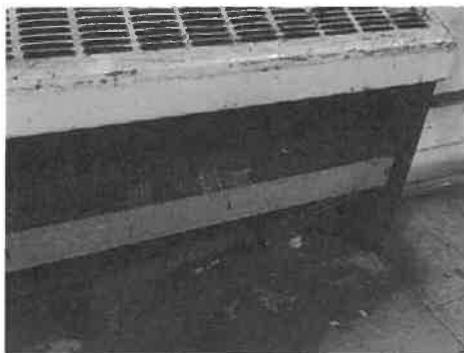
The office area and sleeping quarters utilize wall mounted hot water convectors. The office area on the first floor utilizes wall mounted hot water convectors which is controlled via a wall mounted standalone thermostats. The second floor sleeping quarters also utilizes convectors, majority of these units are damaged, dirty and non-functional. Majority of them do not have any type of control associated with them and those that do utilize thermostatic control valves that are wall mounted. These pieces of equipment run wild and generally overheat or do not provide enough heat for the spaces. Overall the terminal heating system throughout the building is damaged, missing components, and antiquated. The systems require a complete replacement.

Typical Damaged Convector

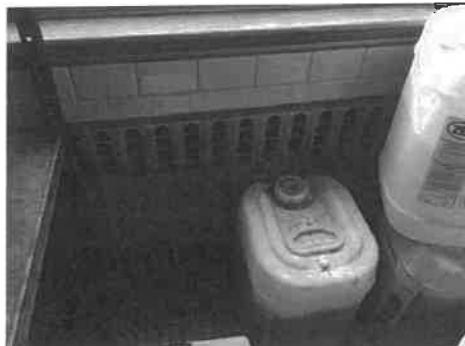
There is no mechanical exhaust system for the shower or toilet room which is not code compliant. Operable windows provide natural ventilation to these spaces. Floor mounted convector is located in the bathroom on the second floor. The convector is antiquated and is in need of replacement.

Typical Cast Iron Convector

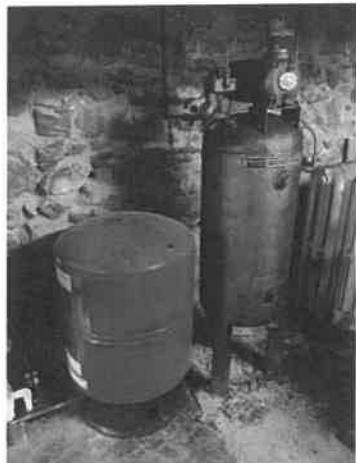
Hot water expansion is completed through the use of a vertical non-insulated bladder style expansion tank. This tank was also recently replaced and in excellent condition. However, it is not insulated and should be to help reduce the systems heat loss.

Expansion Tank

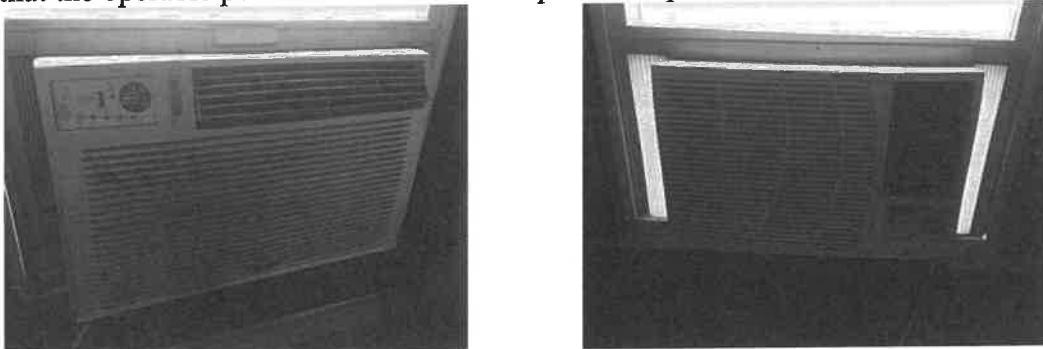
There is no central air conditioning system in the Fire Station. Window air conditioning units are located throughout the fire station. As for ventilation air, there are no mechanical ventilation units. The building utilizes operable windows as its means for ventilation, this is allowed by code however the actual requirements required by the code do not appear to be achieved with the current windows. A review of the current windows and square footage would need to occur to ensure that the operable portion of the window equals four percent of the floor area.

Typical Window Air Conditioner

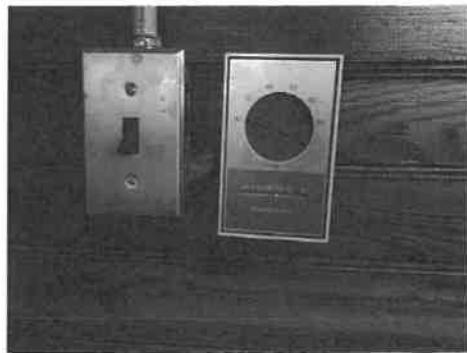
Automatic temperature controls for the building is minimal, some equipment such as the unit heaters in the apparatus bay are controlled with standalone electronic thermostats. These standalone thermostats are tied directly into each unit and are antiquated. These thermostats were provided by the equipment manufacturer. Other areas of the building that are heated with hot water convectors are equipped with thermostatic control valves however many of them are not functional and in some cases damaged. The overall control system appears to be malfunctioning and the controllability of the system is less than desirable. We would recommend removing the stand alone electronic system and replacing it with a direct digital control system throughout.

Standalone Thermostat

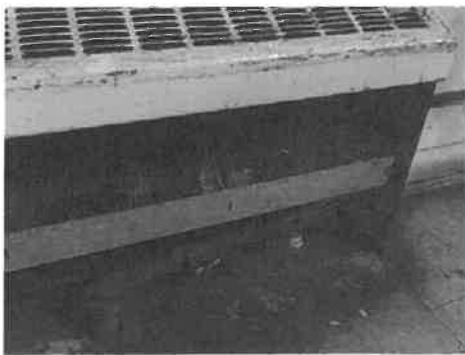
The office area and sleeping quarters utilize wall mounted hot water convectors. The office area on the first floor utilizes wall mounted hot water convectors which is controlled via a wall mounted standalone thermostats. The second floor sleeping quarters also utilizes convectors, majority of these units are damaged, dirty and non-functional. Majority of them do not have any type of control associated with them and those that do utilize thermostatic control valves that are wall mounted. These pieces of equipment run wild and generally overheat or do not provide enough heat for the spaces. Overall the terminal heating system throughout the building is damaged, missing components, and antiquated. The systems require a complete replacement.

Typical Damaged Convector

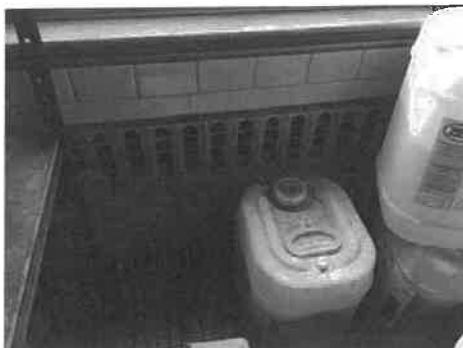
There is no mechanical exhaust system for the shower or toilet room which is not code compliant. Operable windows provide natural ventilation to these spaces. Floor mounted convector is located in the bathroom on the second floor. The convector is antiquated and is in need of replacement.

Typical Cast Iron Convector

Provide heating, ventilation and air conditioning requirements throughout the building through the use of new gas-fired rooftop units and supplemental terminal heating equipment such as radiant ceiling panels or wall mounted fin tube radiation.

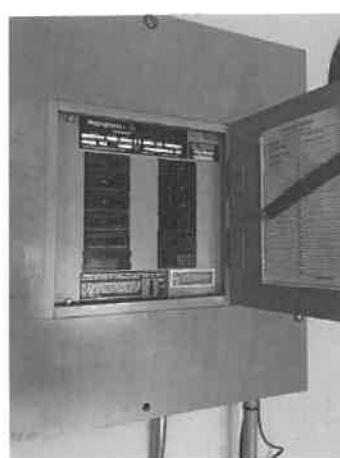
The Distribution System is in poor condition and inadequately sized for a renovation program.

Sub-panel

- The electrical service is marginal for this facility and the voltage and phase is not suitable for a public safety facility. The entire service should be replaced with a 120/208V, 3Ø, 4W service adequately sized and housed in a code compliant space.
- Electrical power will be brought into the site via underground medium voltage cables from the utility company network. A pad mounted step-down transformer will be located at grade adjacent to the building. Service entrance and distribution switchgear will be located in the Electrical Room near the Mechanical Room, along with lighting and power distribution panels.

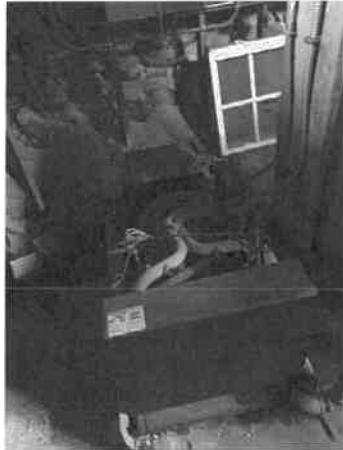
The emergency generator and the automatic transfer switch are in poor condition. Life safety lighting is fed from the generator and is not compliant with today's codes. Exit signs are in fair condition; however, are not installed in all required locations. The generator is undersized and should be replaced in a renovation program.

Generator

- The Emergency Power System should be replaced with a code compliant generator rated at 120/280V, 3Ø, 4W with adequate capacity for emergency loads and other critical stand-by loads.

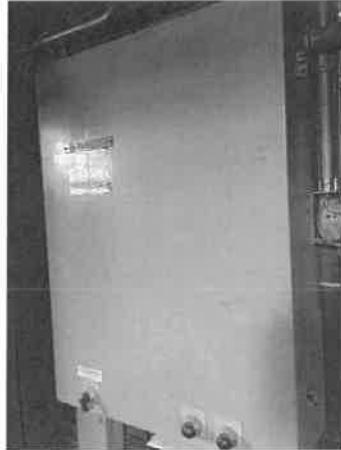
Automatic Transfer Switch

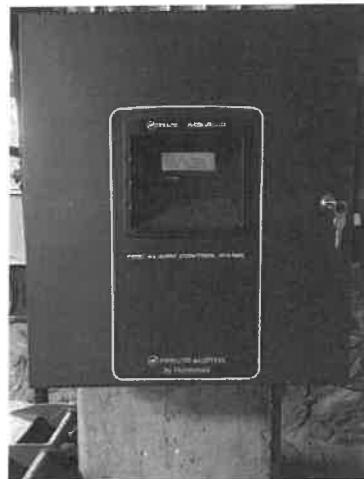
The building has a 4 zone microprocessor based fire alarm control panel manufactured by Fire Lite, Model MS-5UD. The panel seems to be in good condition; however, the notification devices and detection devices are in poor condition.

There is a combination of heat detectors and smoke detectors located throughout the building. The dorms do not meet the latest codes with respect to notification as they do not have low-frequency horns in sleeping areas. Self-contained Kidde wall mounted CO detectors are located in the Corridor outside the dorms. Horn strobe coverage is inadequate.

FACP

- Fire Alarm System should be replaced with an addressable, ADA compliant system with full coverage.
- A Fire Alarm and Detection System will be provided with 60 hour battery back-up. The system will be of the addressable type, where each device will be identified at the control panel and remote annunciator by device type and location to facilitate search for origin of alarms.

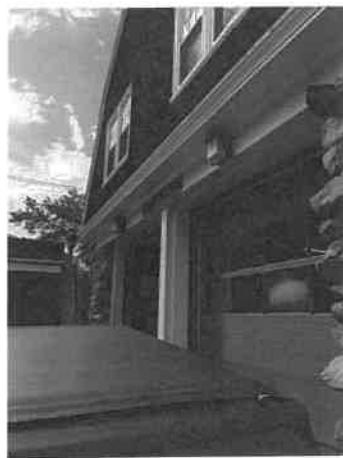
Exterior lighting consists of HID building mounted floods. Fixtures are in poor condition and are not dark sky compliant.

Exterior Lighting

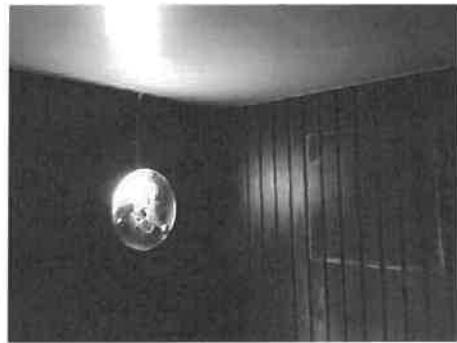
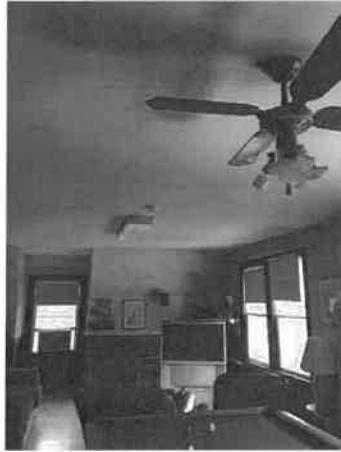
Lighting in general is in poor condition, lacks proper controls, and light levels are too low in most spaces.

Ceiling Compact Fluorescents

Wraparound – General Lighting

All lighting should be replaced in a renovation program.

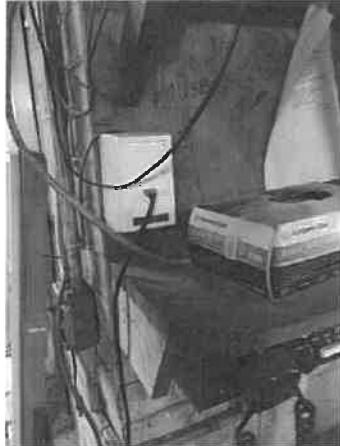
Receptacle coverage is minimal and inadequate in various spaces. Extension cord use was noted due to scarcity of the outlets.

Extension Cords

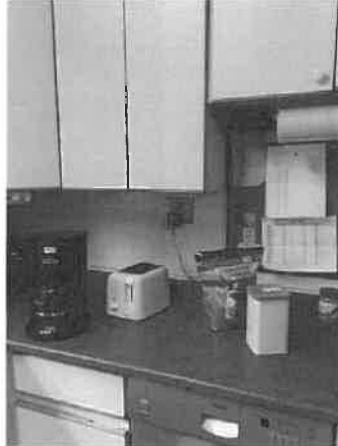
Kitchen receptacles and Boiler Room do not have ground fault protection. The general wiring method is pipe and wire.

Kitchen Receptacles

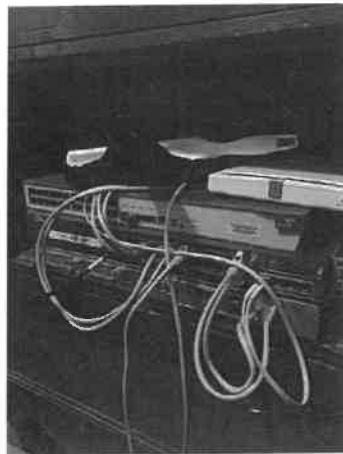
Tel/Data

The telephone service, CATV, and town fiber run overhead in the street and enter the building underground in the lower level. The fiber is terminated on a wall mounted fiber optic cabinet in the upper level Closet and connects to the building's data rack. The data rack is located in a closet with poor ventilation which will lead to shortened life of the equipment.

The building data/phone infrastructure consists of Cat5e wiring directly to the Cisco switches that are plugged into a local APC UPS.

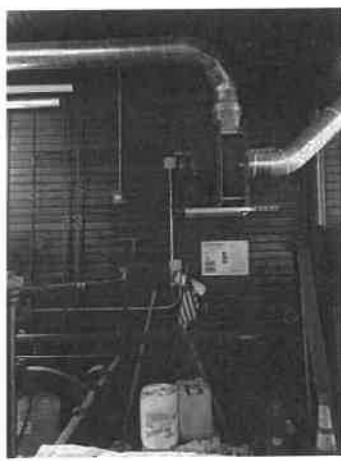
Plymovent Control Panel

Plymovent Vehicle Exhaust System exists; control panel is located in the Apparatus Bay and is in good condition.

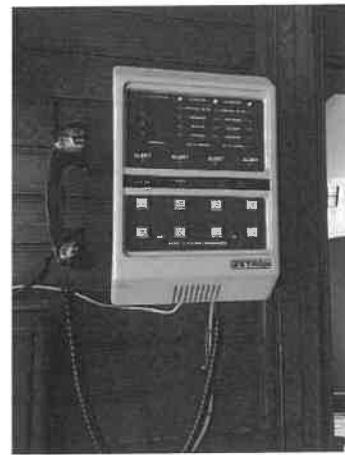
Zetron Model 6 for incoming alarms is located outside the Watch Room and is in fair condition.

Antiquated technology is used to monitor City fire alarms.
