APPENDIX D

MEMORANDUM

TO: Route 138 Corridor Planning Study Files

RE: Task 6: Recommend Corridor Improvement Alternatives

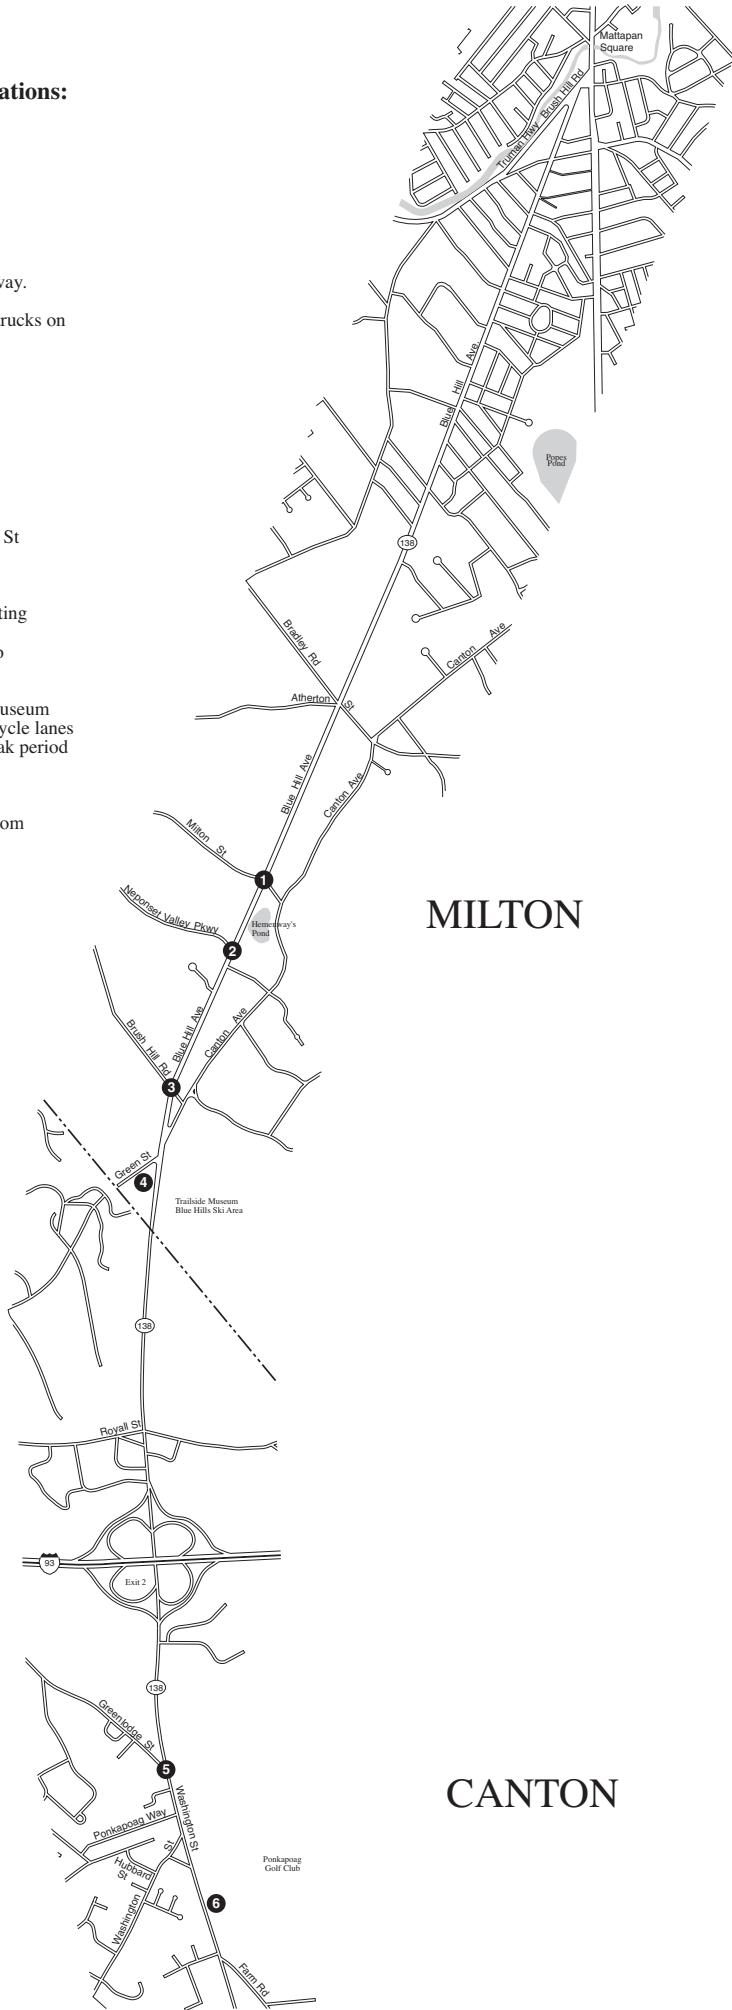
FIGURE 1a
Route 138 Corridor Concerns and Recommendations:
Northern Half
(Milton/Canton [partial])

5. Add signage prohibiting AM and PM peak period left turns from Greenlodge St. to Route 138.
6. Improve roadway drainage on and/or adjacent to Route 138.

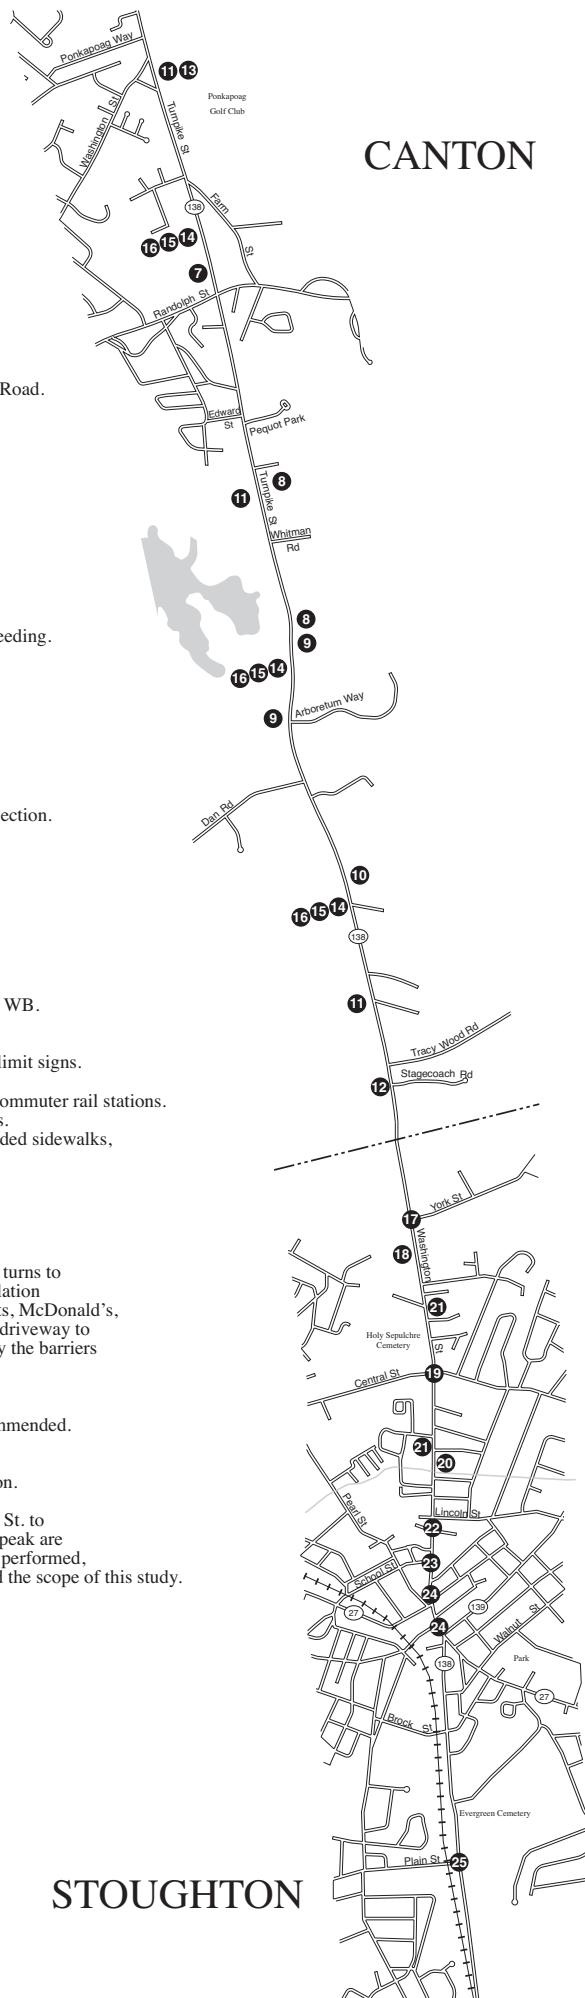
FIGURE 1b
Route 138 Corridor Concerns and Recommendations:
Southern Half
(Canton [continued]/Stoughton)

12. An exclusive left turn lane has been proposed to be added to Stagecoach Road WB. A signal is not warranted.
13. Enforce speed limits through greater police presence and/or portable roadside speed indicators reminding drivers of posted speed limits. Add missing speed limit signs.

20. Make curb cuts more defined (#472, #500, #590, others).
21. Install an exclusive left turn lane on Route 138 northbound at the Block Buster plaza driveway. Sidewalks on the northbound side are also recommended.

24. Enhance existing crosswalks. Add signage prohibiting left turns from Wyman St. to Stoughton Square in the AM peak period. Currently, left turns during the PM peak are prohibited. It is recommended that a full traffic study of Stoughton Square be performed, with analysis and development of improvement alternatives, which are beyond the scope of this study.

25. New traffic signal and widening of Route 138 at Plain St intersection.

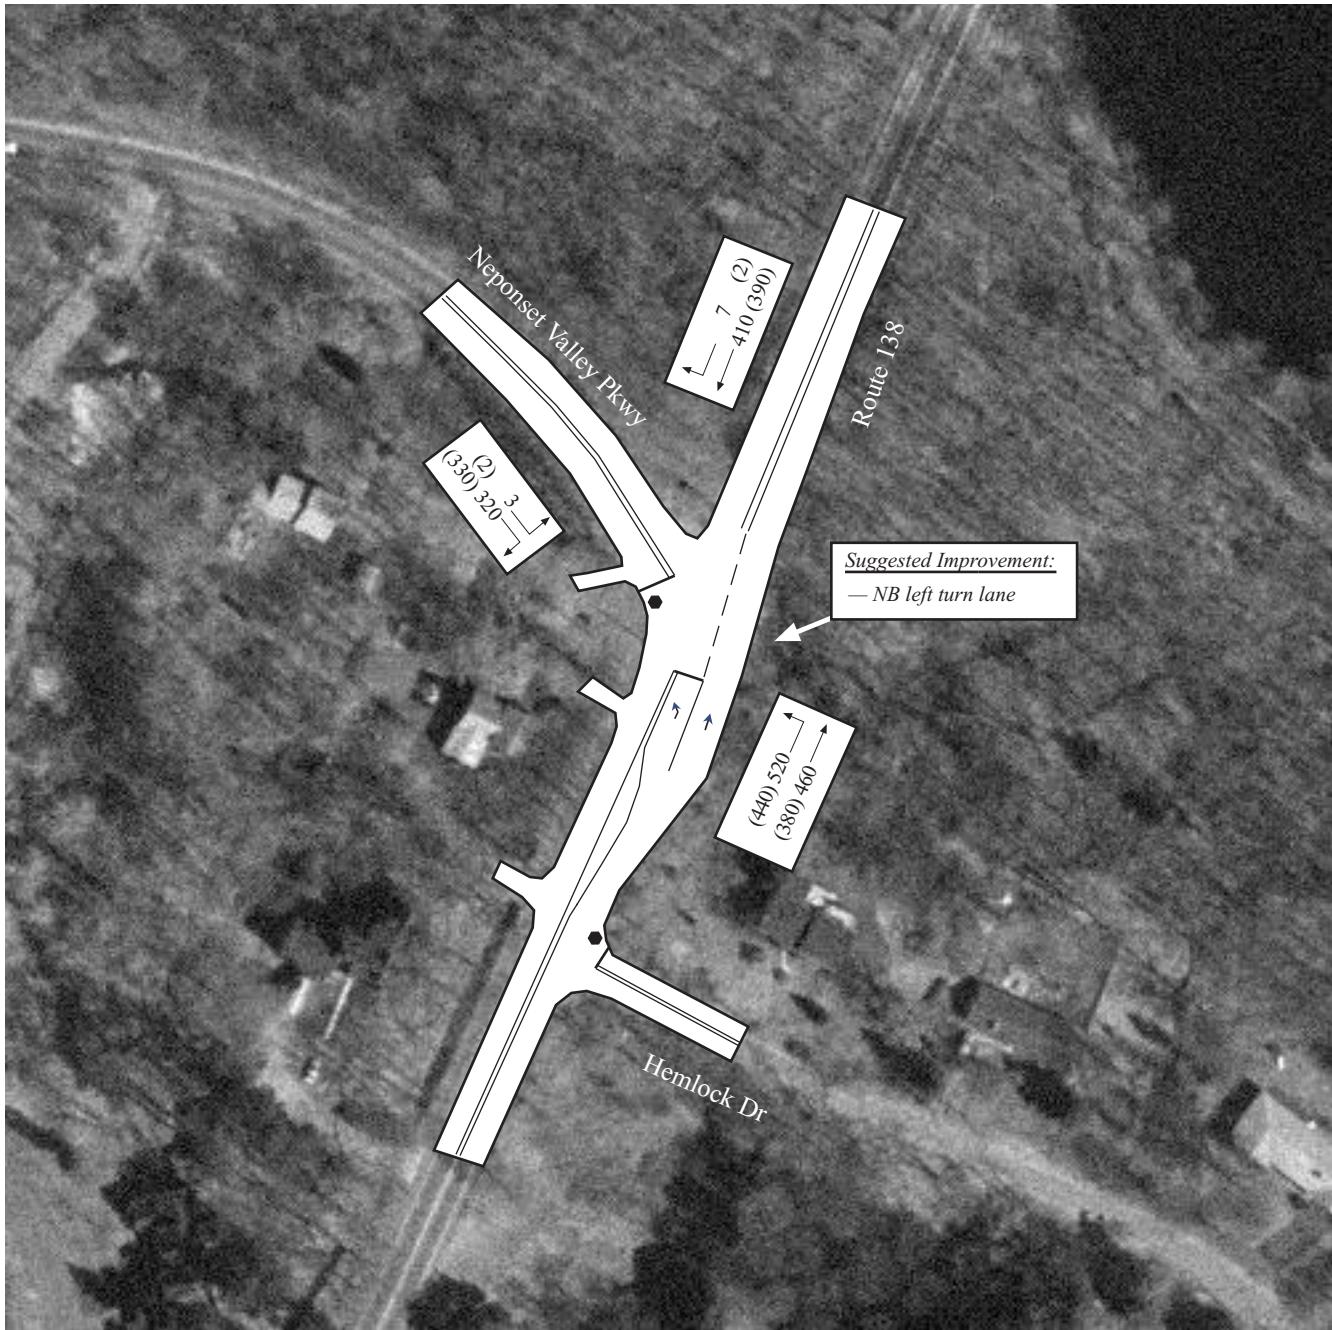
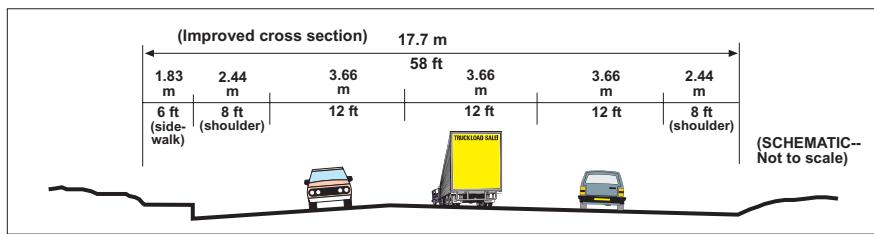
Figure 2
Route 138 at Neponset Valley Parkway (Milton)
— **Suggested Intersection Improvements**
— **1999 AM (PM) Peak Hour Turning Movements**

were angle collisions. Figure 2 shows the intersection and the 1999 AM and PM peak hour turning volumes.

It is recommended that an exclusive left-turn storage lane be created on Route 138 in the northbound direction. The large proportion of vehicles turning left onto Neponset Valley Parkway would thereby be accommodated. The added lane, which would fall under the jurisdiction of MassHighway, would also enable through traffic to safely bypass turning vehicles, potentially reducing the incidence of rear-end collisions. It would especially provide additional storage for Stop & Shop and other trucks making left turns. Available right-of-way (ROW) is 55 ft. However, widening this location to a three-lane cross section would result in a width of 64 ft, requiring waivers. The cross section would consist of three 12-ft lanes, painted 8-ft shoulders/bicycle lanes, and 6-ft sidewalks on both sides. The new cross section would be 58 ft if sidewalks are constructed on just one side of Route 138 (see Figure 2).

Analysis showed that warrants for installing a new traffic signal at this intersection are met (see Appendix D-3). MassHighway has previously proposed a signal for this location. It is recommended in this study that, in the event that the proposed signal project goes forward, a northbound left-turn lane be included as well. LOS analysis showed that without such a left-turn lane the intersection would experience unacceptable levels of service.

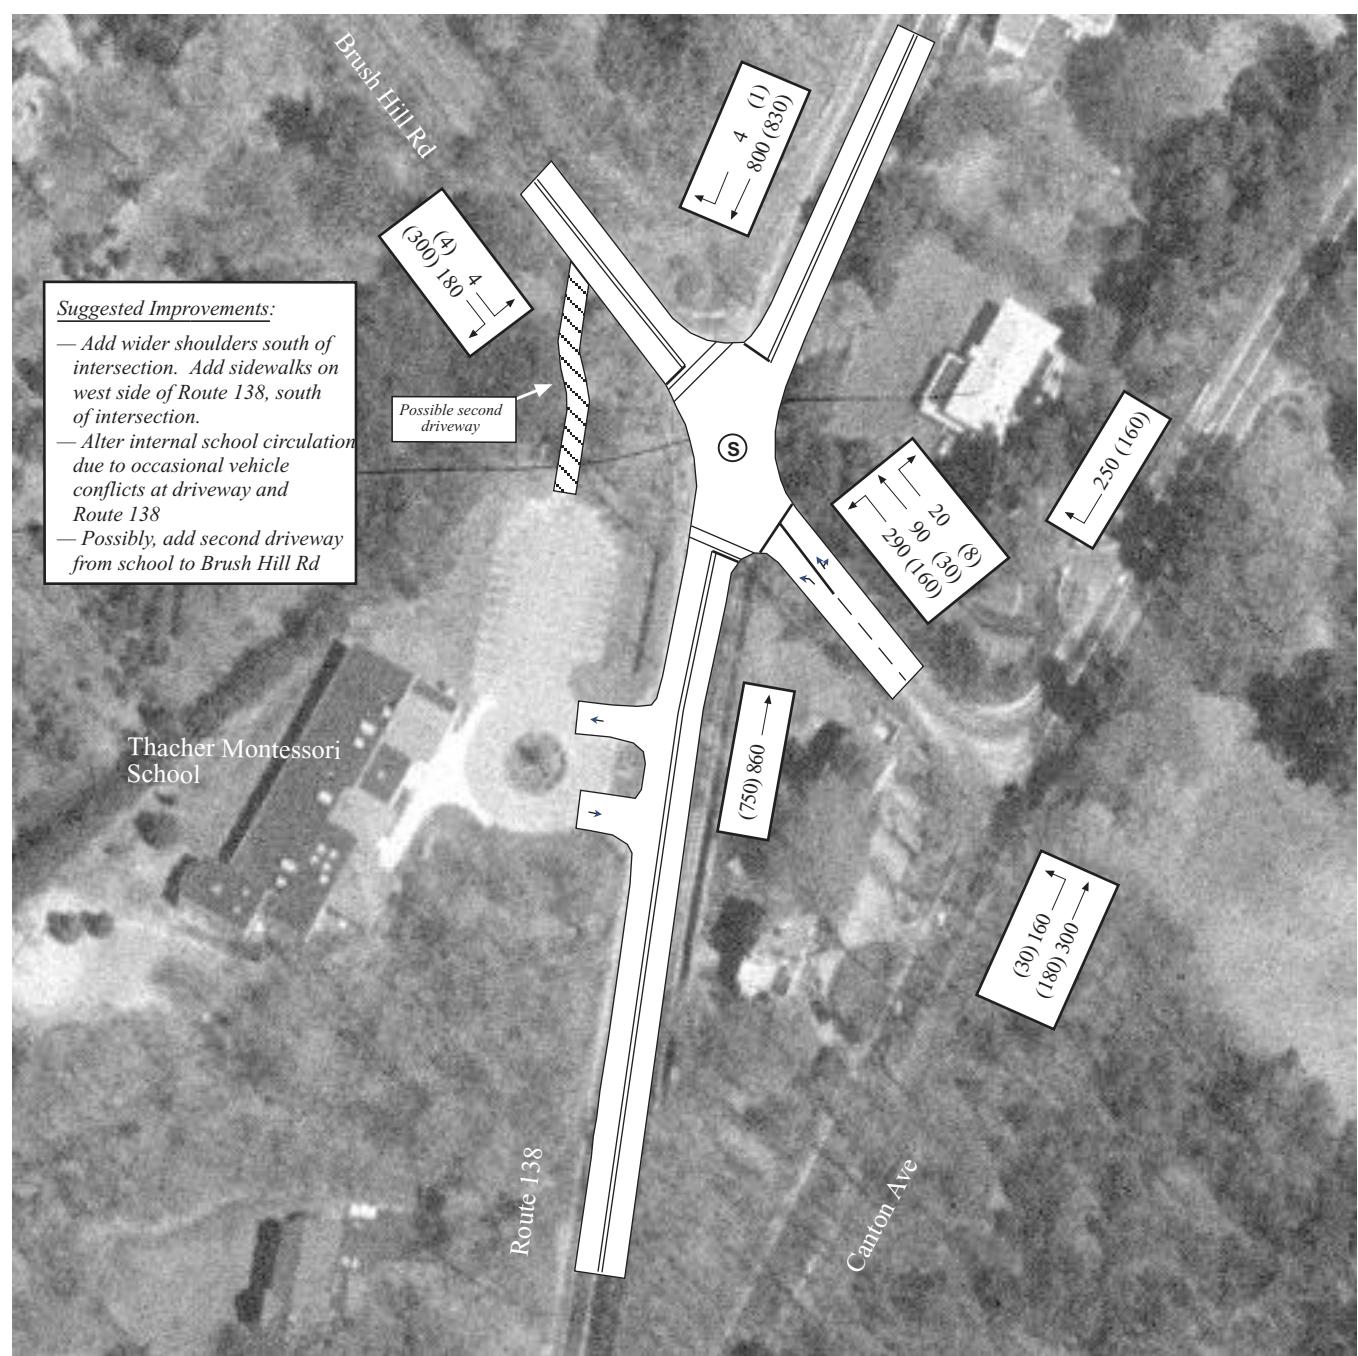
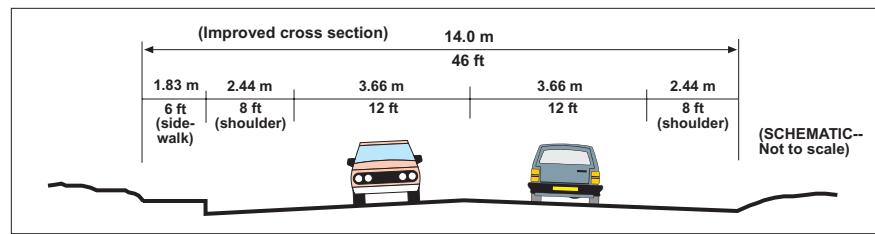
An additional recommendation is that the Town of Milton propose to the school that it alter its internal driveway circulation, by requiring parents to park their vehicles in the parking lot prior to dropping off/picking up their children. This would decrease the potential for vehicles backing out onto Route 138. It should also be investigated by Milton officials whether a second driveway from the school could be added with access to Brush Hill Road, west of the signal. A second driveway would further decrease the potential for driveway/Route 138 vehicle conflicts (see Figure 3 for 1999 turning movements and recommended improvements).

Recommended improvements at this location are based on improving safety. *It is recommended that Route 138 south of the signal be resurfaced and widened to current standards. This would provide wider breakdown/bicycle shoulders on both sides, sidewalks on the west (southbound) side, and crosswalks and a pedestrian phase at the signal* (see Figure 3 for an improved cross section as well as existing turning movements). These improvements would help to facilitate movements in and out of the school due to the wider shoulders, would not require waivers, and would fall under MassHighway's jurisdiction. New bicycle/breakdown shoulders on both sides (8-ft minimum), and sidewalks (6-ft minimum) on the west side of Route 138, would be constructed within the available 55 ft ROW, and would benefit local residents as well as residents at the new Fuller Senior Housing development just to the north. New sidewalks are not recommended on the east side of Route 138, because they would encourage pedestrians to try to cross the busy intersection where Route 138 and Canton Avenue diverge.

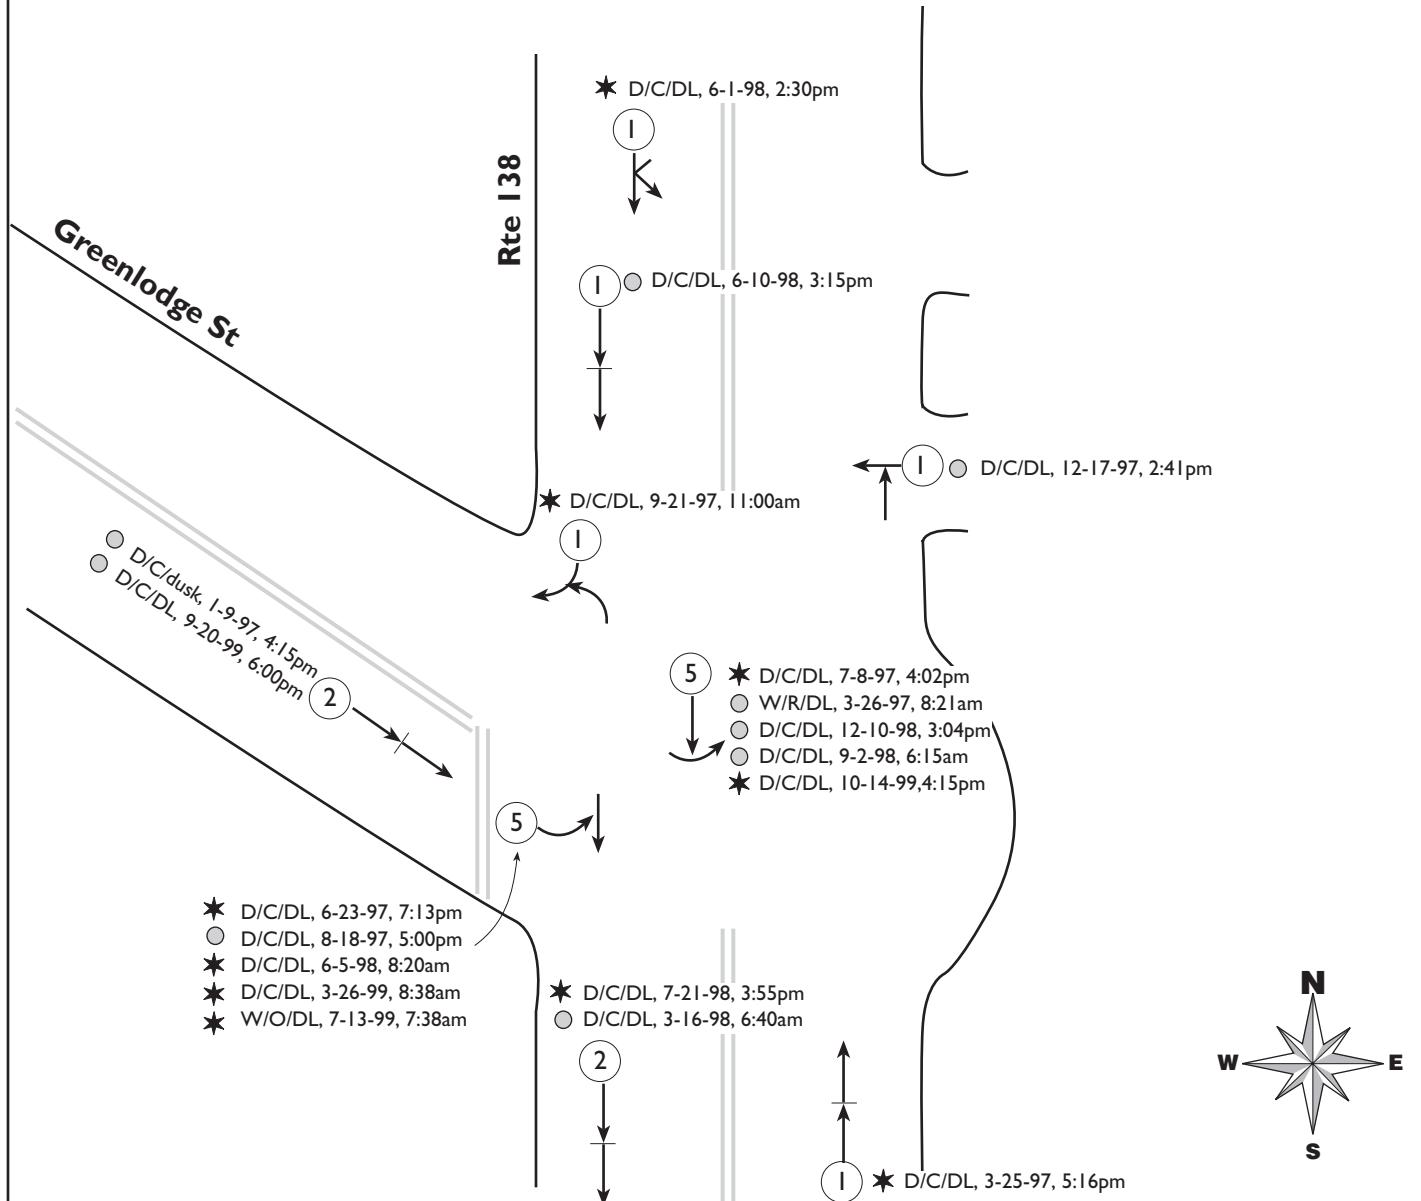
Figure 4
Collision Diagram
1/1/97 to 12/31/99
Route 138 @ Greenlodge St
Canton

Recommendation: Of the 19 accidents at this intersection reported to the Canton Police in 1997–1999, 13 were angle collisions. Of these, 10 involved left-turning vehicles from Greenlodge Street to Route 138 northbound, most of them occurring during the AM or PM peak

periods (see Figure 4). The intersection geometry is such that Route 138 has a significantly steep slope, and Greenlodge Street intersects Route 138 from the west at a 45° angle. Figure 5 shows the area around the intersection as well as the 1999 AM and PM peak hour turning movements.

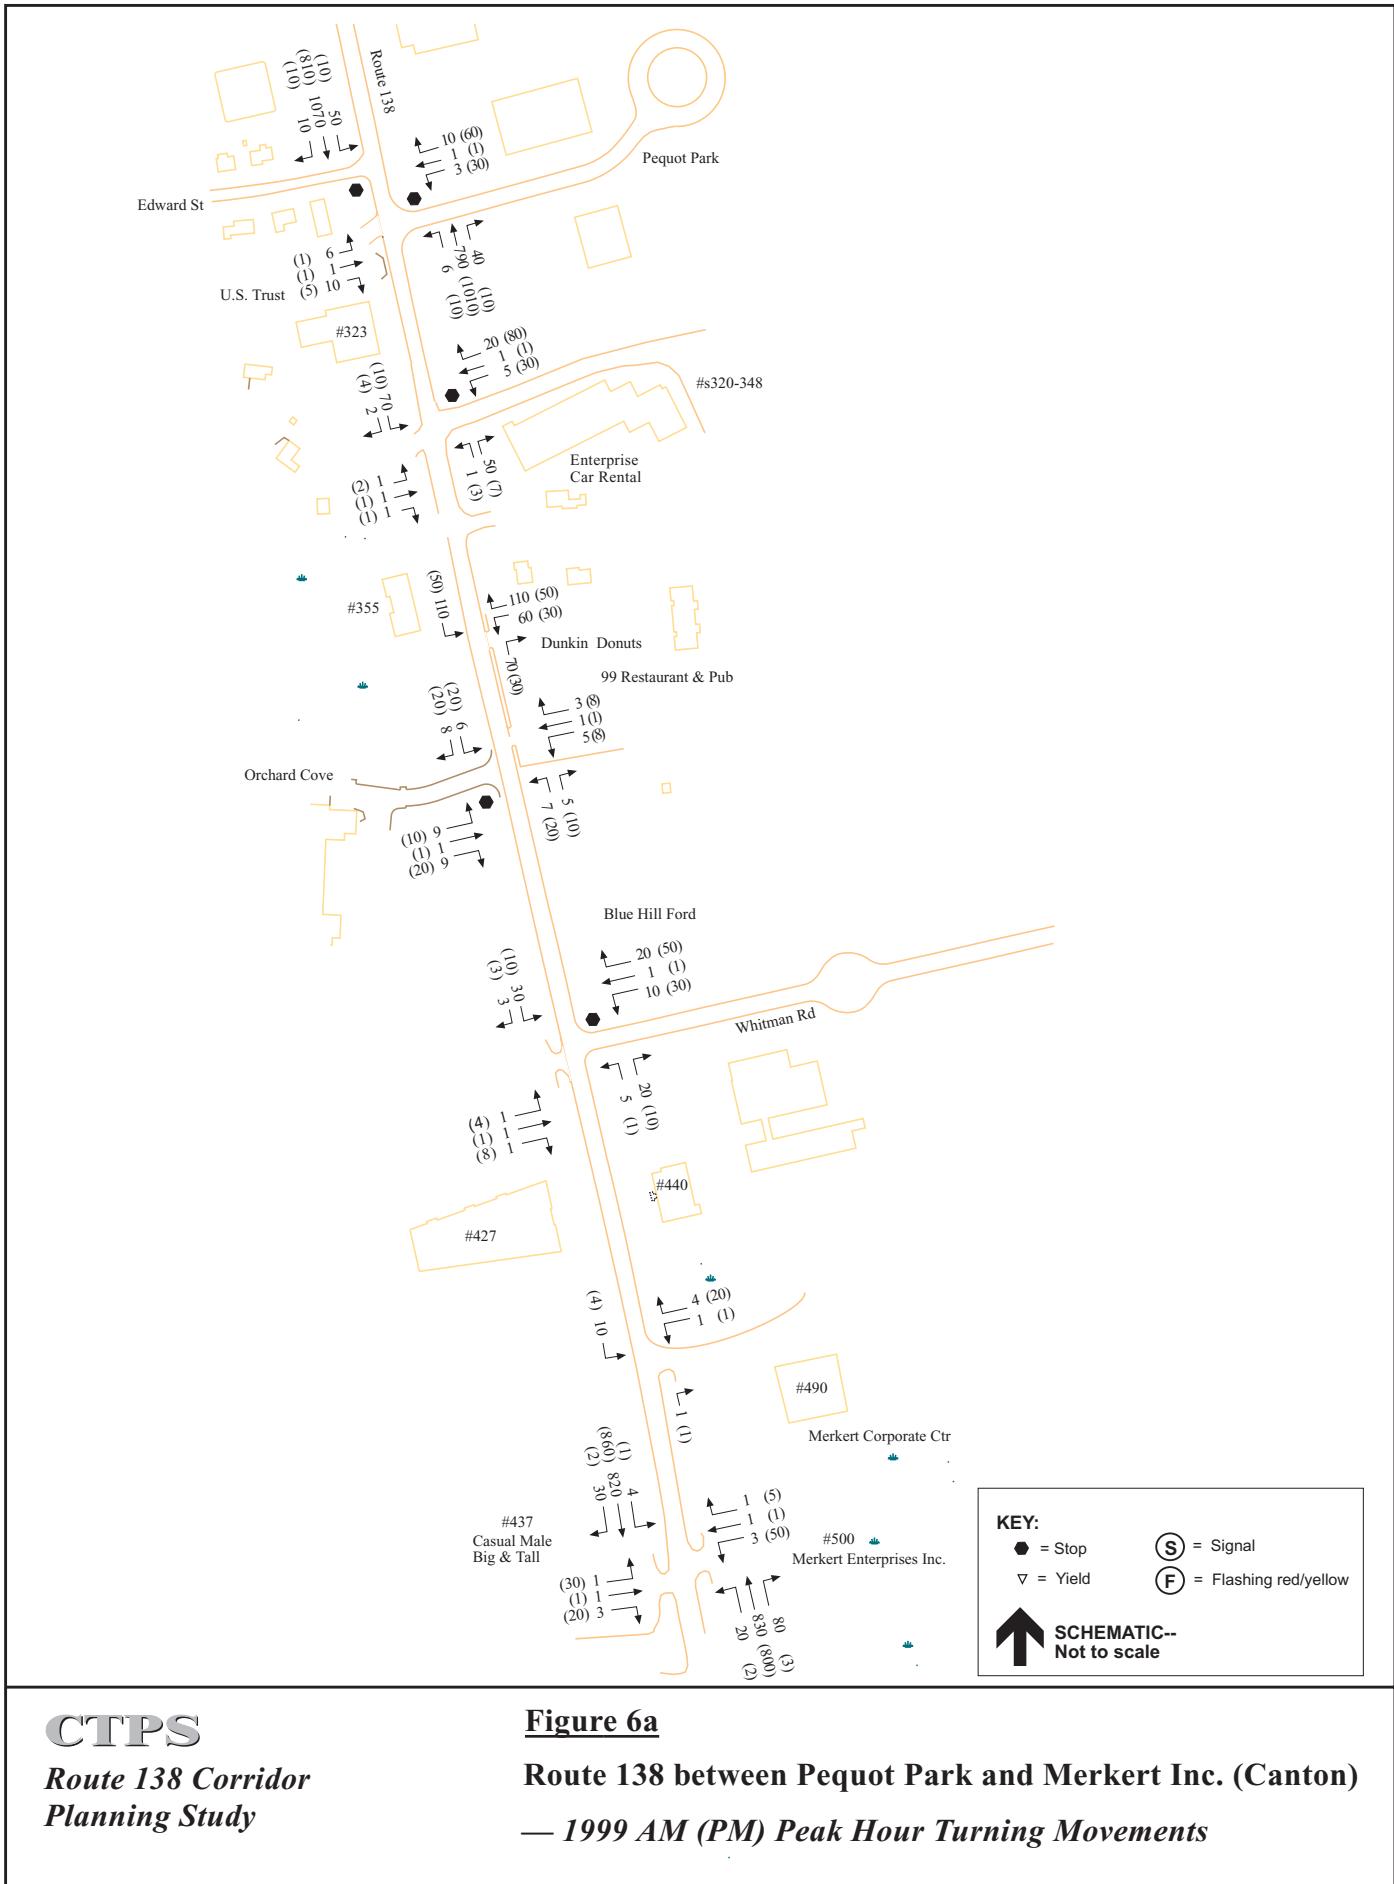
Recommendation: This segment of Route 138, approximately 3,400 ft in length, contains a number of driveways with AM or PM peak hour left-turn volumes ranging from fewer than 10 to more than 100 (see Figure 6a). As seen in Figure 6a, the vast majority of left (and right) turns are to/from properties on the east side of Route 138. Eighty-seven accidents (1995–1997, Mass. Registry) were about evenly split between rear-end and angle collisions throughout the segment. This indicates both the existence of congested, stop-and-go through traffic and an abundance of side street or driveway turning movements.

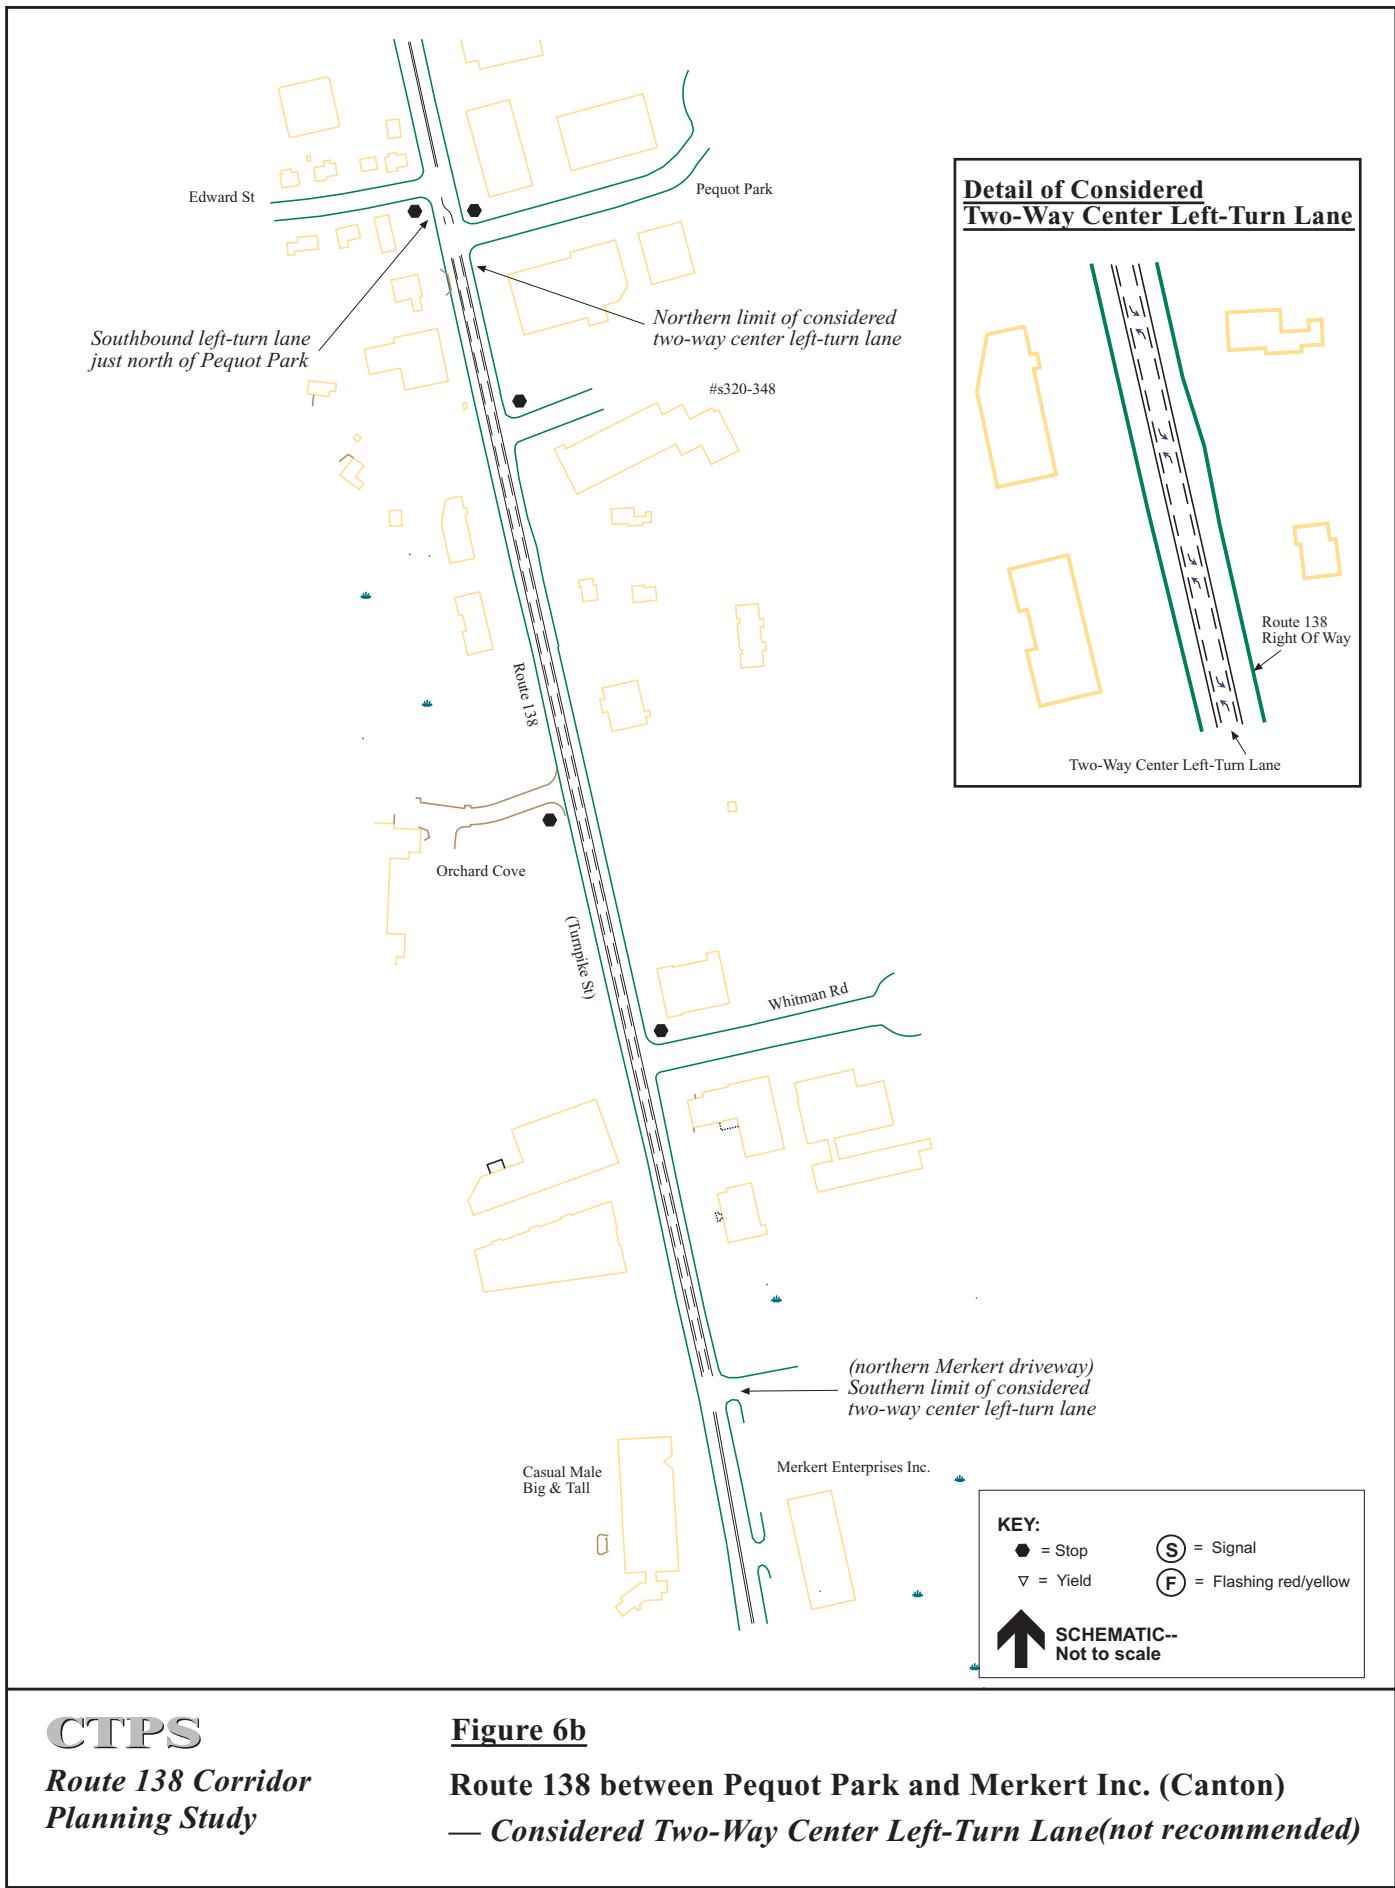
1. Install a 3,400-ft continuous two-way center left-turn lane between Pequot Park and Merkert Inc. (see Figure 6b).

increased risks for head-on collisions for the relatively few northbound left-turning vehicles. Also, a two-way center left-turn lane as part of a three-lane cross section is generally designed for roadways with daily volumes below 12,000.⁹ Route 138 has daily volumes of about 25,000 in this area. Therefore, a two-way center left-turn lane would not be an appropriate solution.

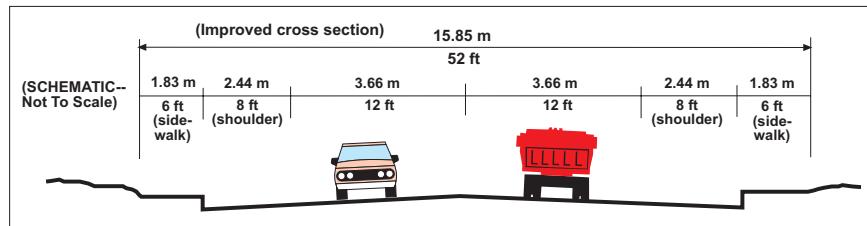
4. *It is recommended that the existing two-lane section from just north of Pequot Park to the northern Merkert Inc. driveway be resurfaced and widened. This would become an improved two-lane section, with wider shoulders and sidewalks, as well as curb cut consolidation (see diagram below).*

The rationale for this recommended improvement is the same as that for the preceding suggested improvement (#3): to accommodate the numerous left-turning vehicles in the segment.

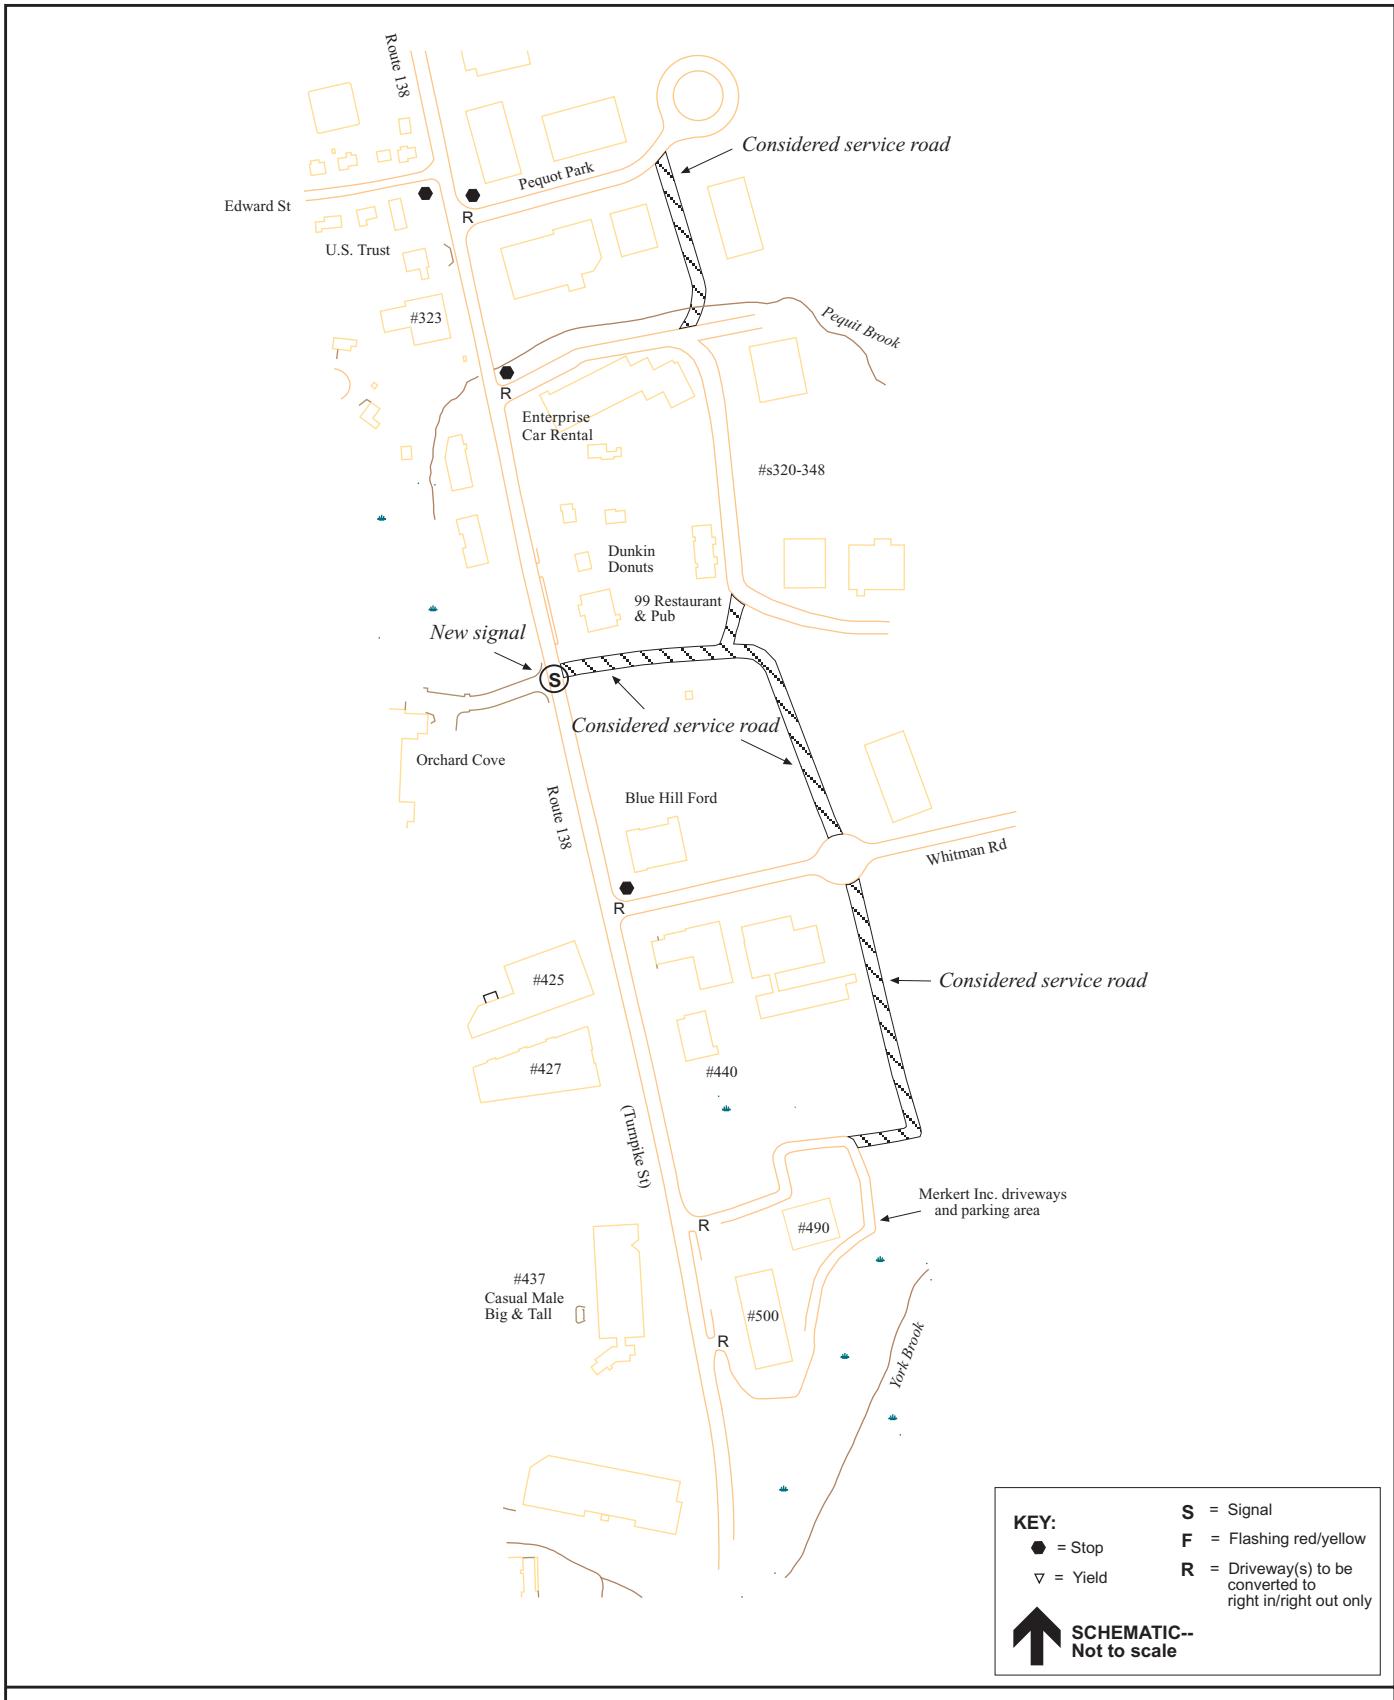
Figure 6c

2. Install a new signal at Route 138 at the Orchard Cove/99 Restaurant & Pub driveways, and an east side service road connecting at least five existing driveways (see Figure 6c). The five (or more) driveways would become right in/right out only, with all left-turn movements taking place at the new signal.

**Route 138 between Pequot Park and Merkert Inc. (Canton)
— Considered Service Road System(*not recommended*)**

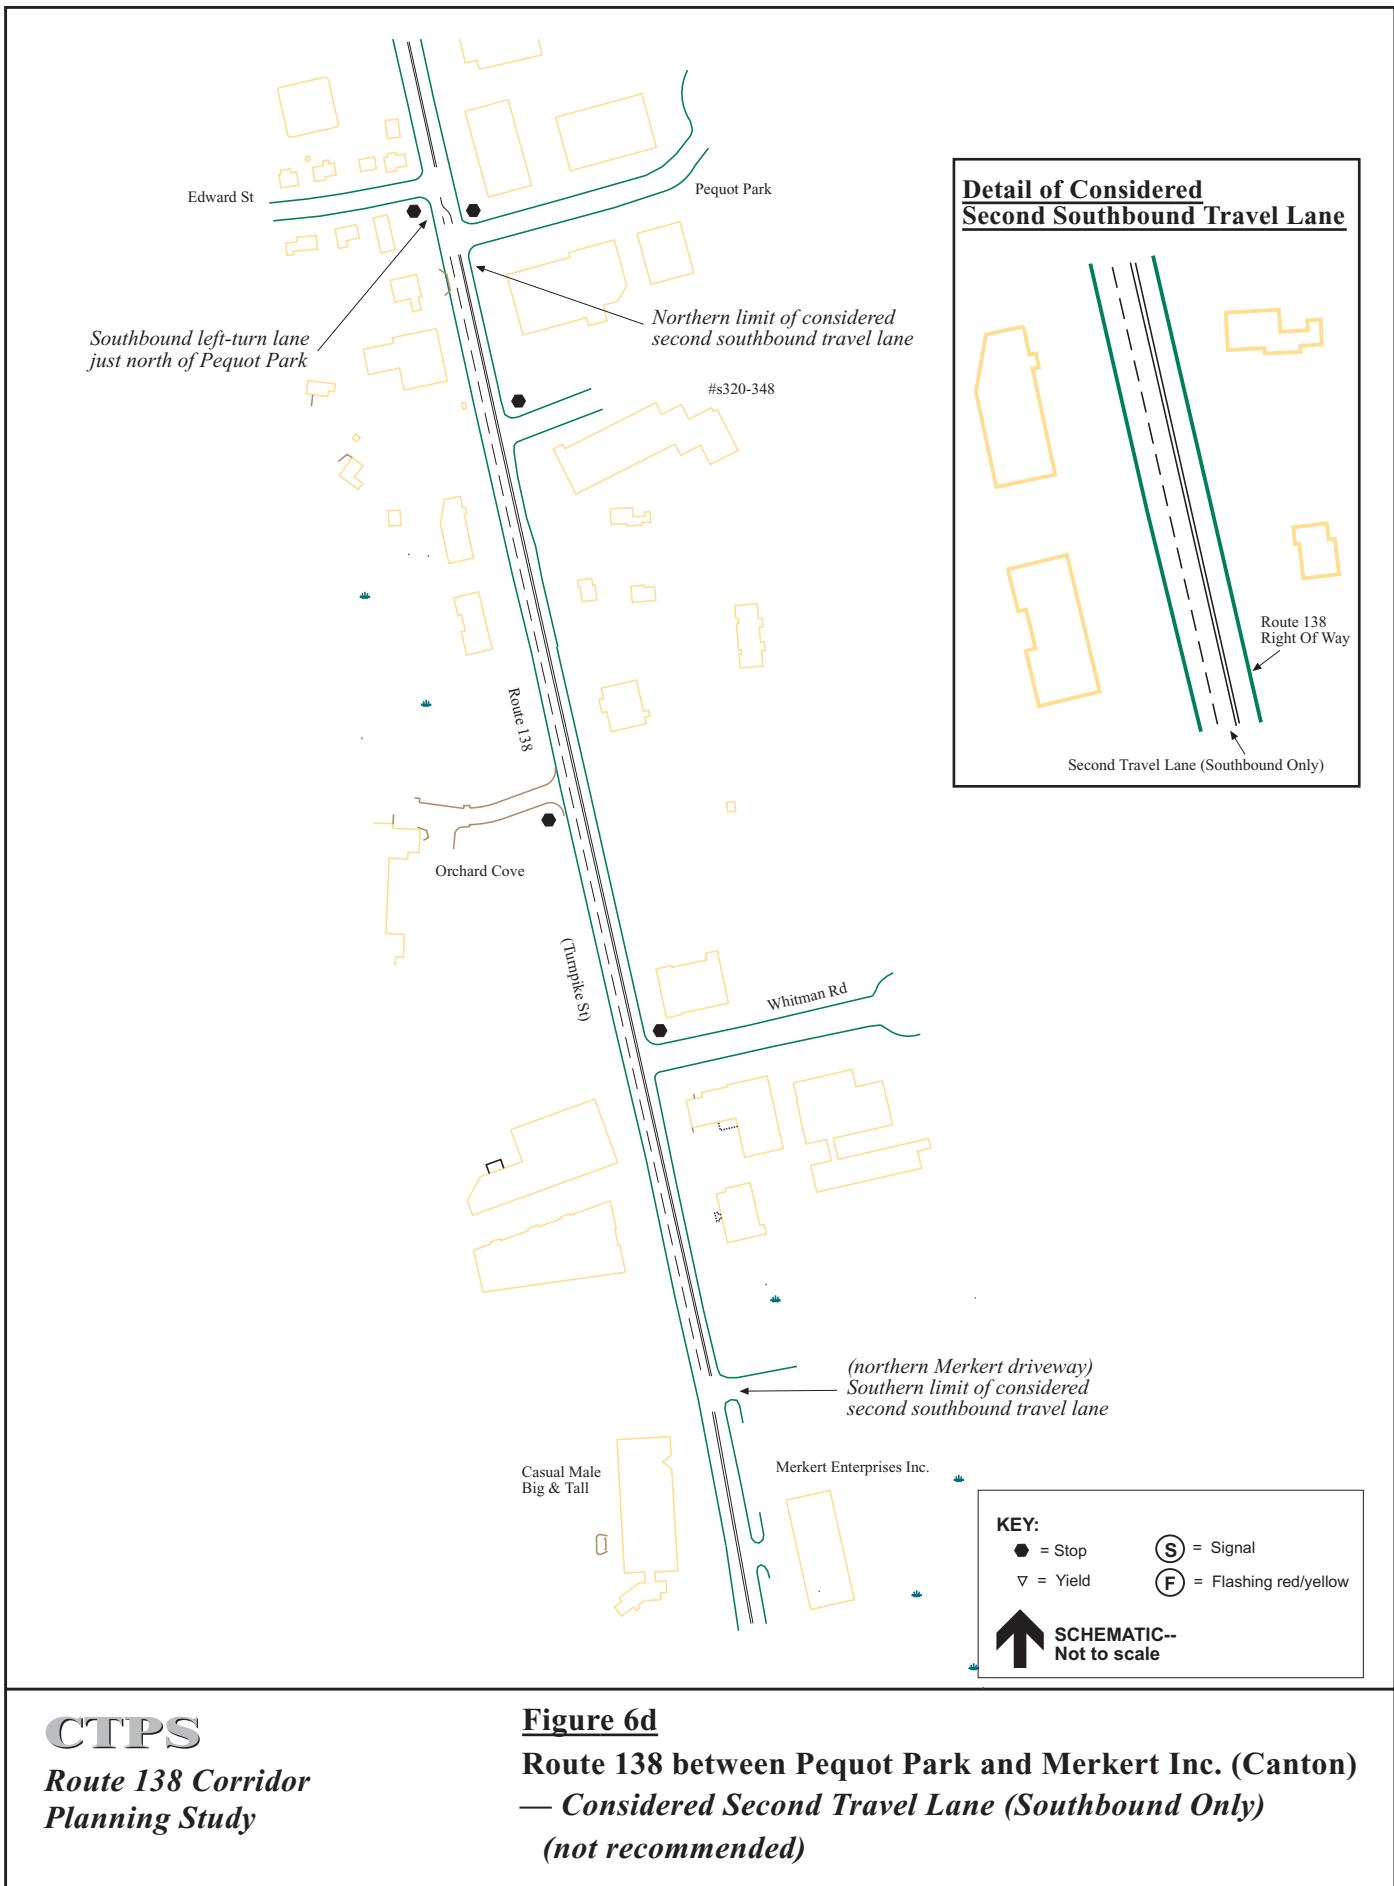
3. Install a second travel lane in the southbound direction only, from just north of Pequot Park to the northern Merkert Inc. driveway (see Figure 6d).

During data collection, manual turning movement counts were performed at six driveway locations within the segment. From these counts, it was found that more than 80 percent of all AM and PM peak hour left turns were to or from the east side streets and driveways.¹⁰ Any future development is more likely to occur on the east side due to the existence of a reservoir and wetlands on the west side. However, this improvement is not recommended since it would create an unbalanced cross section, potentially causing driver confusion and higher risks for collisions.

However, it is felt that it would be sufficient, and less confusing to drivers, to widen and resurface the roadway rather than add a full travel lane in one direction only.
